**Appendix E**  
**Cultural Resource Report**

# TOLAY LAKE CARDOZA RANCH

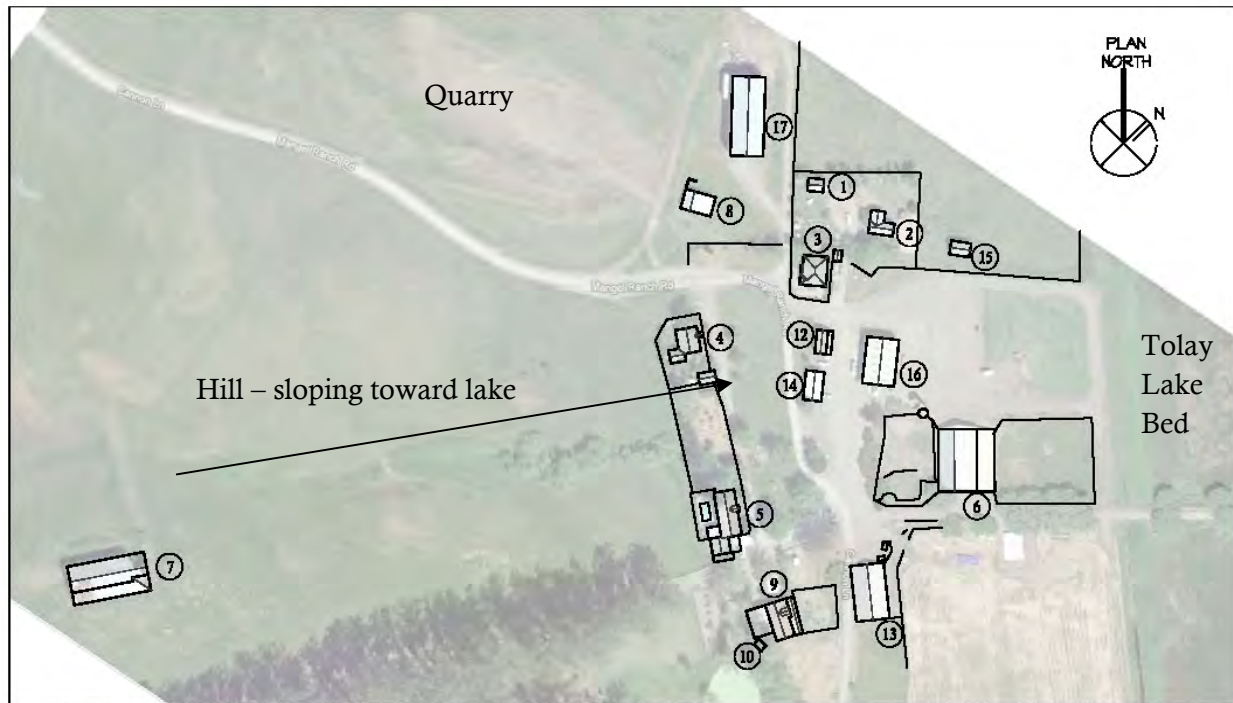
#### BUILDING LOCATION KEY

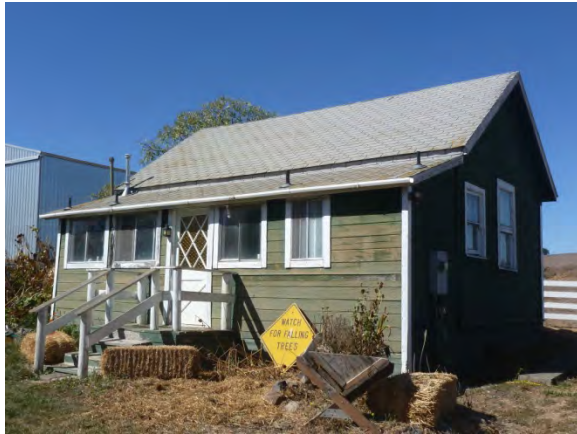
Image 1 - Entrance to Cottage, south side

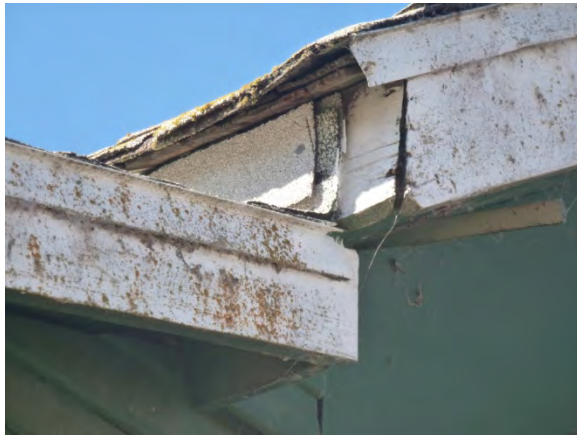
**Image 5 - Enclosed porch roof at Cottage**

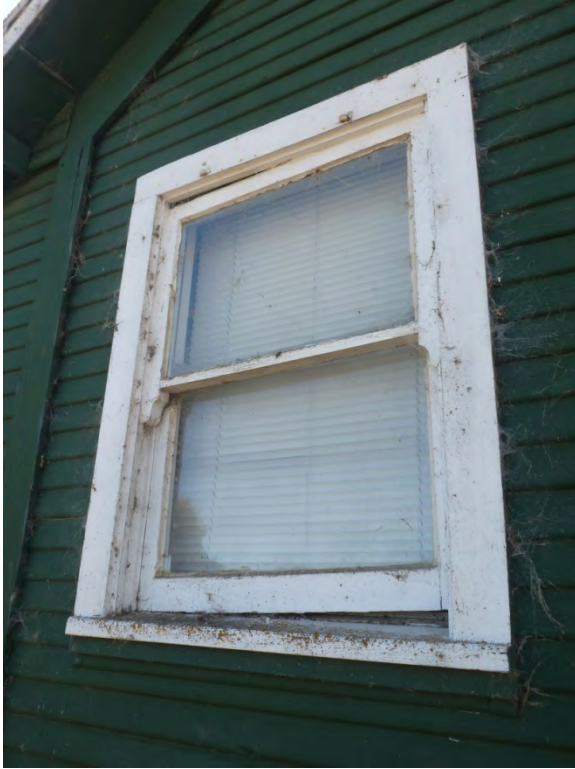
**Image 7 - Window at east wall showing frame  
wracked due to settlement**

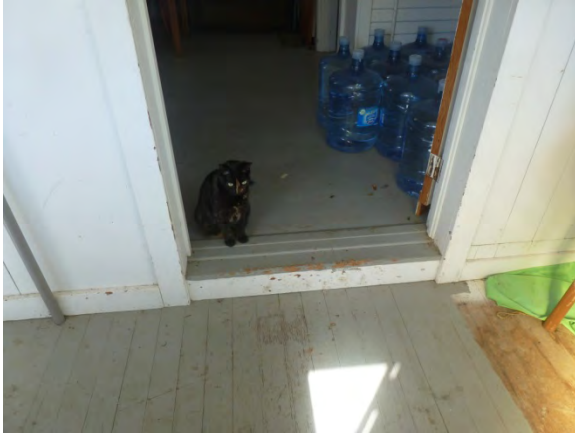
Image 8 - Step between enclosed porch and cottage

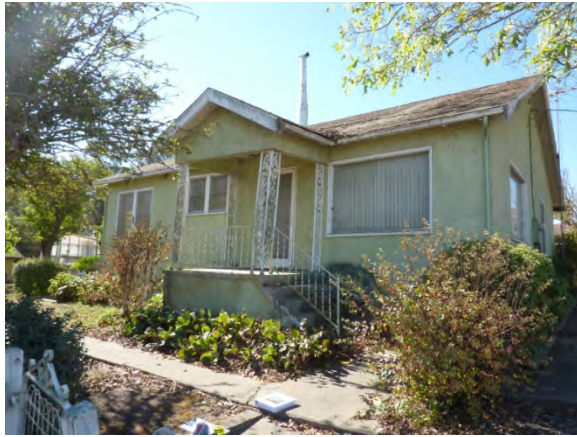
Image 10 – Front entrance to George and Vera’s House, east side

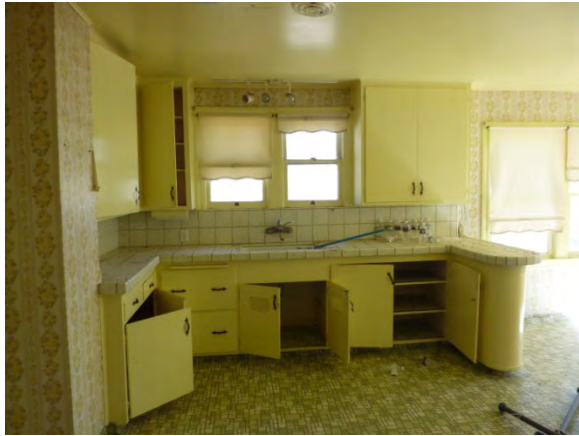
**Image 12 - Kitchen with original cabinets and counters**

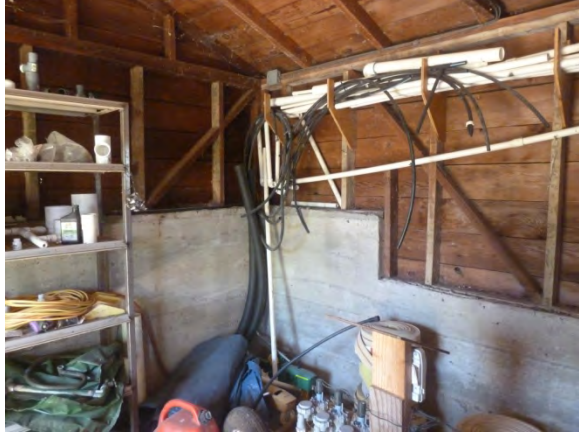
Image 15 - Interior of garage showing stepped foundation walls

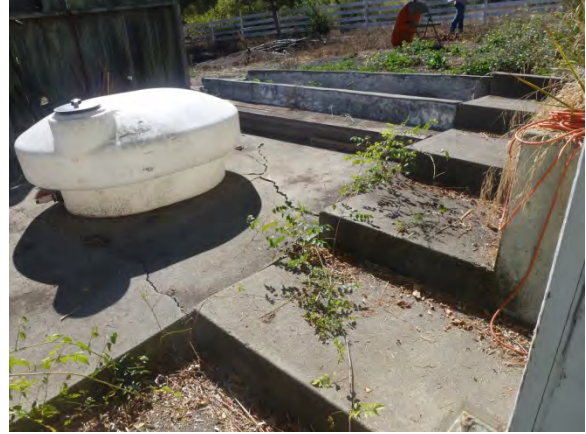
Image 16 - Terraced patio on south side of garage

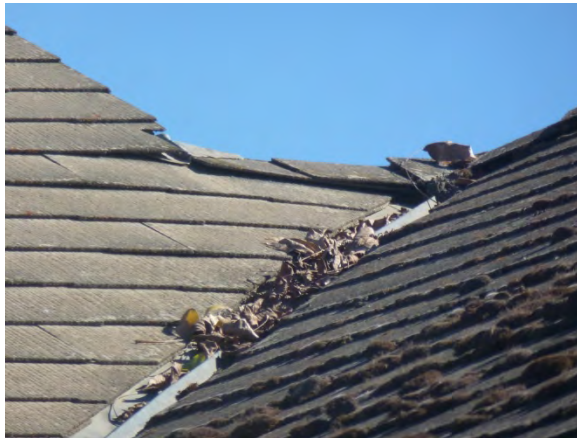
**Image 17 - Deteriorated shingles and debris**

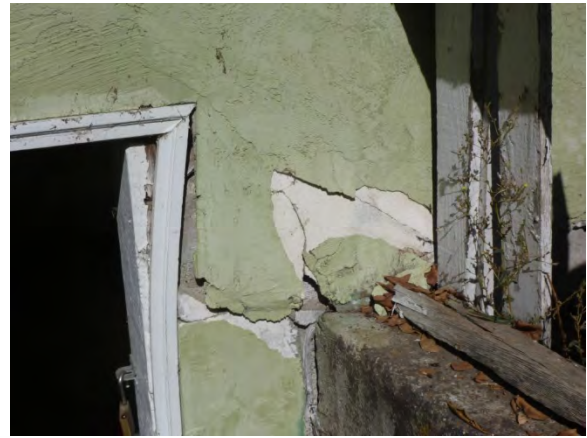
**Image 18 - Stucco at basement stair and door**

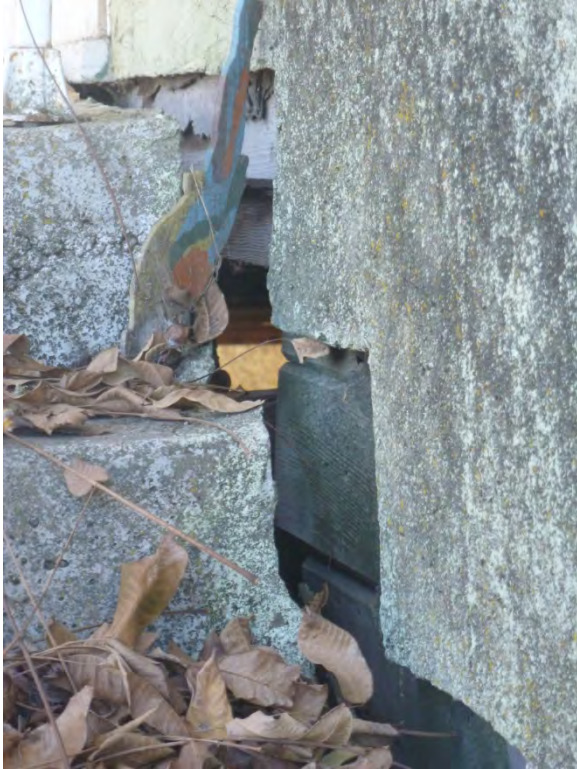
**Image 19 - Front porch separated from wall of house**

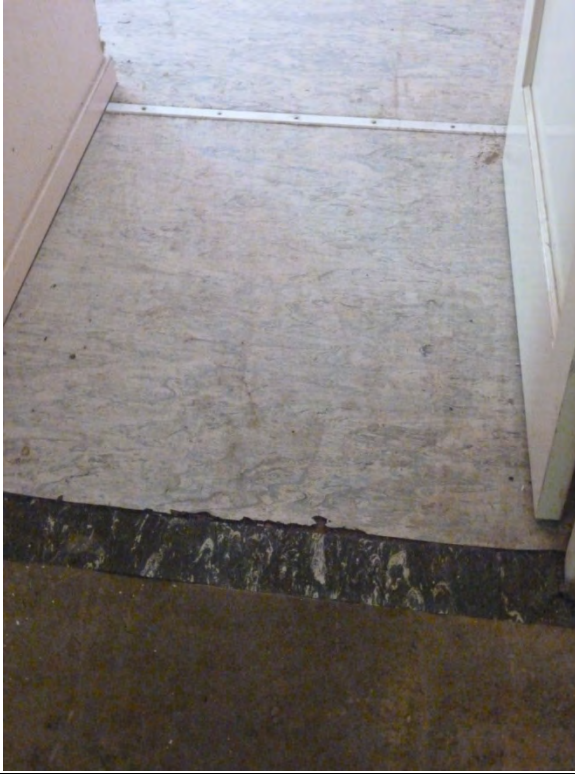
Image 22 - Multiple layers of flooring

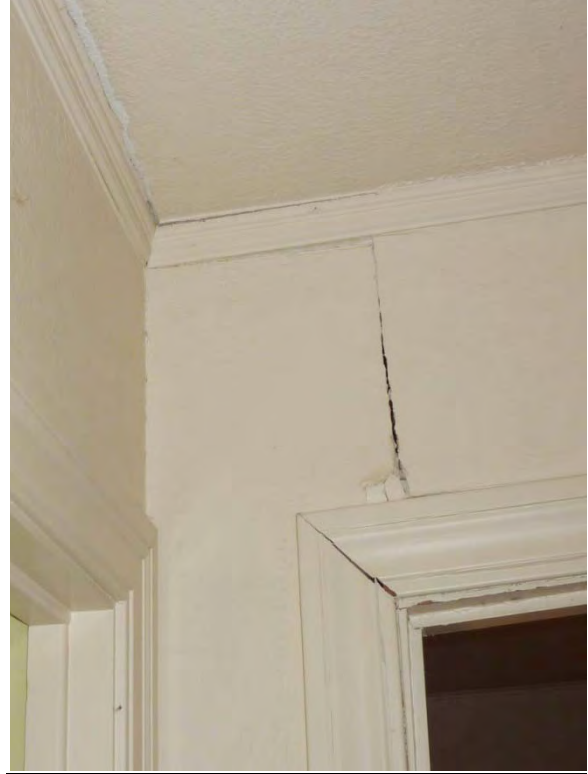
Image 23 - Settlement damage

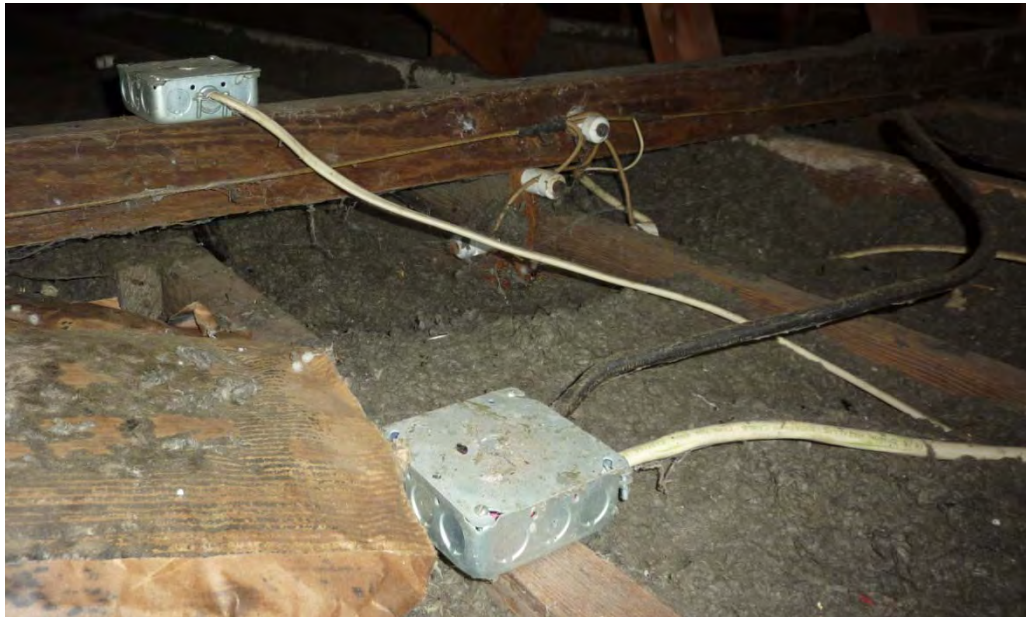
**Image 24 – Mix of knob and tube and newer wiring in attic**

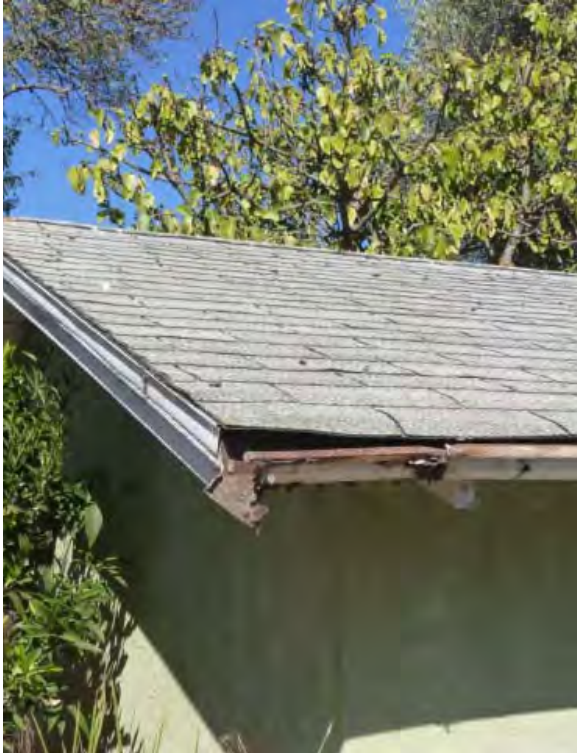
**Image 25 - Garage roof and corroded gutter**

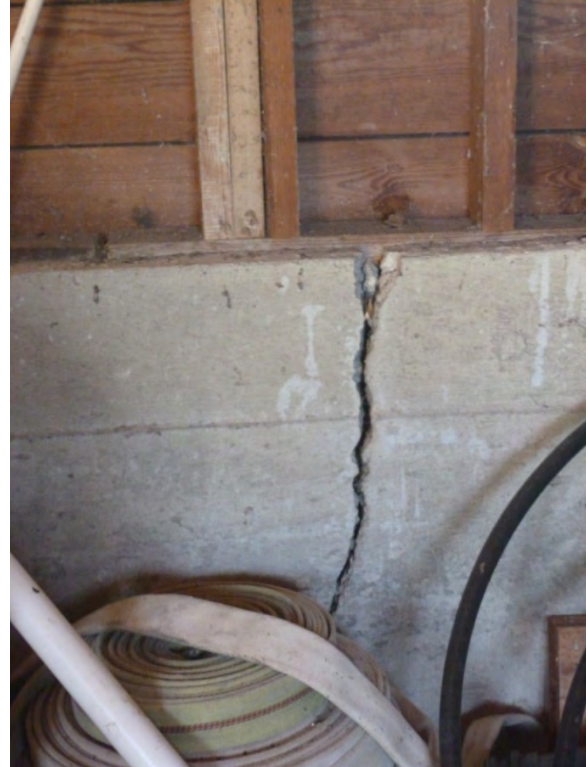
**Image 26 - Structural crack in north wall**

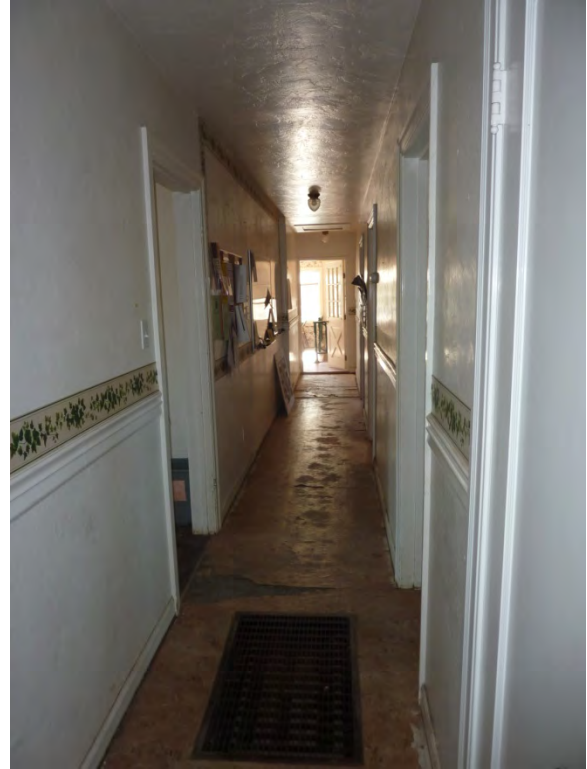
**Image 32 - Hallway looking toward the kitchen. The door at the left is to the entrance hall. The door in the right foreground is the linen closet, the next door is the bathroom and the next two doors are bedrooms.**

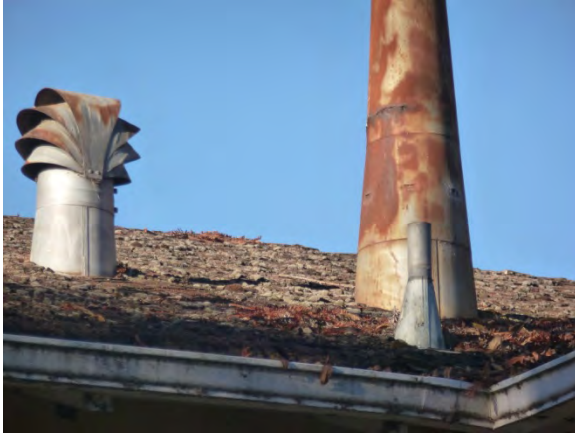
**Image 33 - Deteriorated roofing and vents**

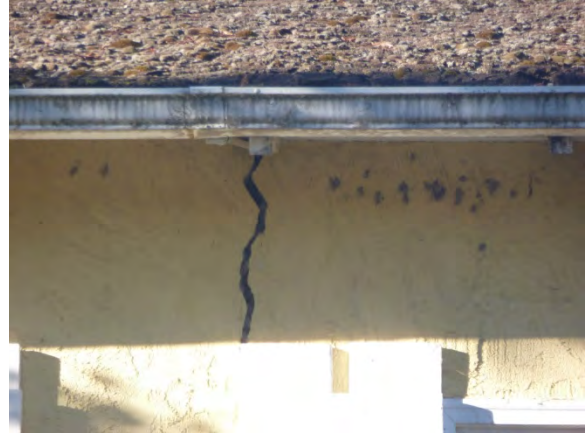
**Image 35 - Crack in east wall at addition**

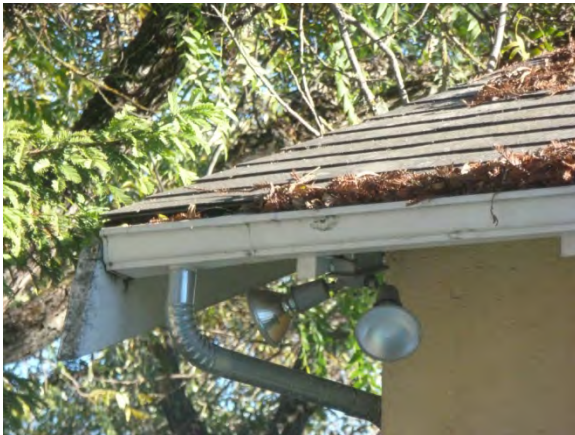
**Image 34 - Debris filled gutter with new downspout**

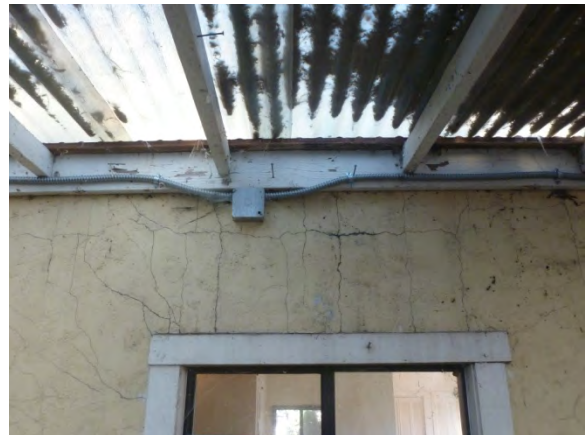
**Image 36 - Extensive cracking at south wall**

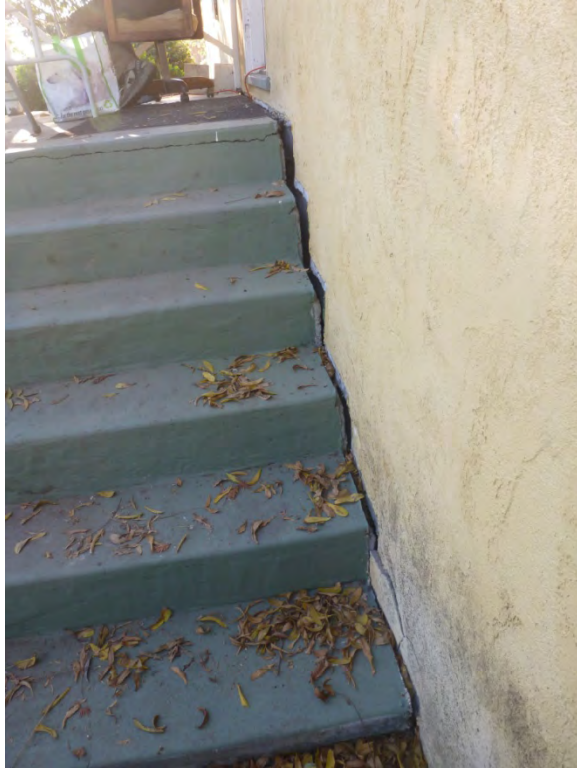
**Image 37 - Front porch stair separated from house wall**

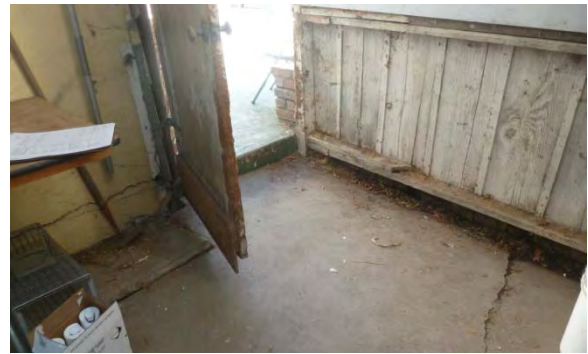
**Image 39 - Deterioration in outdoor storage shed**

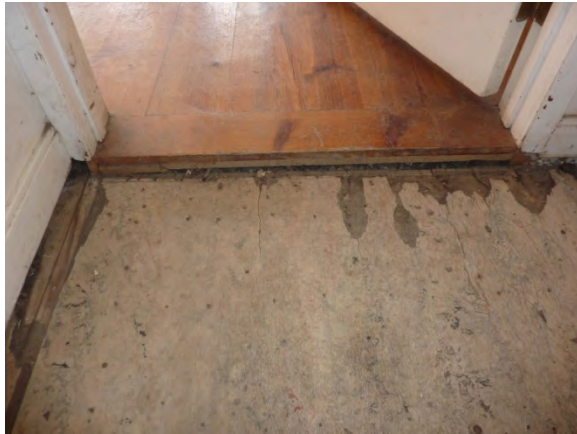
**Image 40 - Flooring deterioration and change of level**

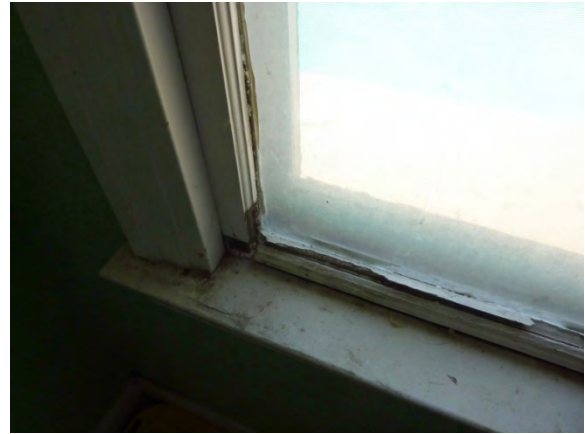
**Image 42 - Deteriorated window at west wall**

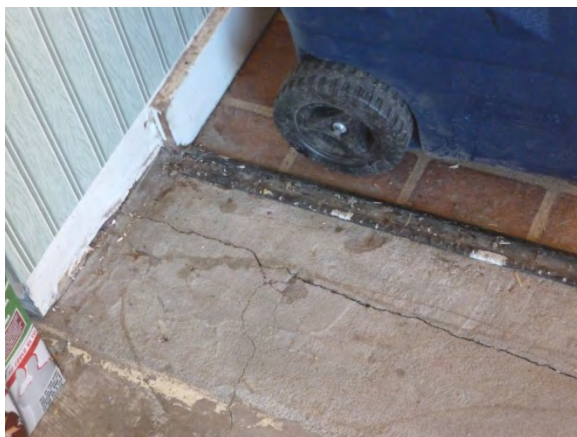
**Image 41 - Floor at former garage**

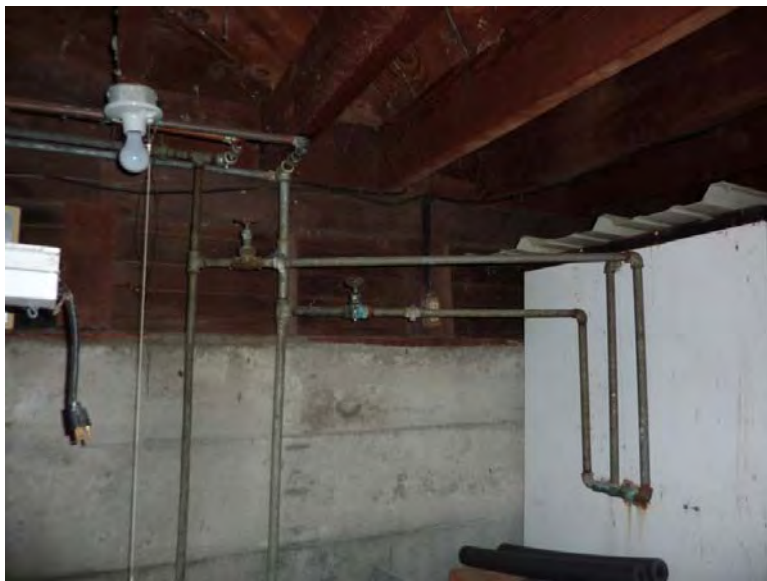
**Image 44 - Deteriorated piping in basement**

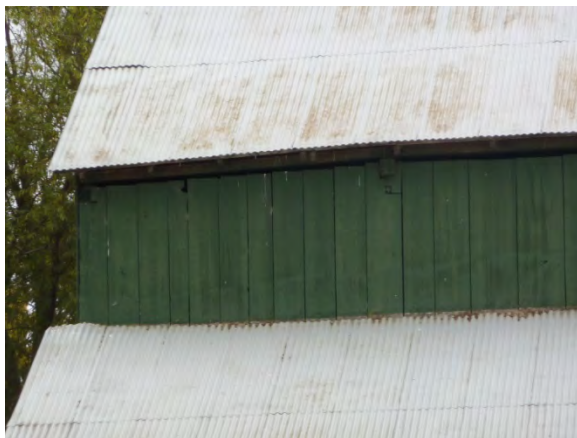
**Image 49 - Typical condition of roof**

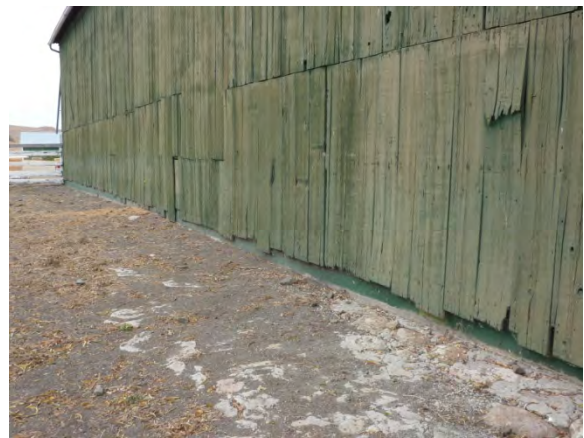
**Image 51 - Typical repurposed and deteriorated siding**

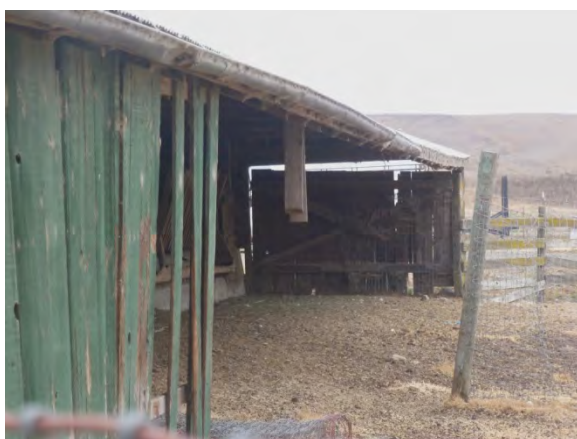
**Image 50 - Failing roof at shed**

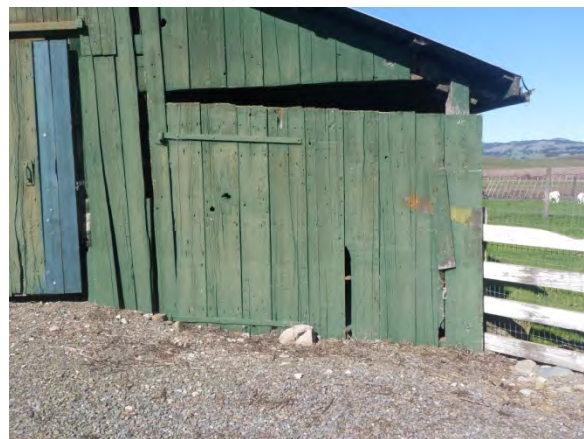
**Image 52 - Shed siding with wood to earth contact**

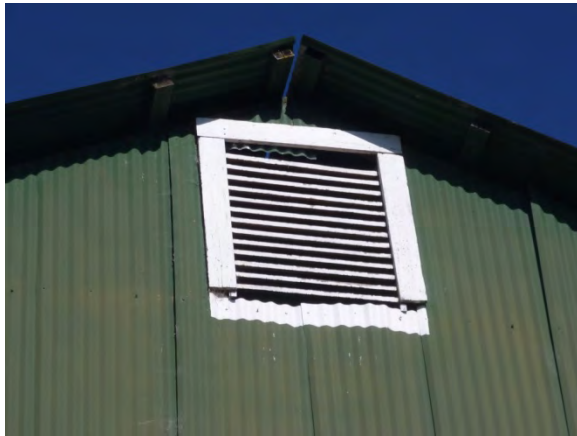
**Image 53 – Gable vent with missing trim**

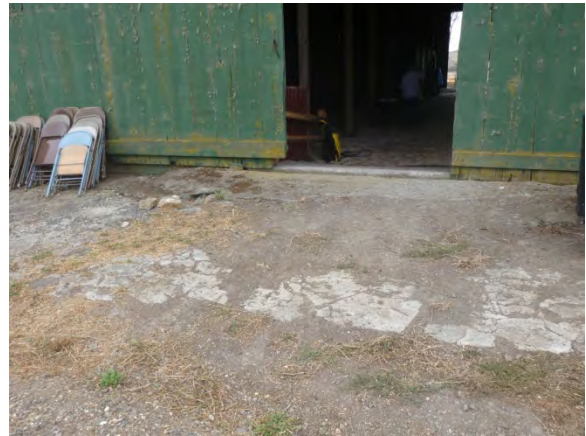
**Image 54 – Stone and concrete paving at north entrance**

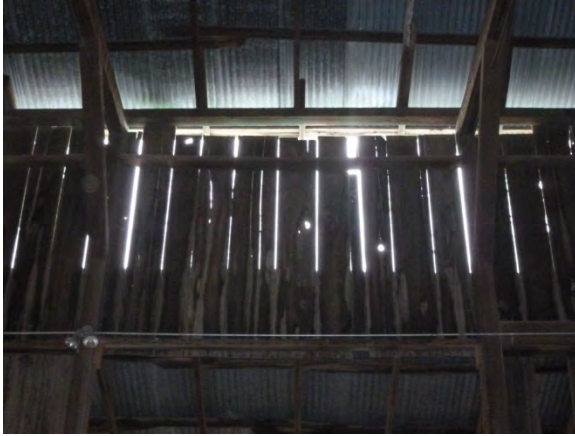
**Image 55 - Interior view showing condition of siding**

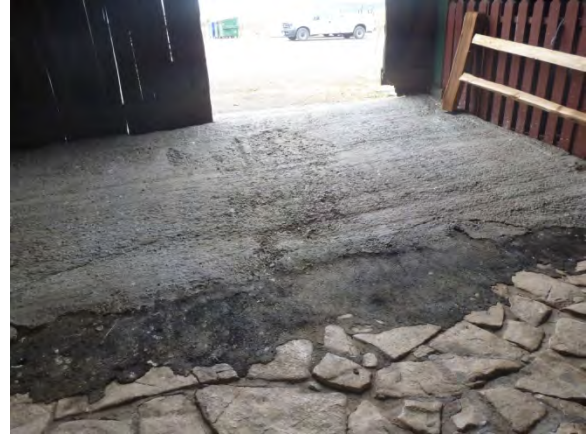
**Image 56 - Stone floor with concrete topping at south entrance**

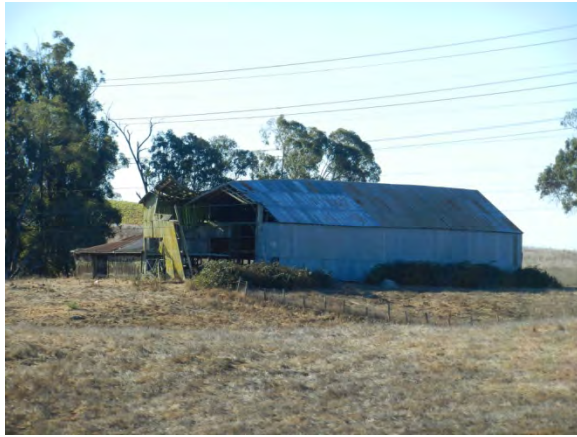
Image 57 – North side of Old Dairy Barn with collapsed section at east end

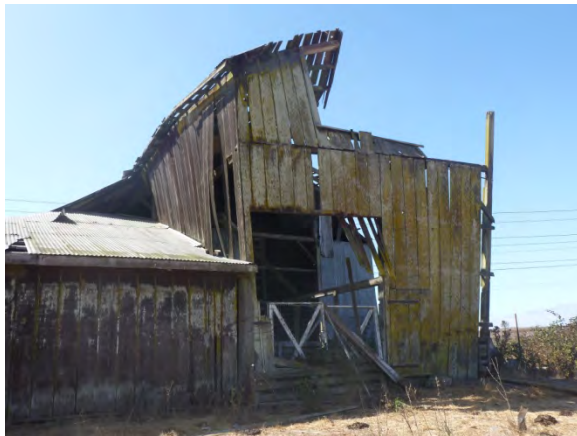
**Image 59 - Collapsed east end of barn**

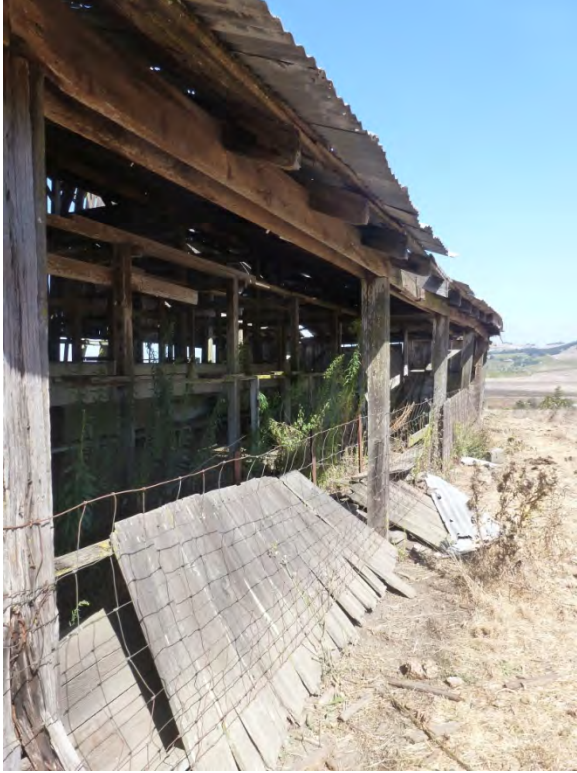
**Image 61 - Failed wall at south side**

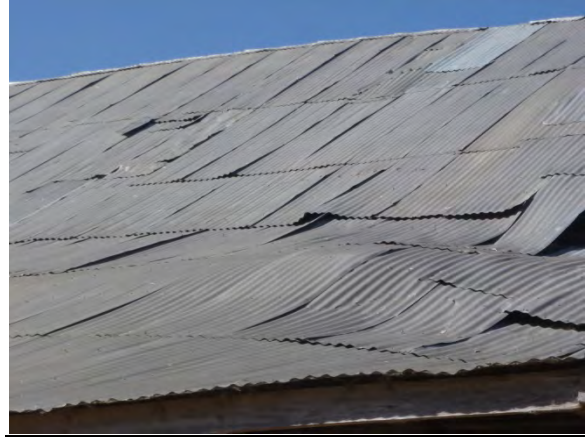
**Image 63 - Sheet Metal Roofing**

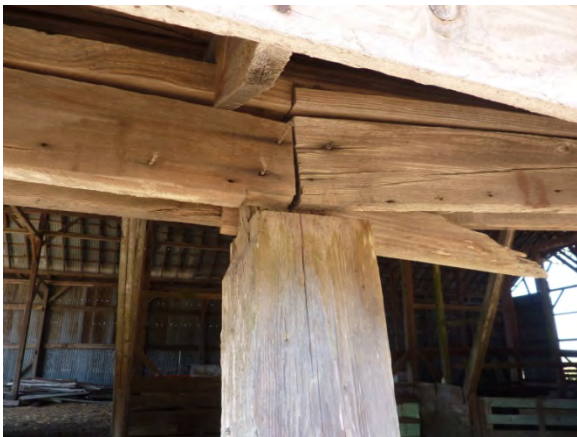
**Image 62 - Structural Damaged at south wall**

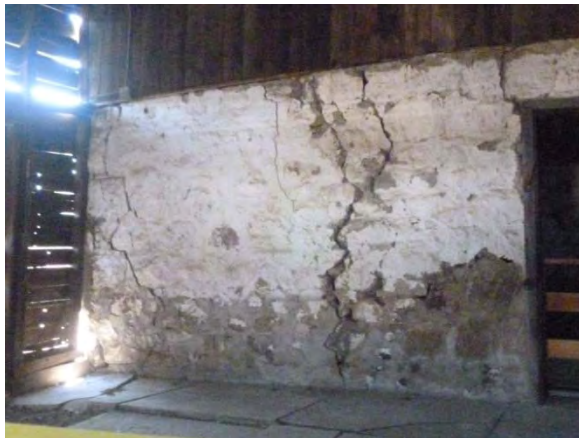
**Image 69 - Severe cracking of masonry wall**

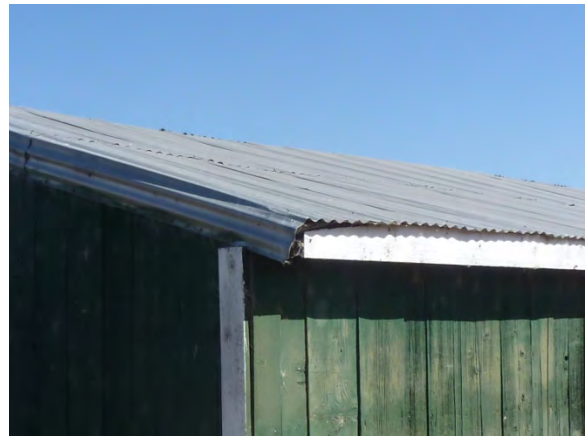
**Image 71 - Metal Roofing, wrapped at gable end**

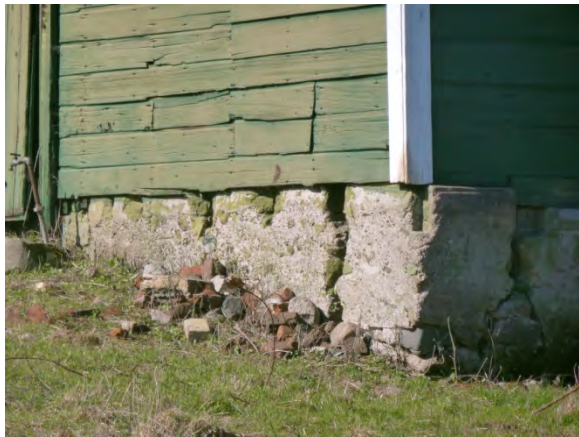
**Image 70 - Failed wall at northeast corner**

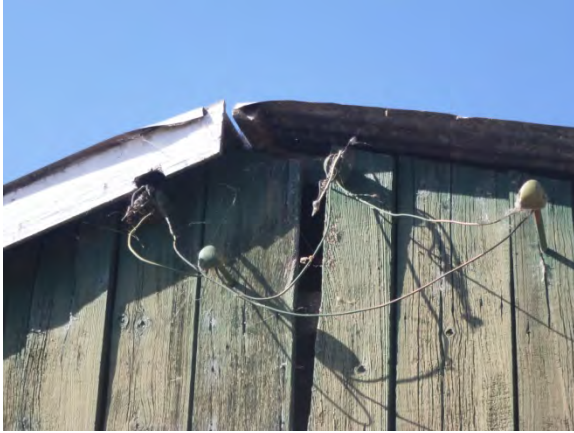
Image 72 - Condition at ridge

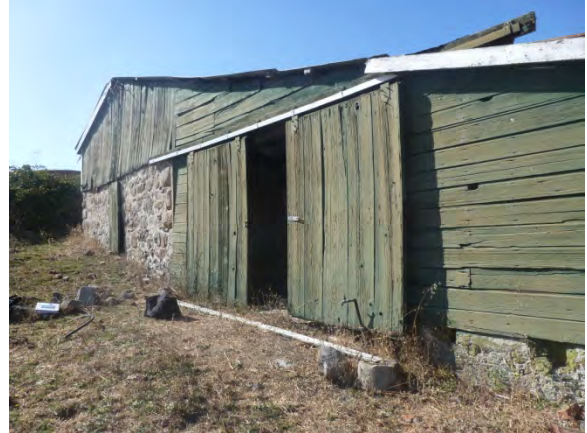
Image 74 - South wall showing poor overall condition of siding and doors

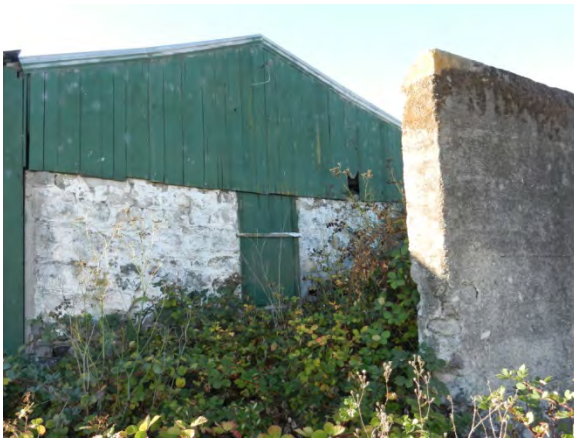
Image 73 - Overgrown vegetation on north side

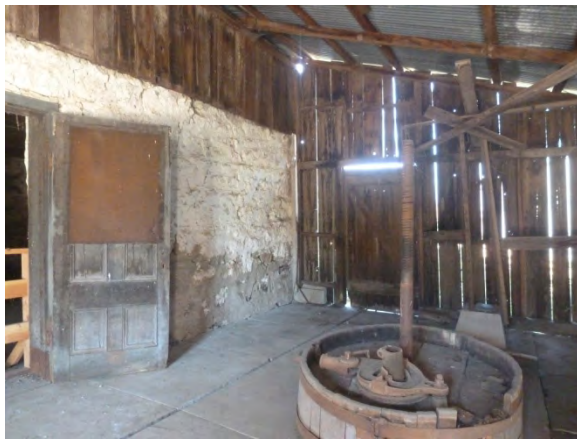
**Image 75 - General condition of interior**

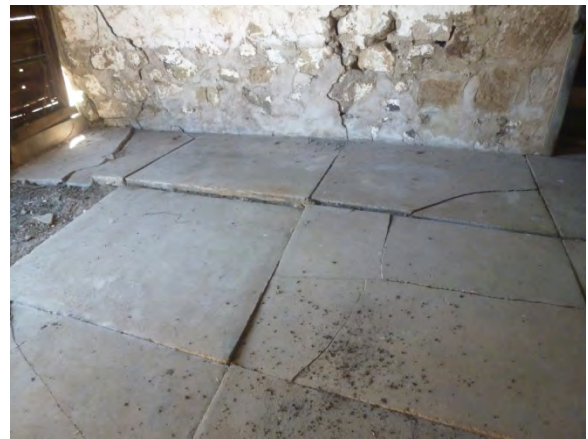
**Image 76 - Floor slabs at mid-level of building**

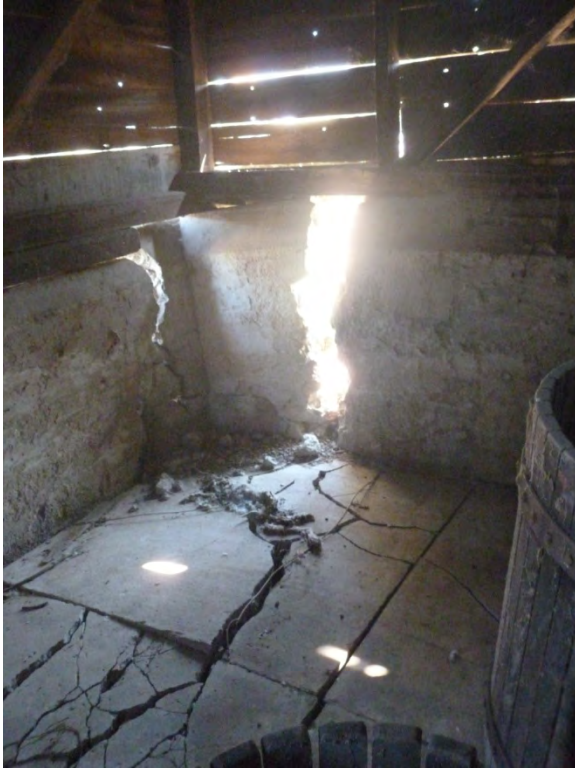
**Image 77 - Condition at northeast corner.**

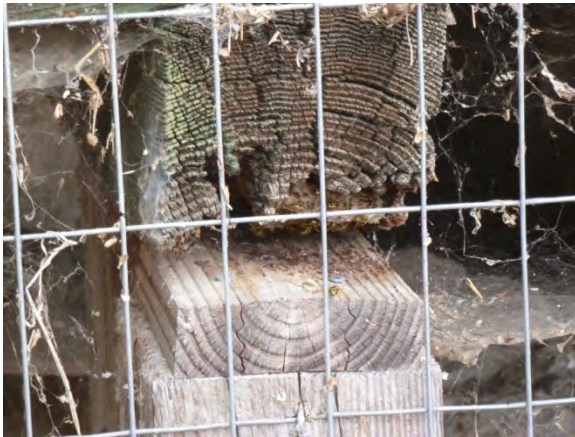
**Image 84 - Deteriorated structure below building**

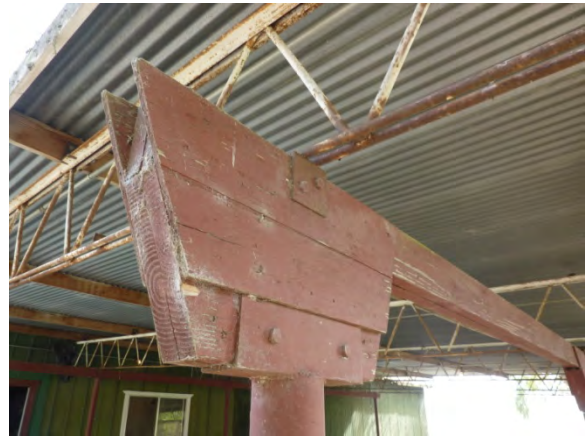
**Image 85 - Deteriorated roof structure over picnic area**

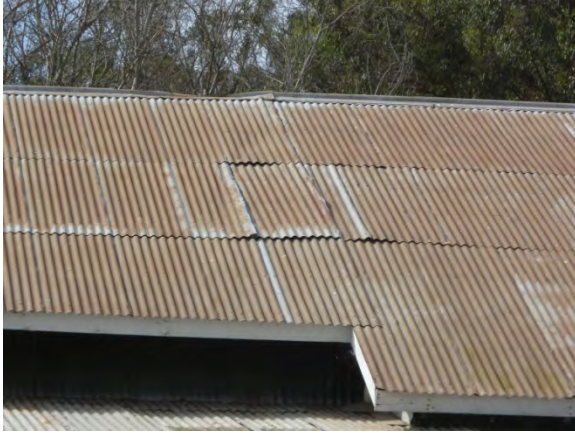
**Image 86 - General condition of roofing**

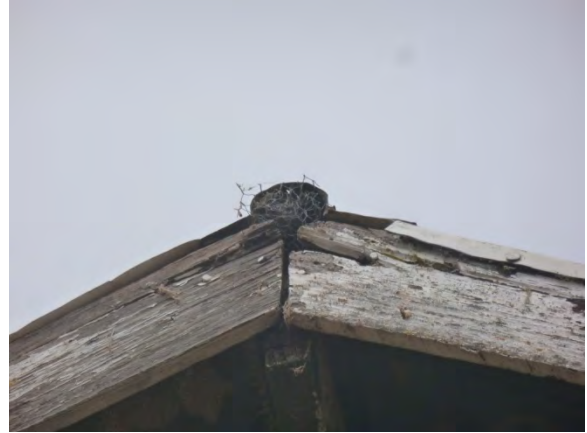
**Image 87 - Roofing and trim at ridge, south end**

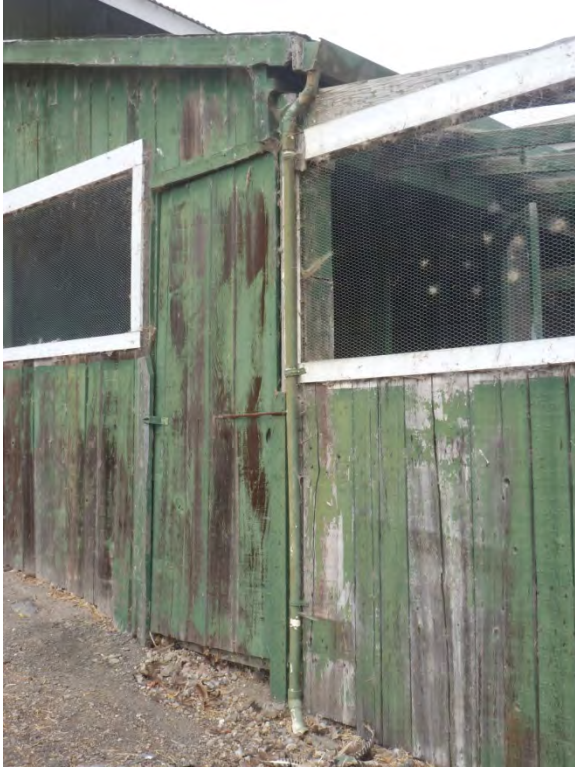
**Image 88 - Typical condition of wood siding and doors to chicken coop.**

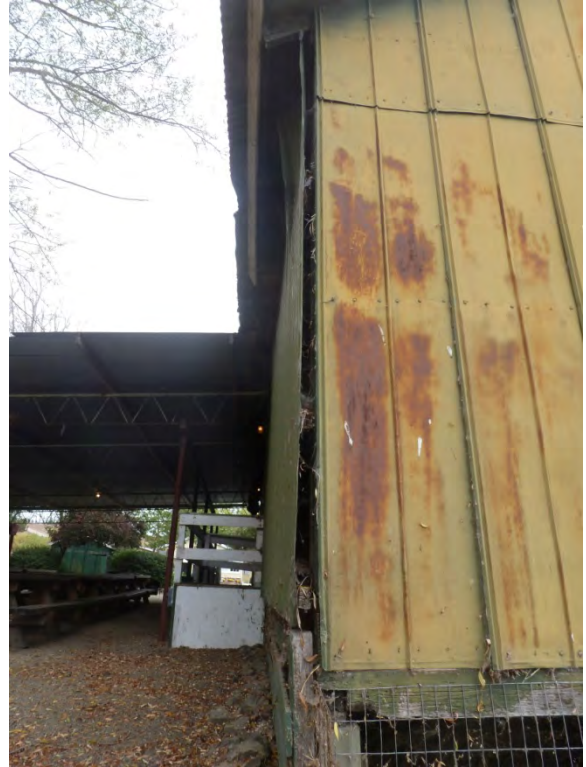
**Image 89 - Typical condition of metal siding.**

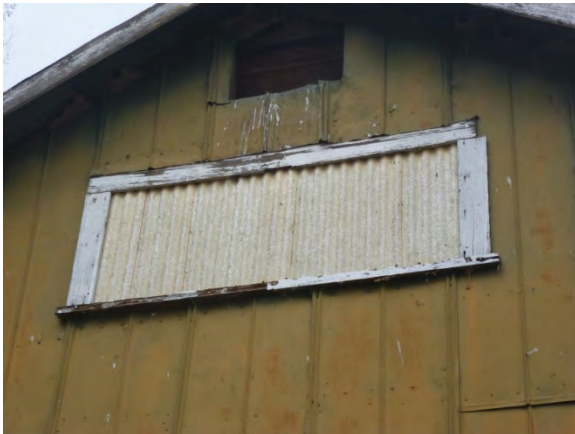
**Image 90 - South Gable window with fiberglass infill.**

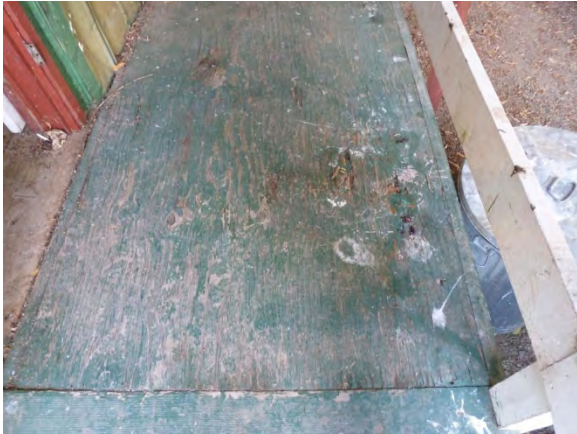
**Image 92 - Deteriorated plywood at ramp to west entrance.**

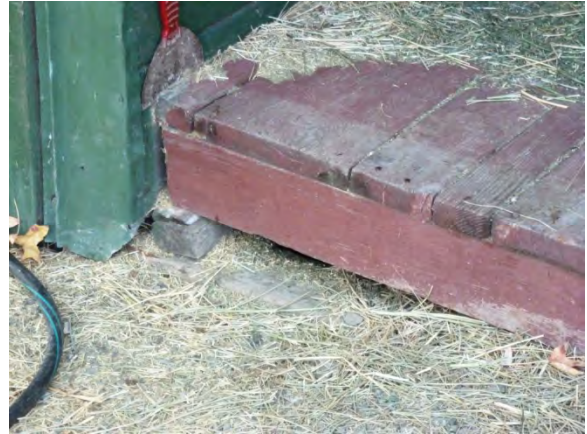
**Image 93 - Wood to earth contact at stairs to north entrance.**

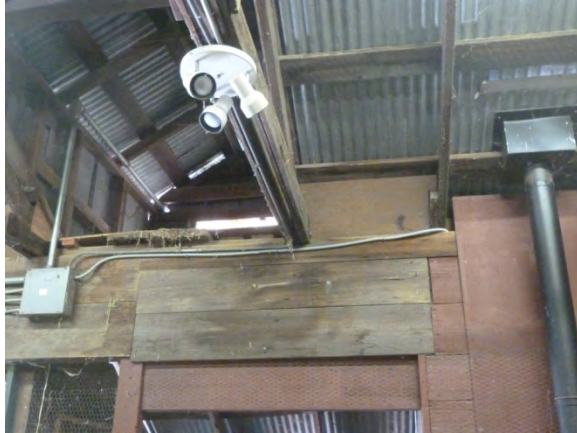
Image 94 - Typical electrical installation.

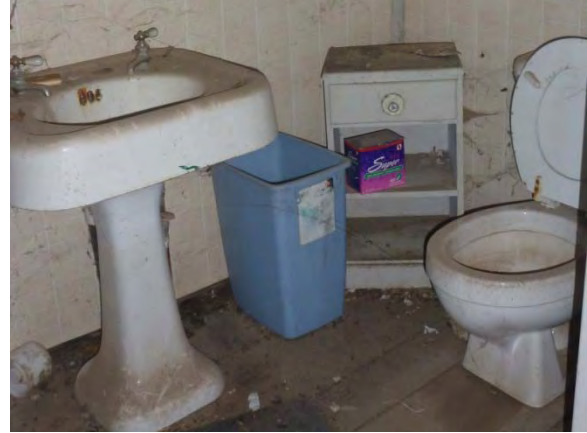
Image 95 - Deteriorated plumbing fixtures.

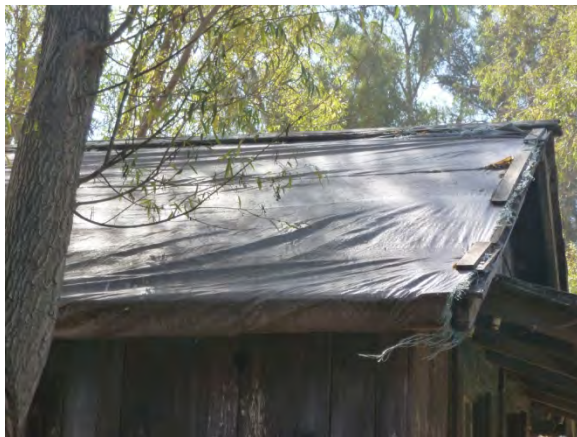
**Image 97 - Tarp-clad east side of roof**

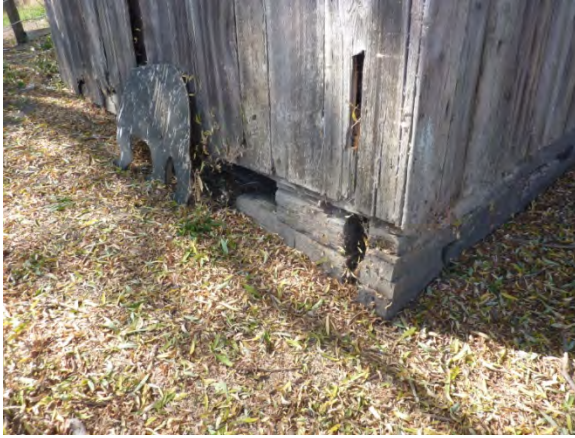
**Image 99 - Building set on wood skids directly on ground**

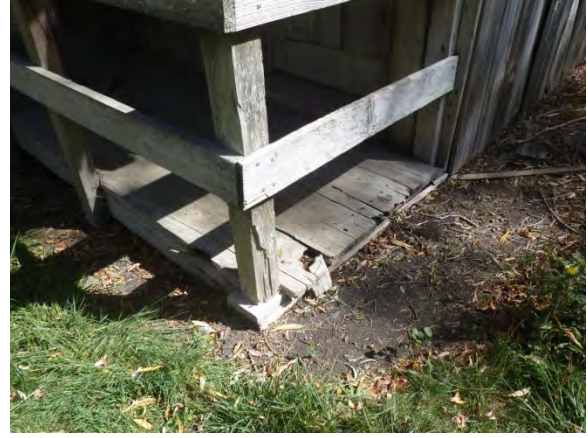
**Image 101 - Deterioration at west end of porch**

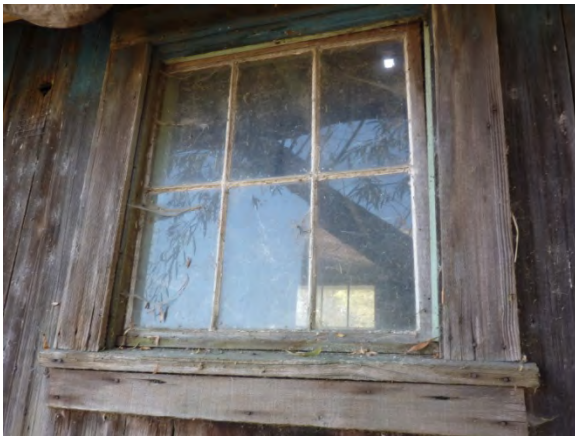
**Image 100 - Deteriorated condition of window (typical)**

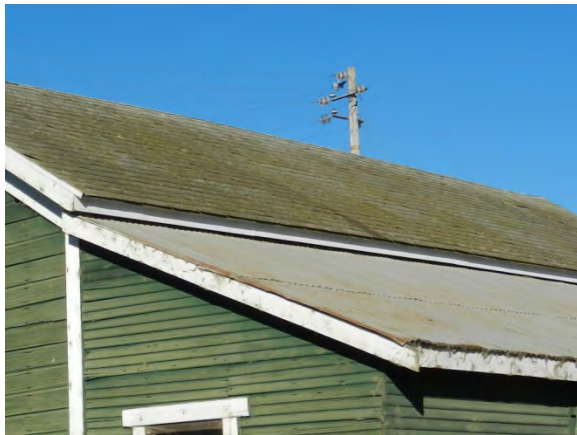
**Image 108 - Typical condition of roofing**

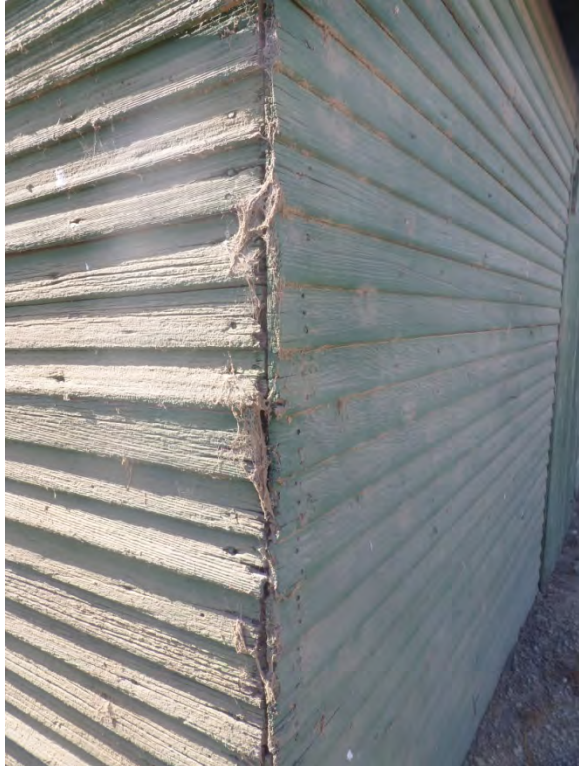
**Image 109 - Siding at southeast corner of shed**

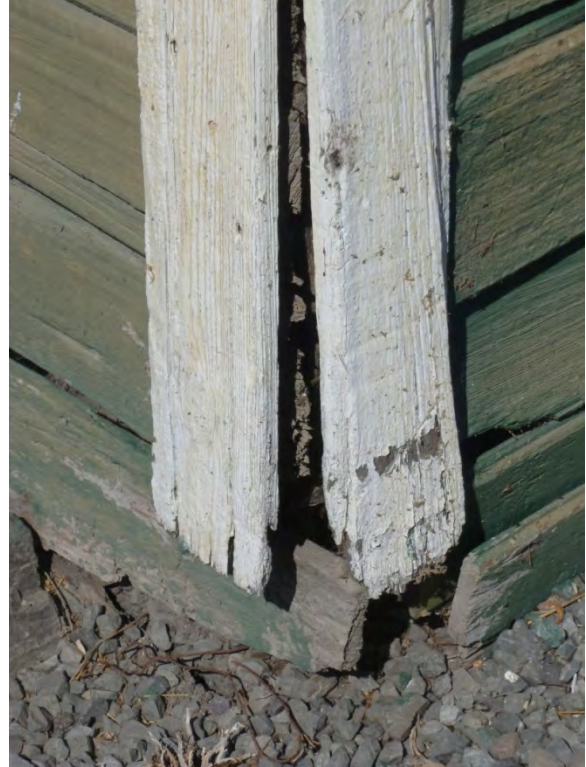
**Image 110 - Deteriorated corner boards and earth to wood contact**

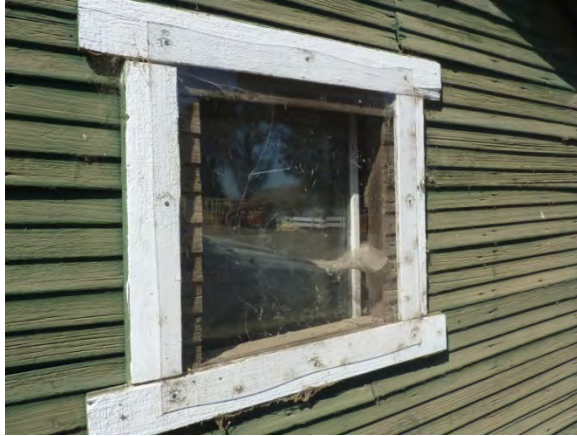
Image 111 - Poorly fit window with Plexiglas panel

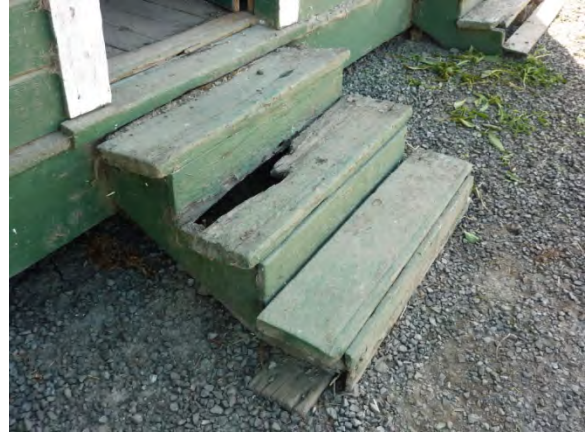
Image 112 - Deteriorated wood stairs directly on ground

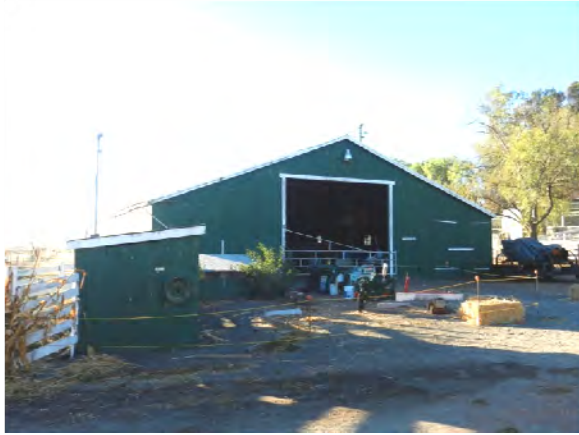
Image 113 – North entrance to Tractor Barn.

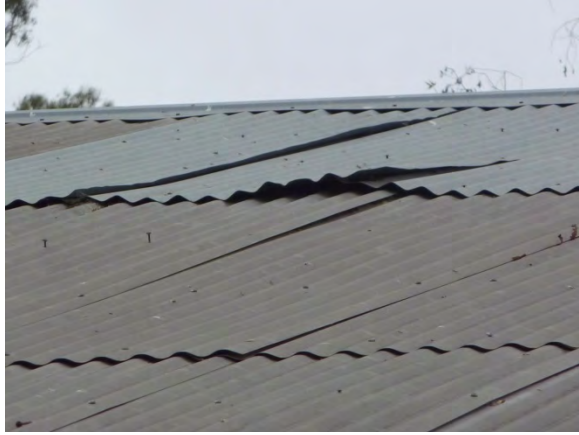
**Image 116 - Typical condition of roofing**
