**Appendix E**  
**Cultural Resource Report**

# TOLAY LAKE CARDOZA RANCH

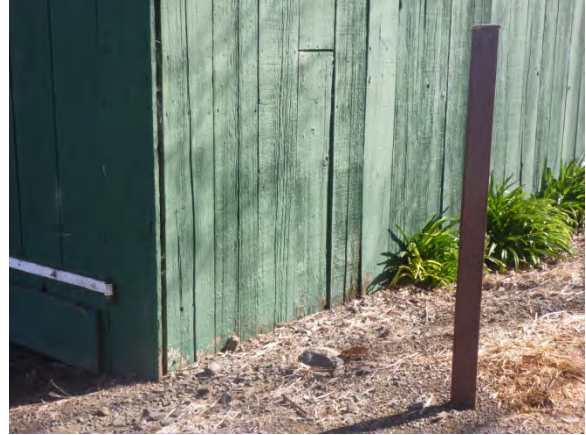
**Image 117 - Wood to earth contact of siding**

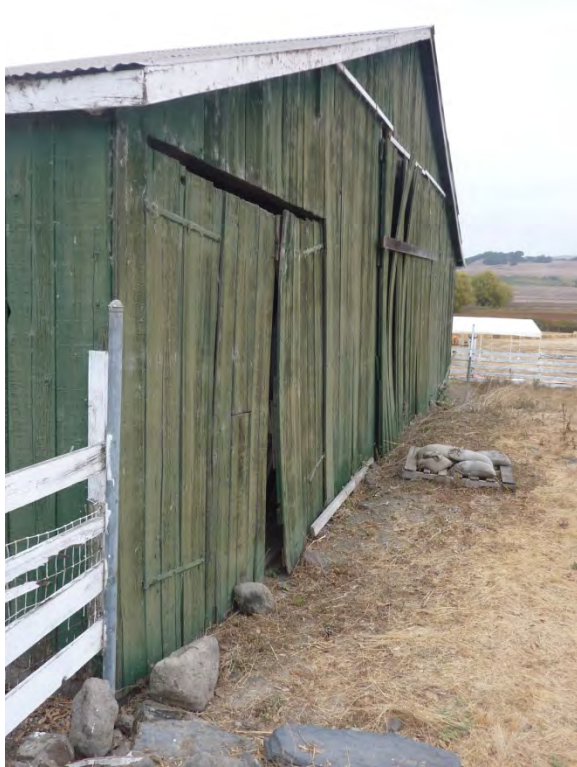
**Image 118 - Deteriorated doors at south end of building**

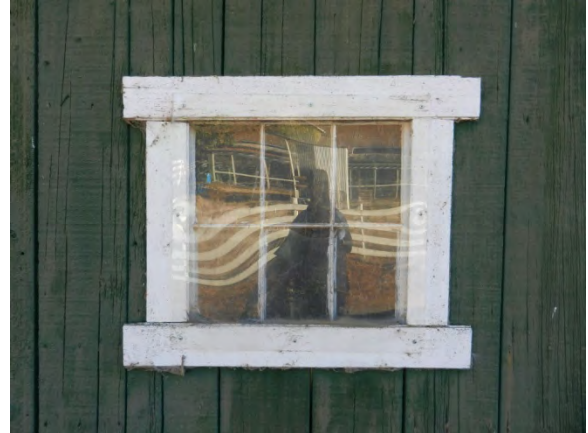
**Image 119 - Typical window with plexiglas cover**

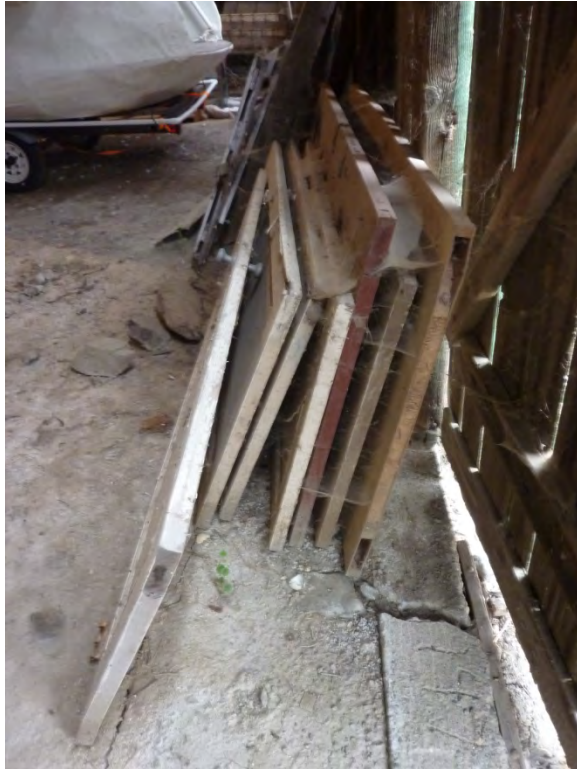
**Image 120 - Cracked foundation at south wall**

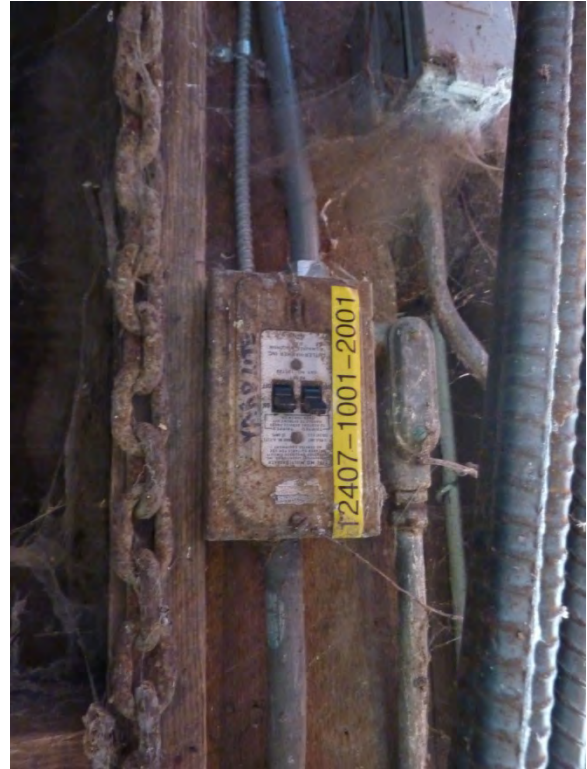
**Image 121 - Corroded electrical components**

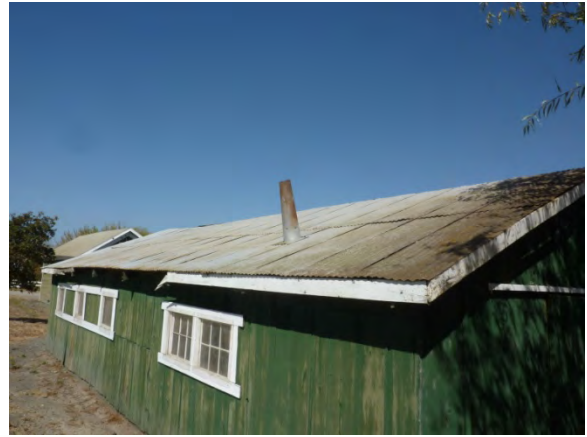
Image 123 – West wall and rusted roof of Storage Shed

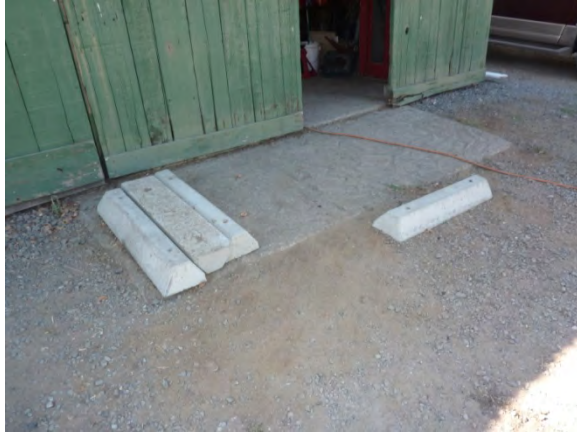
**Image 126 – Entrance to working space in Storage Shed**

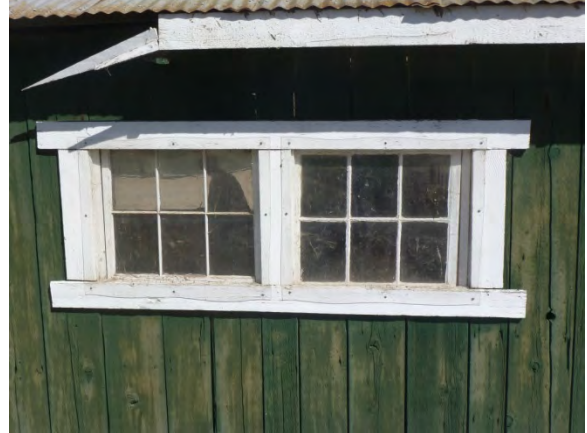
**Image 128 - Typical window with Plexiglas covering; damaged trim**

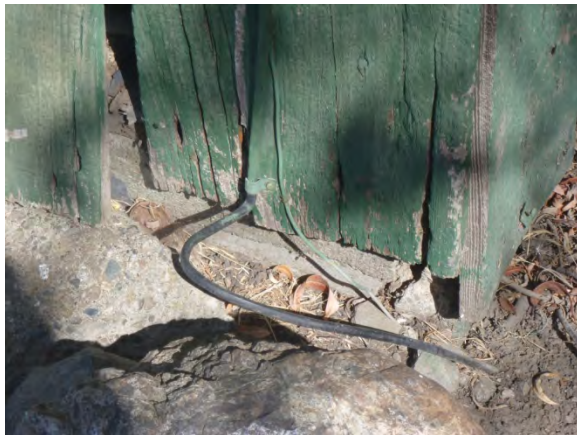
**Image 127 - Deteriorated siding with wood to earth contact.**

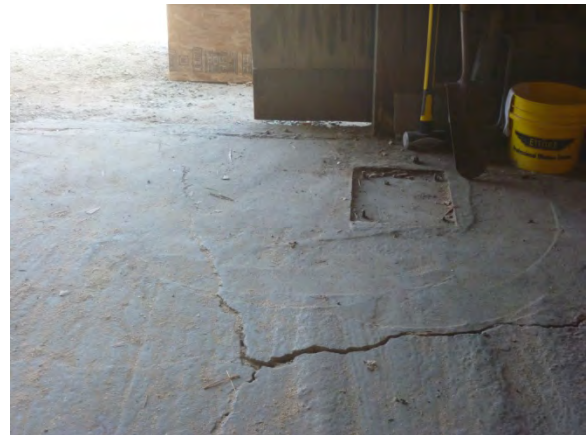
**Image 130 - Cracked concrete slab**

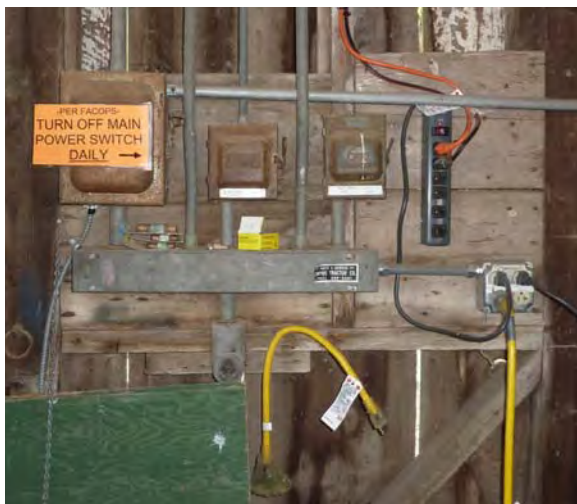
**Image 131 - Miscellaneous non-compliant electrical modifications**

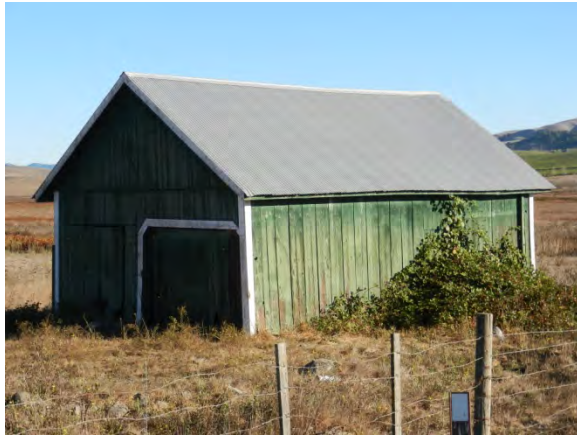
Image 132 – Entrance in west wall of Slaughterhouse

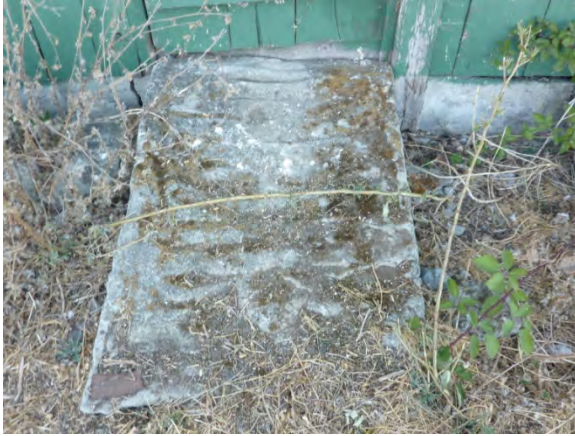
**Image 134 - Concrete drainage trough at east end of building**

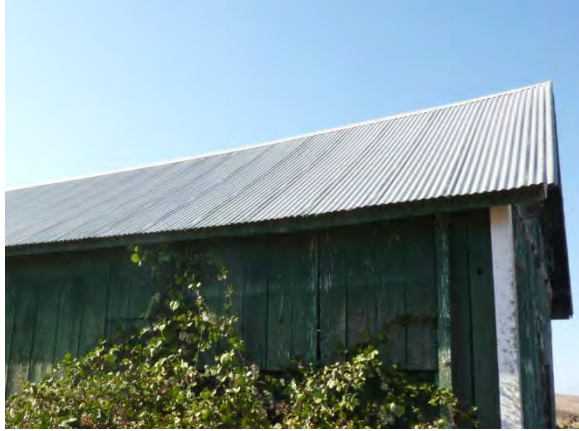
**Image 136 - General condition of roofing.**

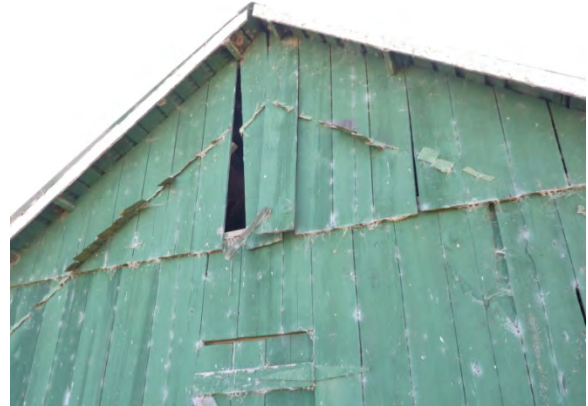
**Image 137 - Typical condition of wood siding and vestiges of former addition east end.**

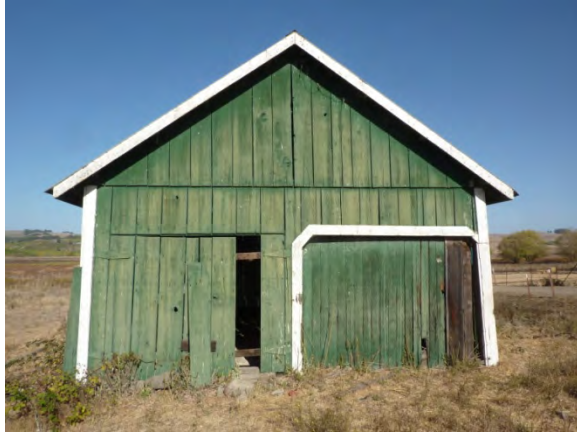
Image 138 - Non-functional doors at west wall.

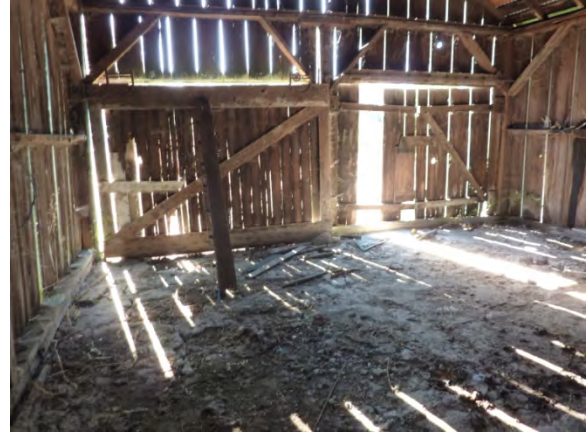
Image 139 - General deteriorated condition of slab and siding.

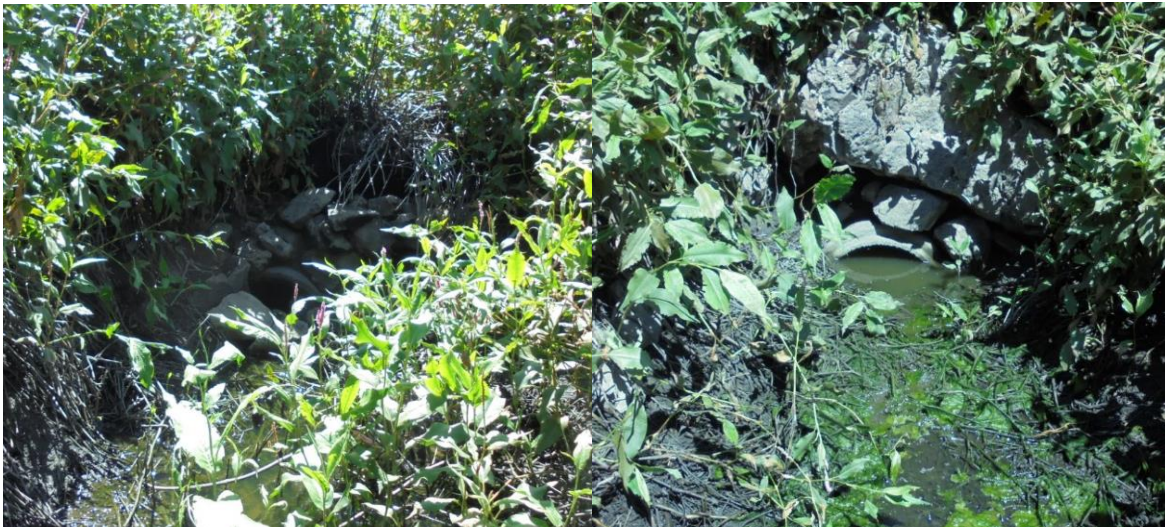
*Figure 3. Largely blocked culvert in Causeway, inlet shown on left, outlet shown on right.*

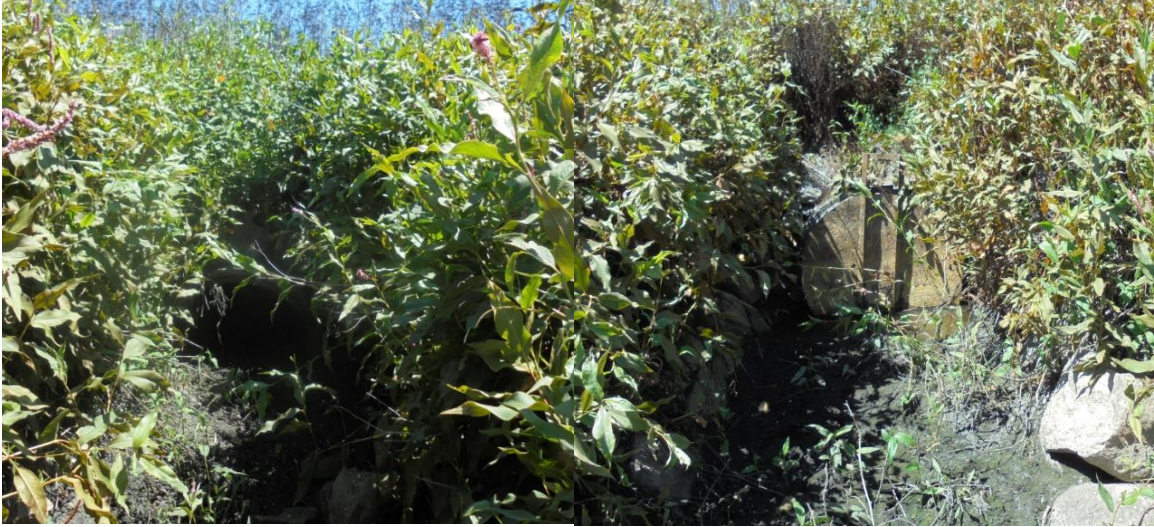
*Figure 4. Closed gated culvert in horseshoe berm, inlet shown on left, outlet shown on right.*

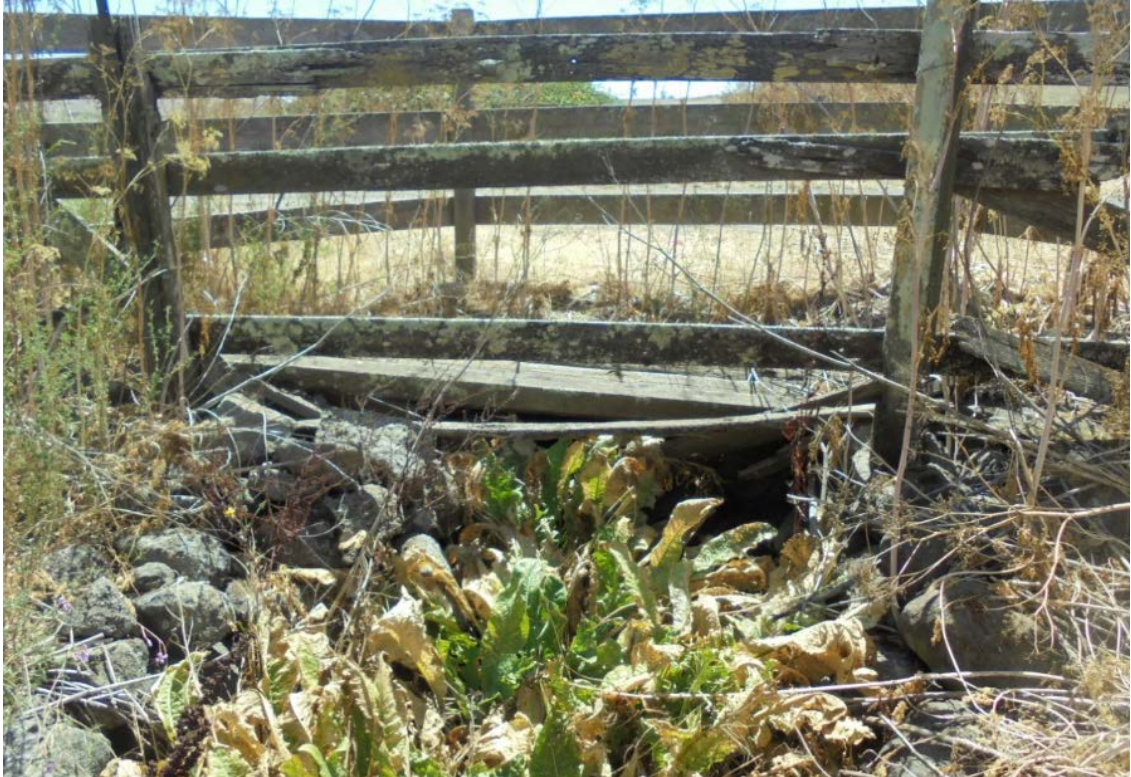
**Figure 2. West Channel Causeway Culvert inlet.**

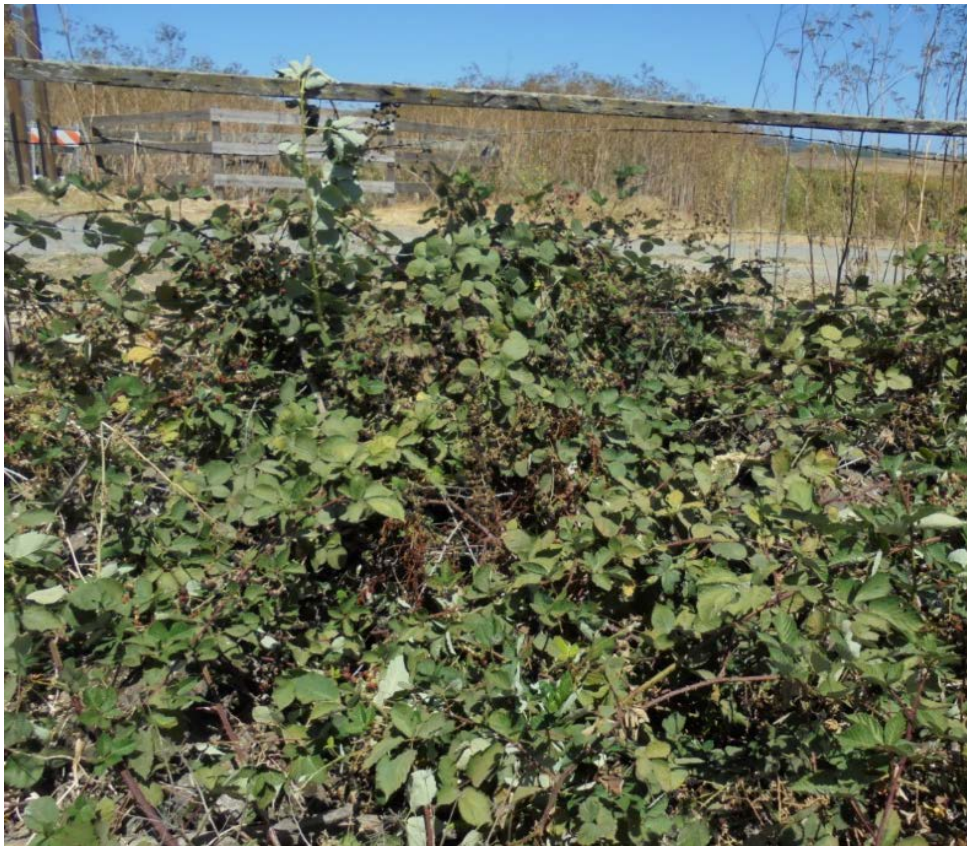
**Figure 3. West Channel Causeway Bridge.**

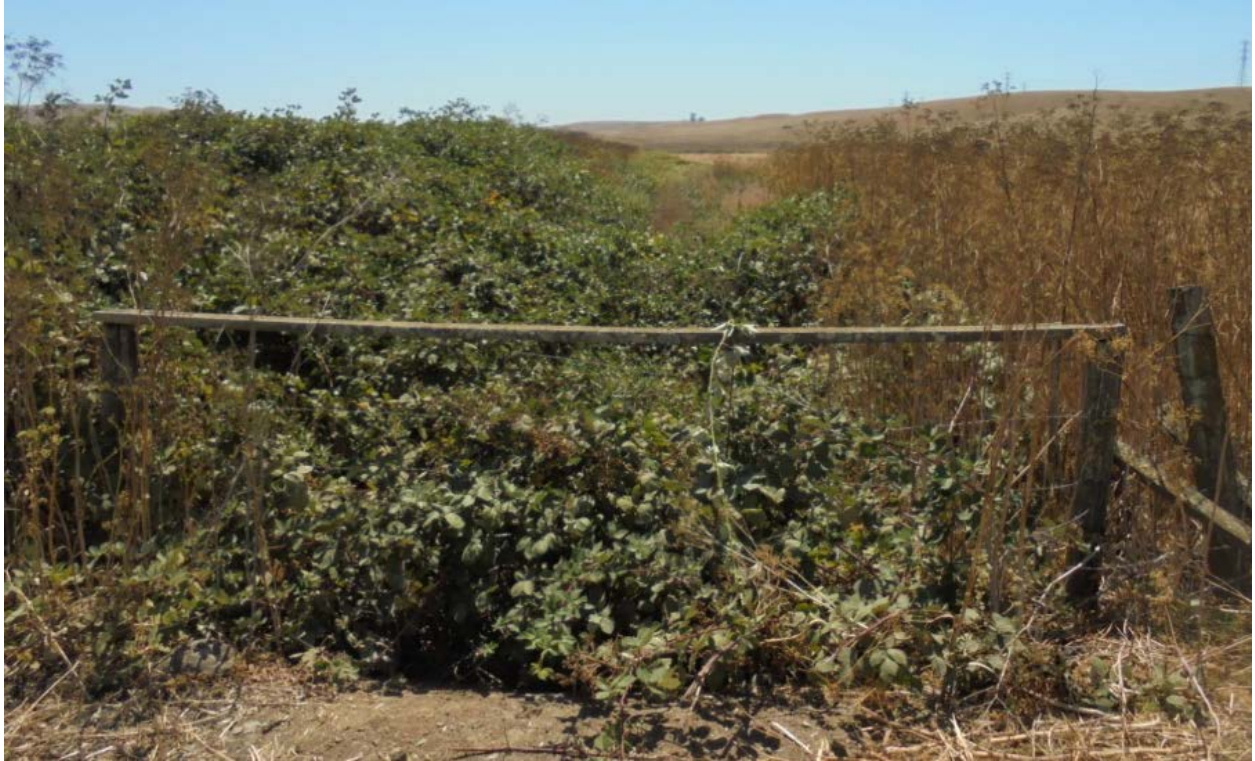
**Figure 4. West Channel downstream of Causeway (viewed from Causeway).**

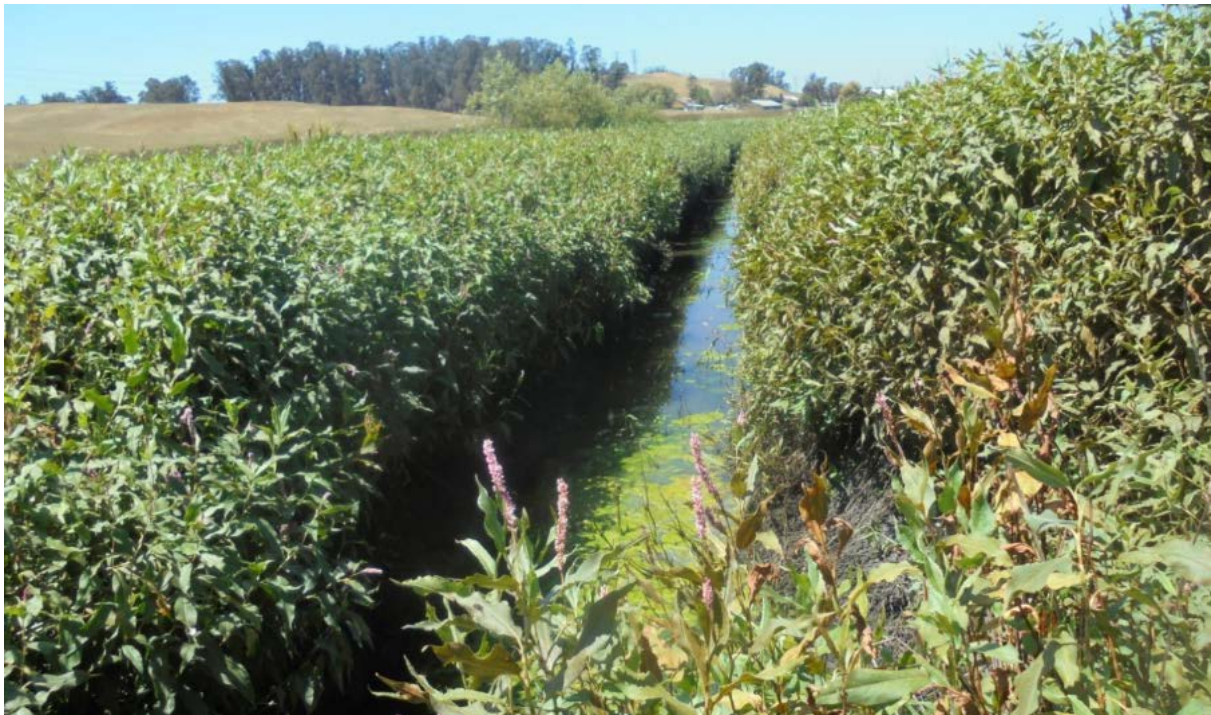
**Figure 5. Tolay Creek Channel (TC) downstream of Causeway (looking upstream from the Horseshoe).**

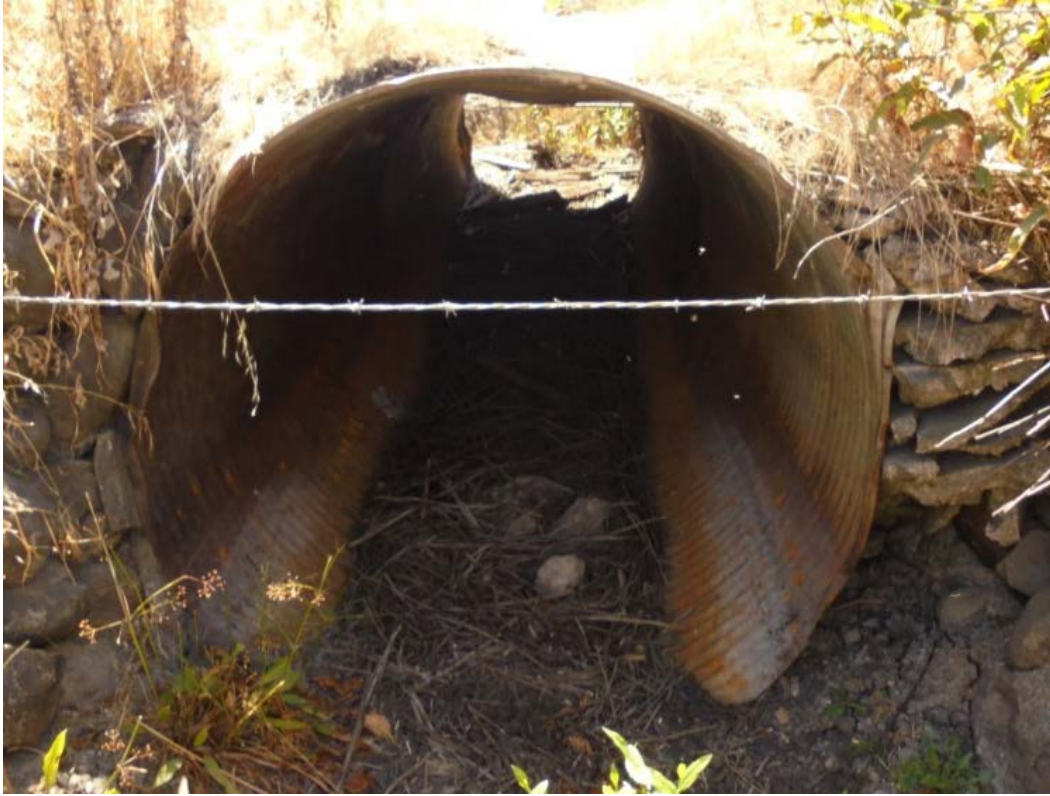
**Figure 6. East Channel Causeway Culvert inlet.**

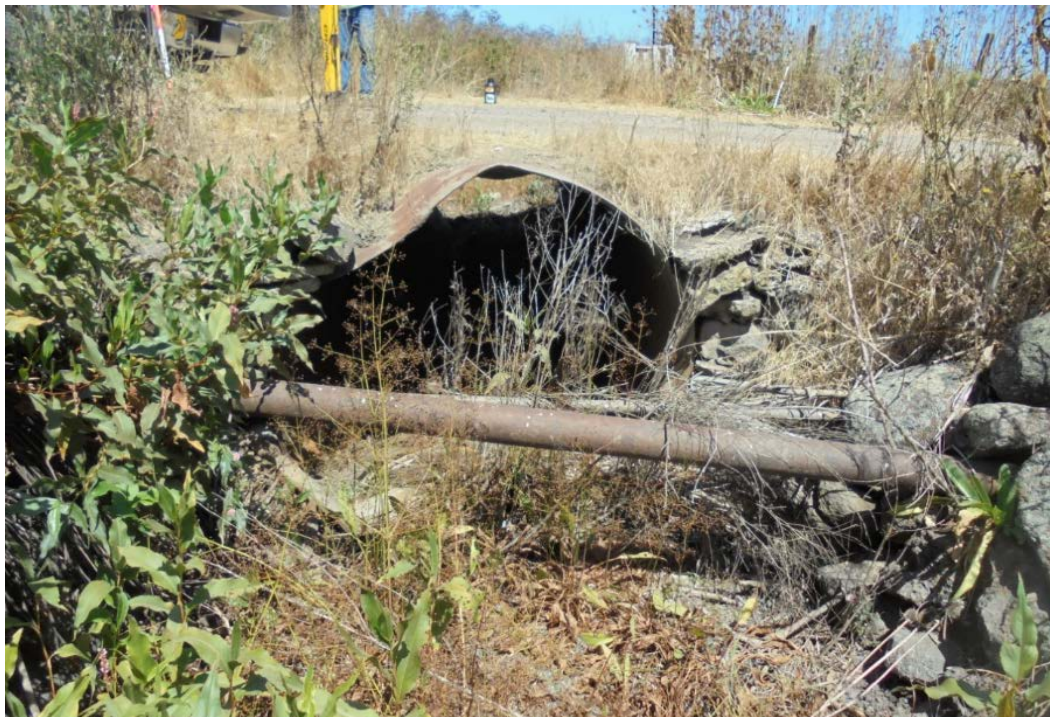
**Figure 7. East Channel Causeway Culvert outlet.**

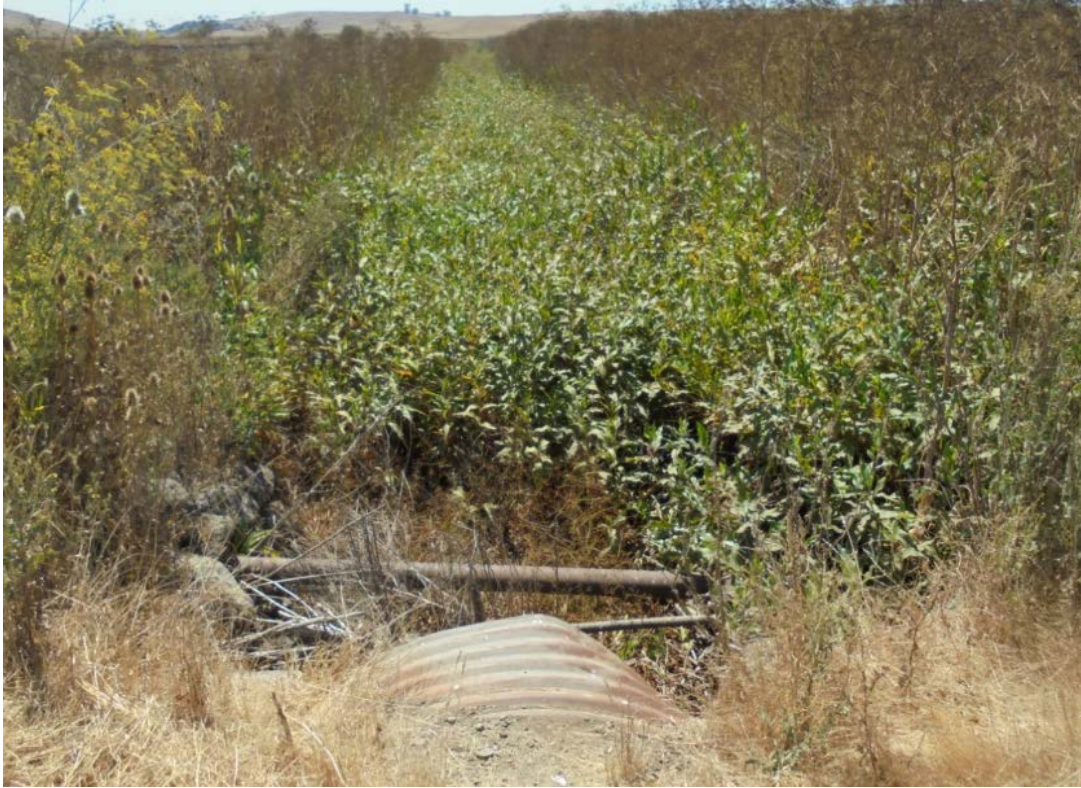
**Figure 8. East Channel downstream of Causeway.**

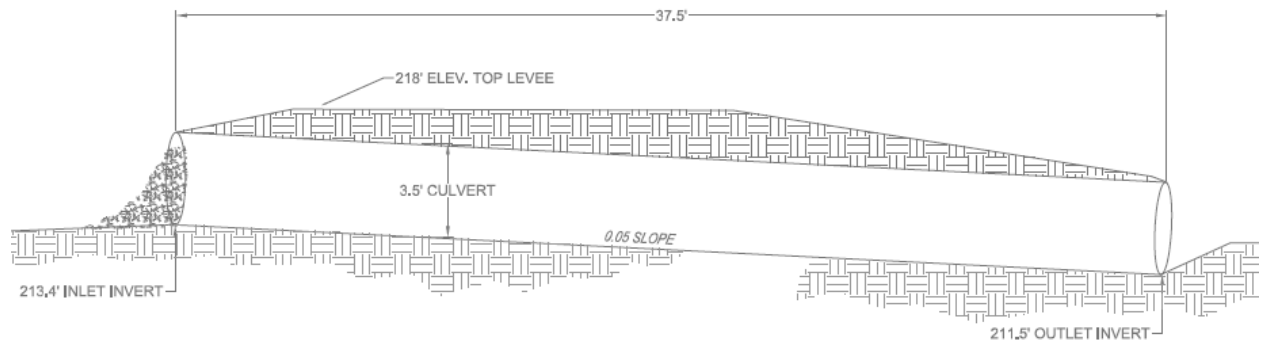
**Figure 9. Horseshoe Culvert approximate profile.**

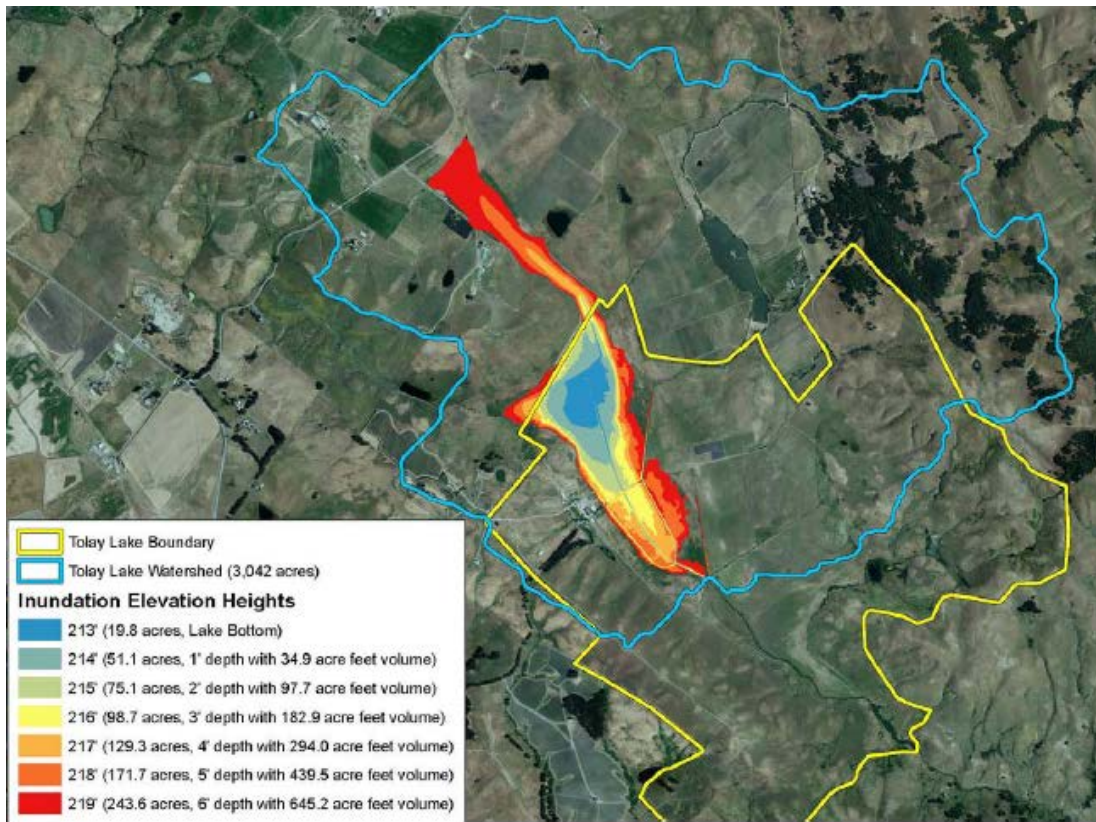
Figure 14. Stage areas from WRA (2013).

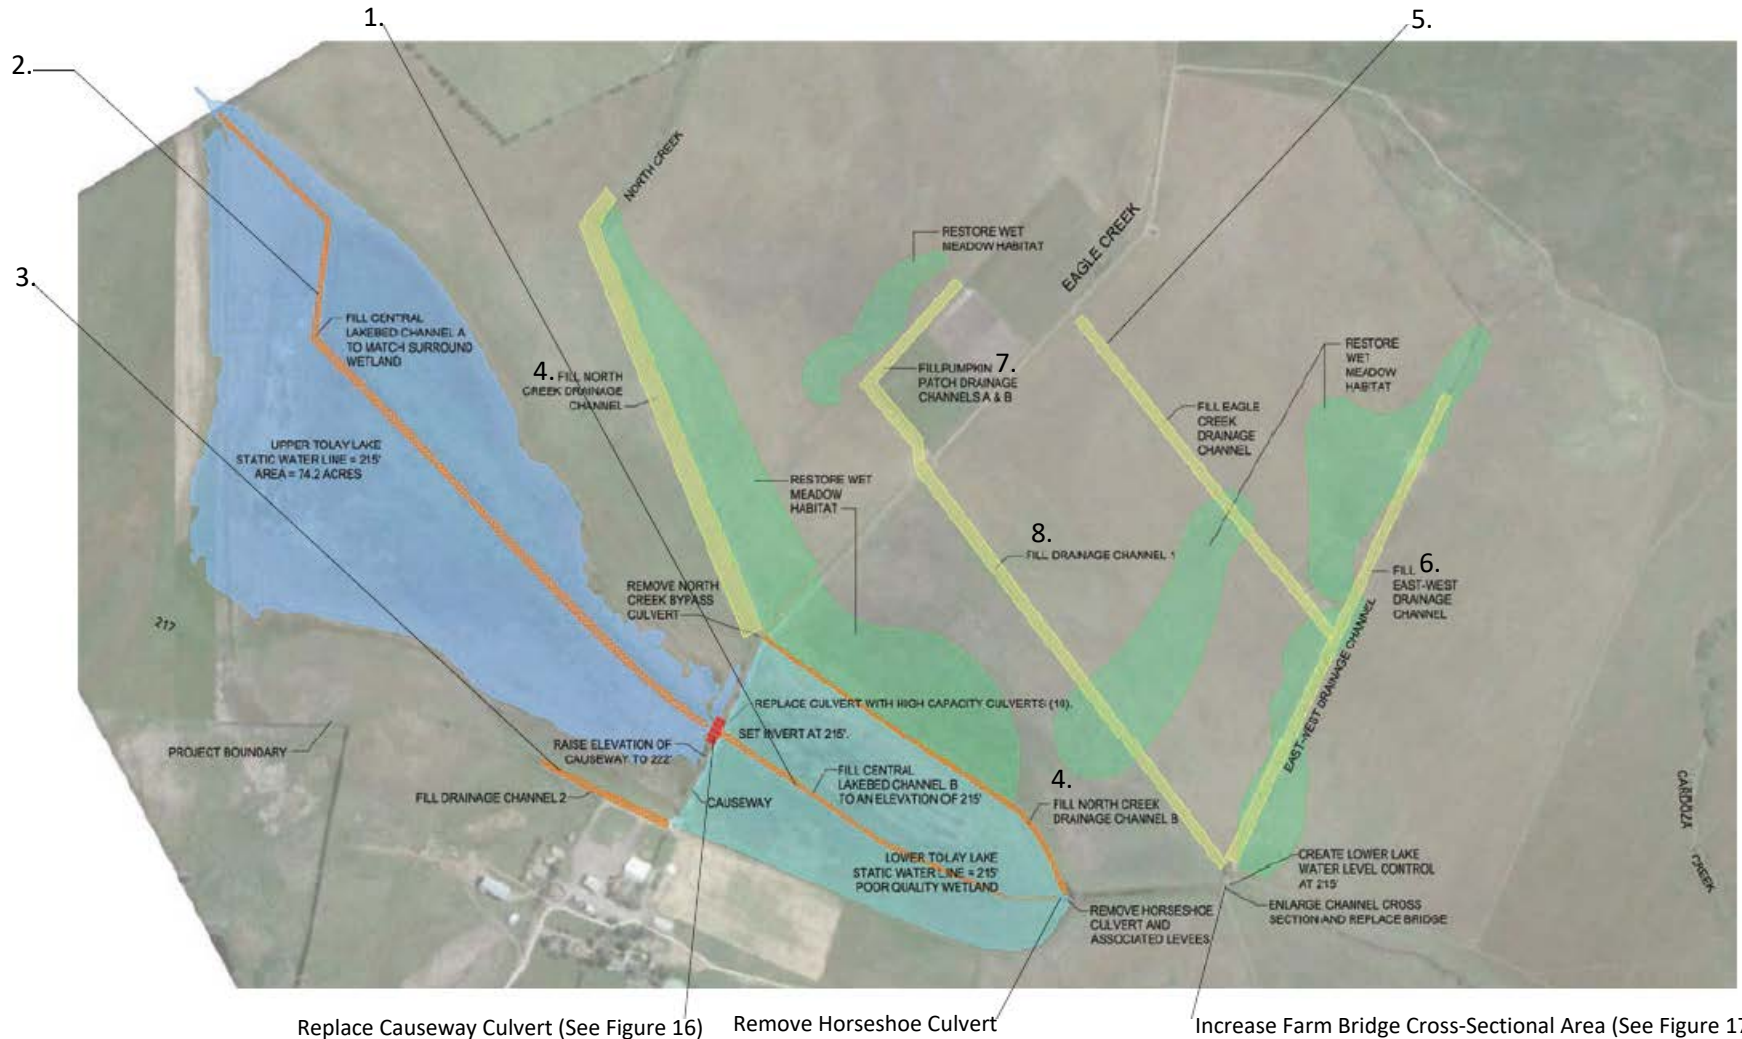
Replace Causeway Culvert (See Figure 16)

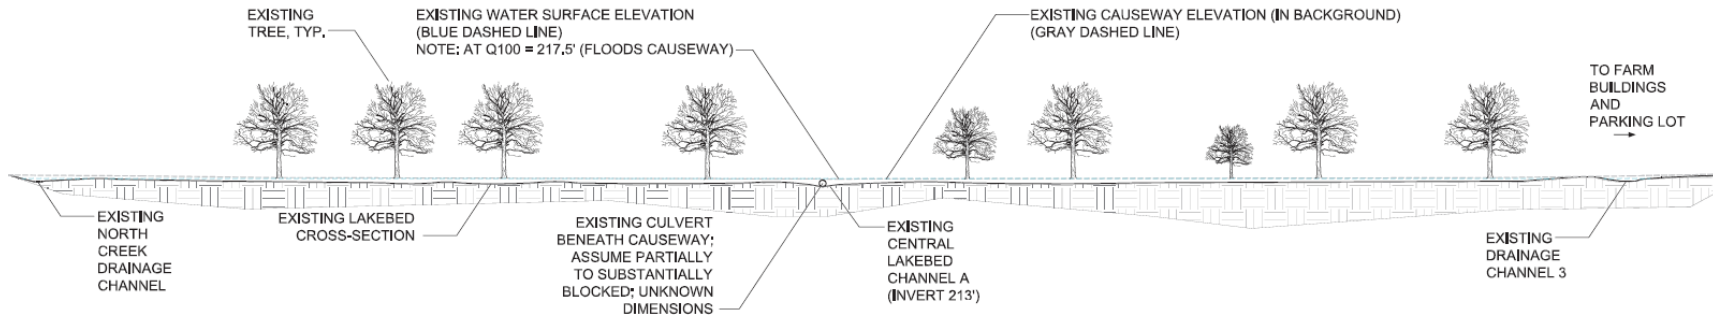
**EXISTING CAUSEWAY CROSS SECTION & ELEVATION**

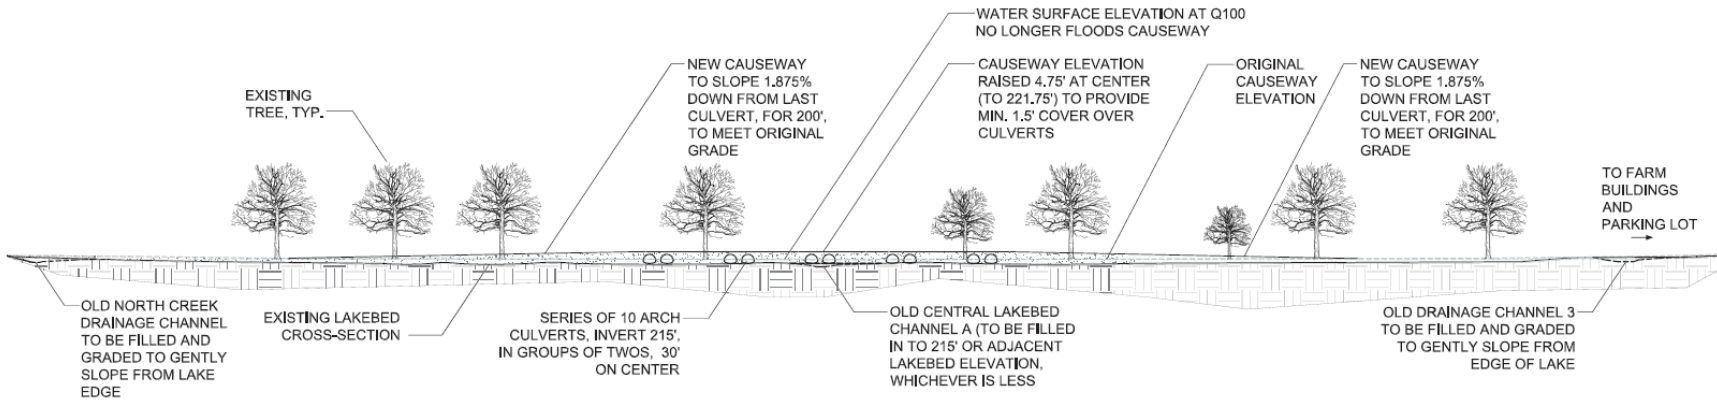
**PROPOSED CAUSEWAY CROSS SECTION & ELEVATION**

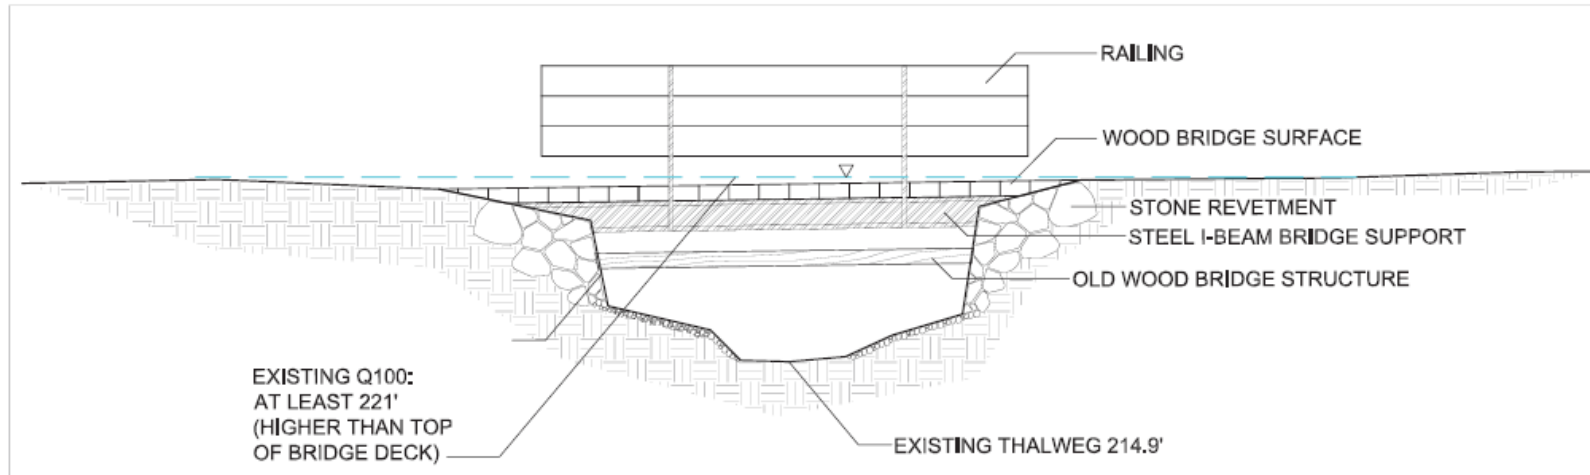
**EXISTING FARM BRIDGE CROSS SECTION**
