TOLAY LAKE REGIONAL PARK MASTER PLAN SUMMARY OF PHASE 1 COMMUNITY QUESTIONNAIRE RESULTS

Introduction.....	1
Purpose of the Historic Structures Report.....	1
Methodology.....	1
Summary of Findings.....	2
Development History.....	3
Historical Overview and Context.....	3
Chronology of Development and Use.....	8
Significance and Integrity.....	10
Physical Descriptions, Conditions, & Treatment Recommendations.....	11
Site.....	11
Building 1: Cottage/Julie’s House/Little Green House.....	13
Building 4: George and Vera’s House/Green House.....	20
Building 5: John Jr. and Beatrice’s House/Yellow House.....	31
Building 6: Hay Barn/Old Stone Floor Barn.....	41
Building 7: Old Dairy Barn.....	48
Building 8: Creamery/ Wine Storage.....	52
Building 9: Granary/Museum.....	59
Building 10: Line Shack.....	67
Building 12: Old Shop/Workshop.....	71
Building 13: Tractor Barn/ Equipment barn.....	78
Building 14: Storage Shed/ Equipment Shed.....	84
Building 15: Slaughterhouse.....	90
Additional Recommendations.....	95

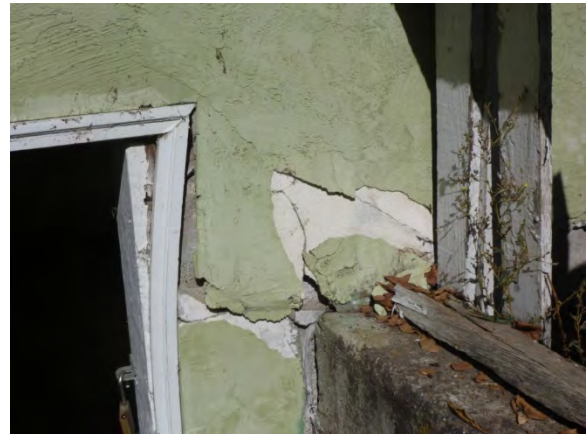
The stucco finish on the house is in generally poor condition with significant cracking due to the building's movement. There is an almost continuous horizontal crack at the foundation; there is serious cracking and spalling where concrete walls meet stucco at the basement stairway and at both porches. The underlying tongue and groove wood siding could not be observed; there is likely some deterioration at grade due to wood to earth contact where planting beds about the stucco.

Image 18 - Stucco at basement stair and door

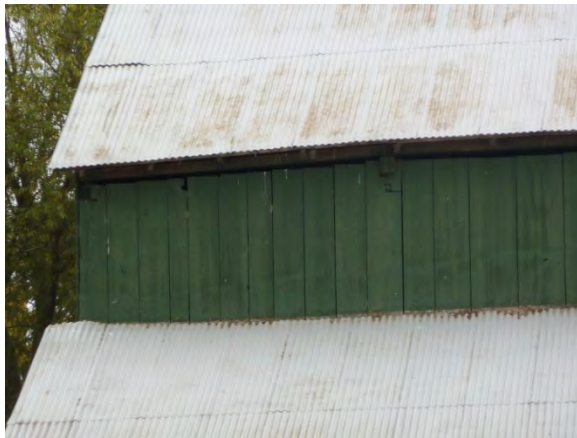
The corrugated metal roofing on both the barn and the shed is intact and in fair condition, with rust staining on the exterior. At the southeast corner of the barn, the roof is sagging and there is corrosion and some warping of the shed roof where it meets the barn wall. The roof drainage system is non-functional. The gutter on the west side of the barn is partially detached and filled with leafy debris. Half of the gutter at the shed is missing. Downspouts are either missing or cut off several feet above grade.

Image 49 - Typical condition of roof

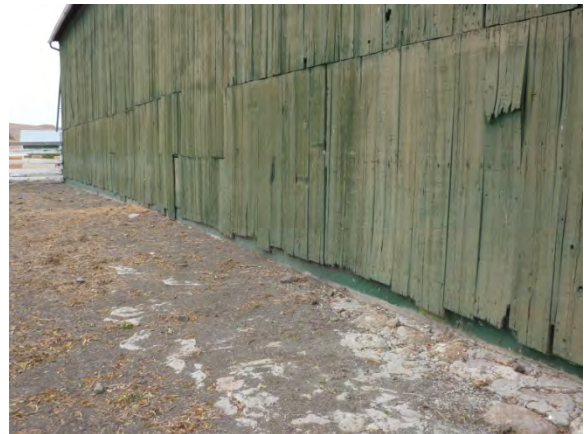
Image 51 - Typical repurposed and deteriorated siding

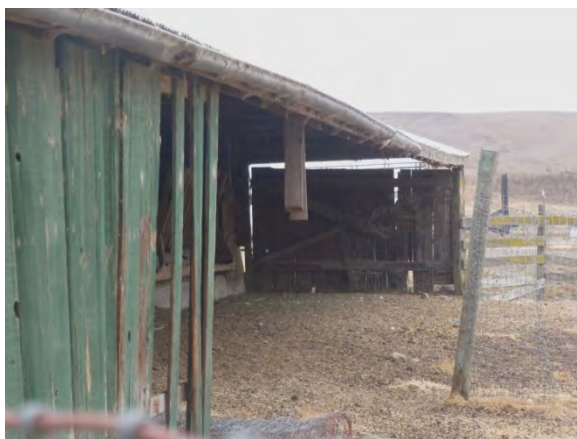
Image 50 - Failing roof at shed

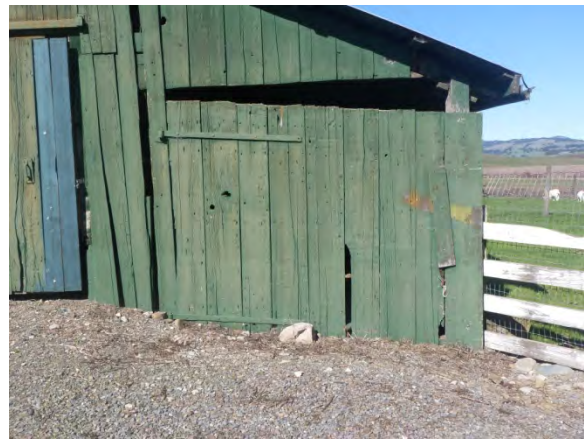
Image 52 - Shed siding with wood to earth contact

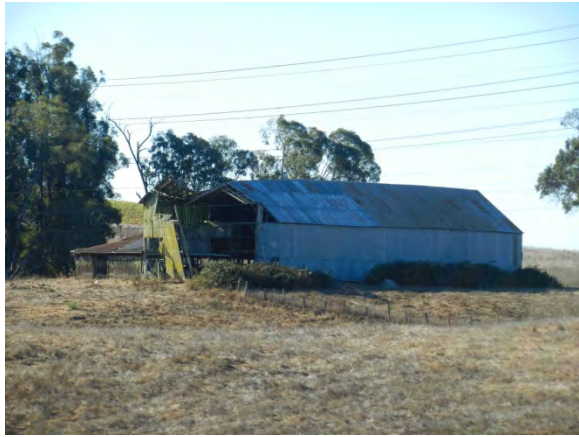
Image 57 – North side of Old Dairy Barn with collapsed section at east end

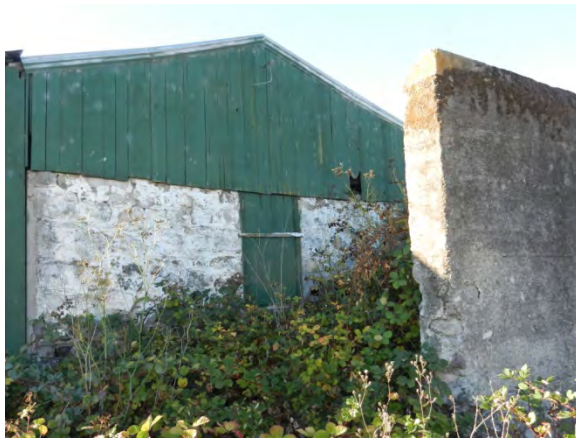
Image 73 - Overgrown vegetation on north side

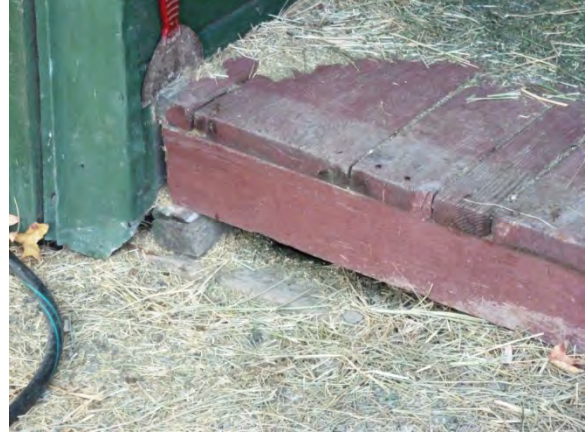
Image 93 - Wood to earth contact at stairs to north entrance.

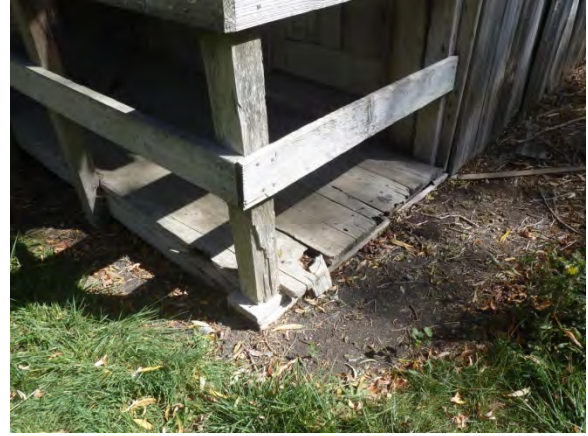
Image 101 - Deterioration at west end of porch

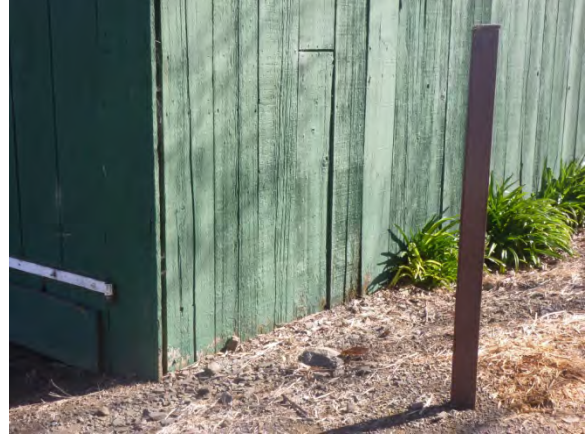
Image 117 - Wood to earth contact of siding

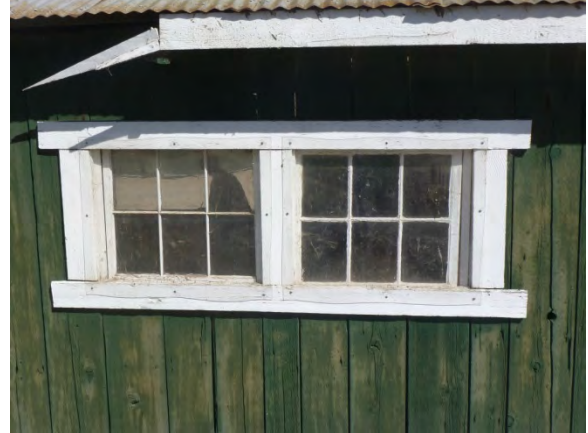
Image 128 - Typical window with Plexiglas covering; damaged trim
