**Roche Ranch  
Conservation Easement  
BASELINE DOCUMENTATION**

### ROCHE RANCH CONSERVATION EASEMENT BASELINE DOCUMENTATION

## **BASELINE DOCUMENTATION**

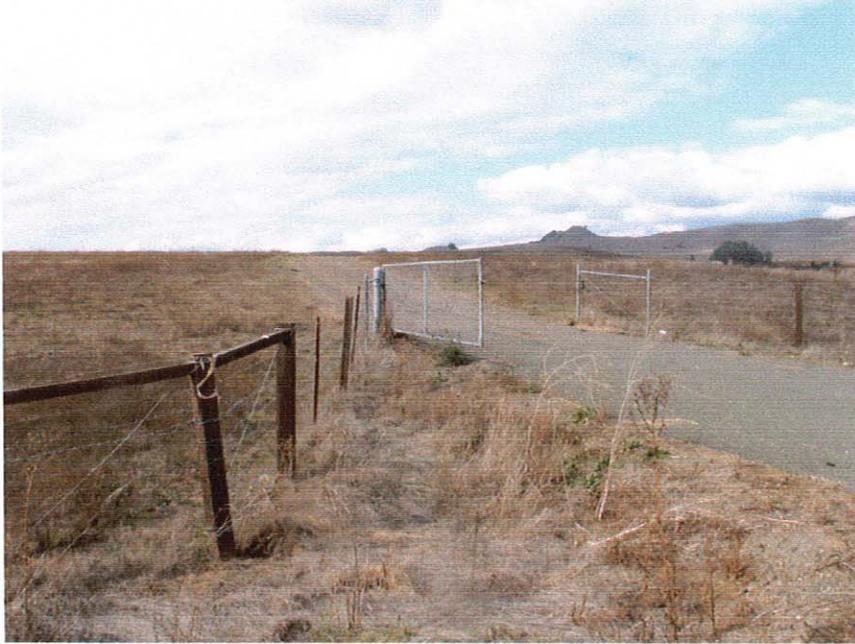
Location #1  
Photograph #1  
Bearing: 305°

Access gate to Property from Hwy 121.

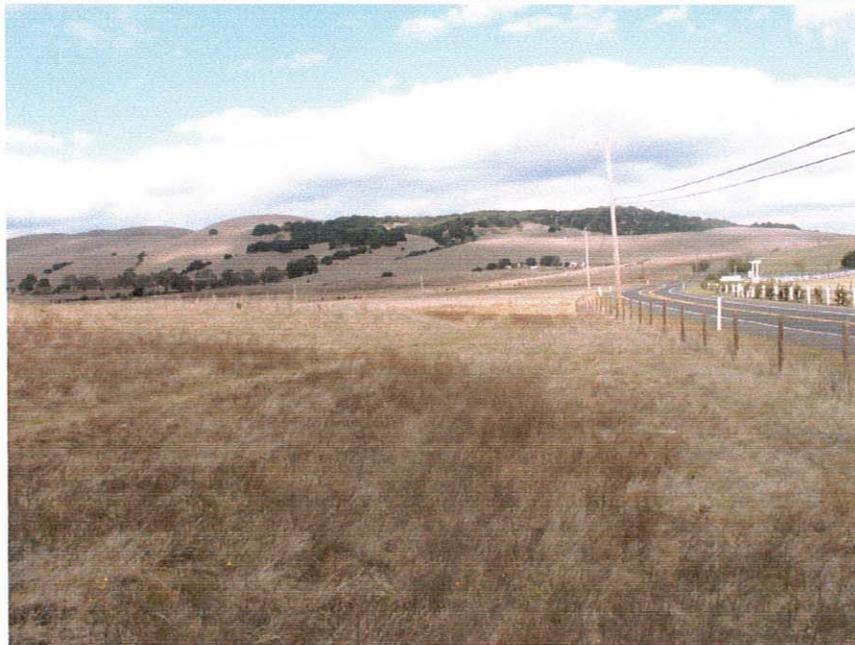
Location #2  
Photograph #2  
Bearing: 375°

Hwy 121 frontage.

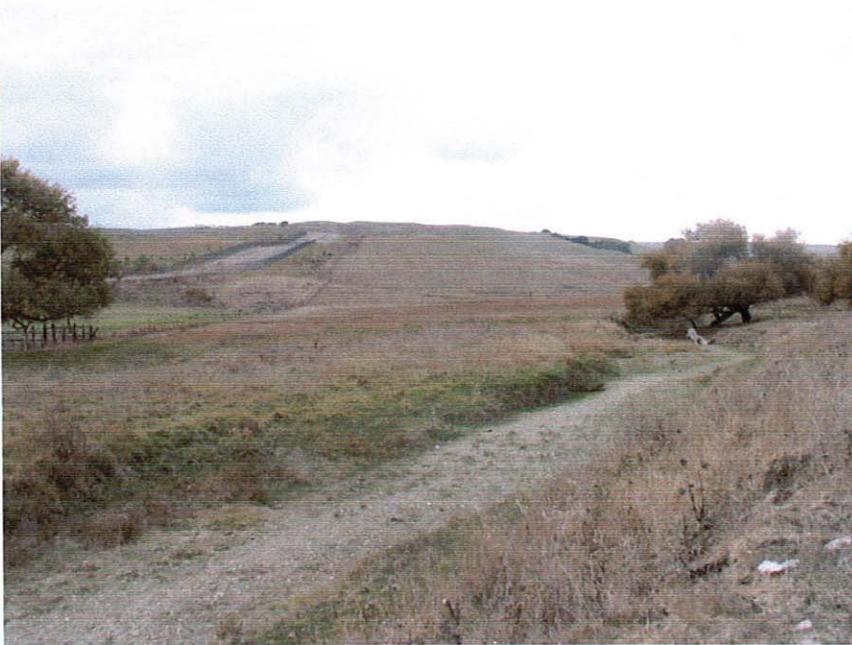
Location #3  
Photograph #3  
Bearing: 255°

Tolay Creek and Infineon Raceway  
property line.

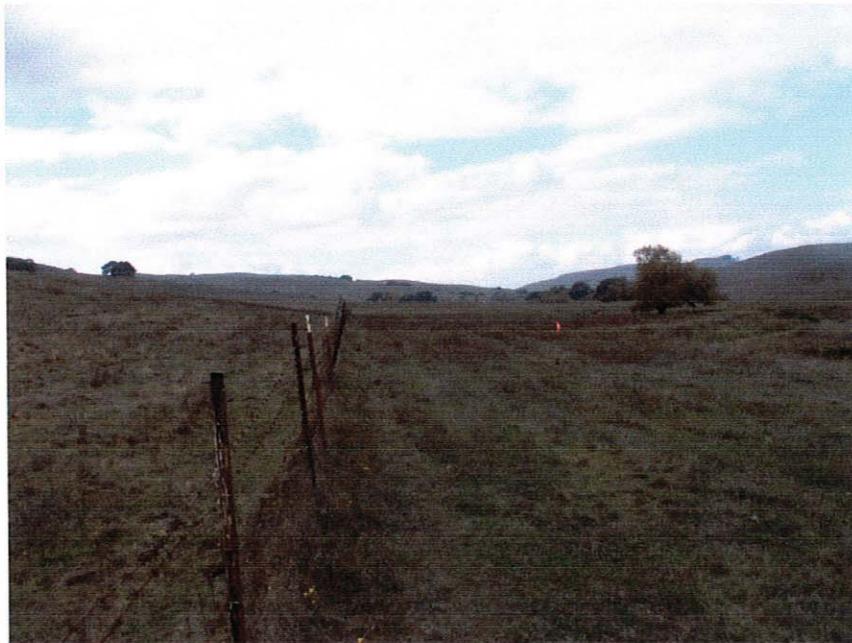
Location #4  
Photograph #4  
Bearing: 285°

Southern portion of Property with Tolay  
Creek / Property line to right and interior  
fence to left.

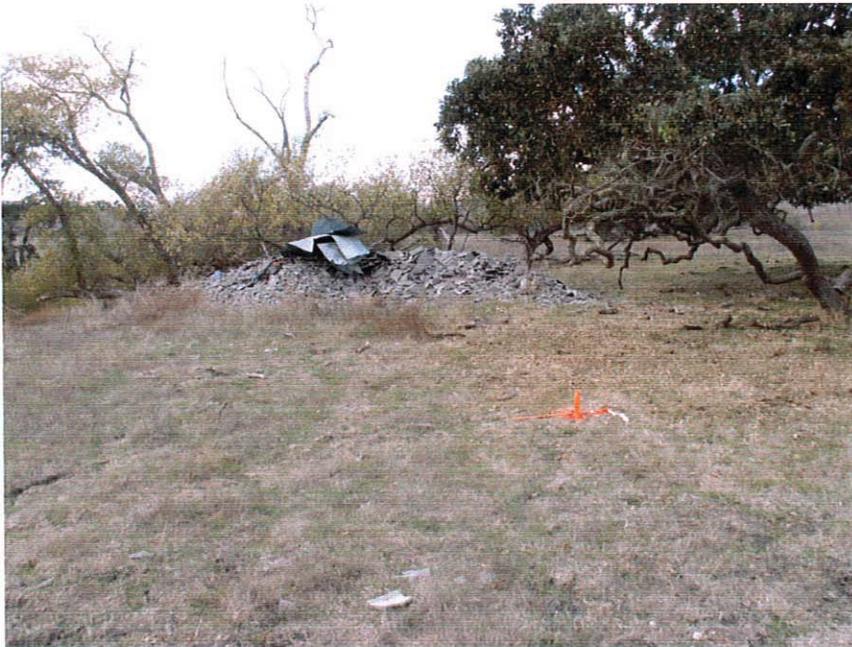
Location #5  
Photograph #5  
Bearing: 310°

Pile of rubble just inside eastern Property line.

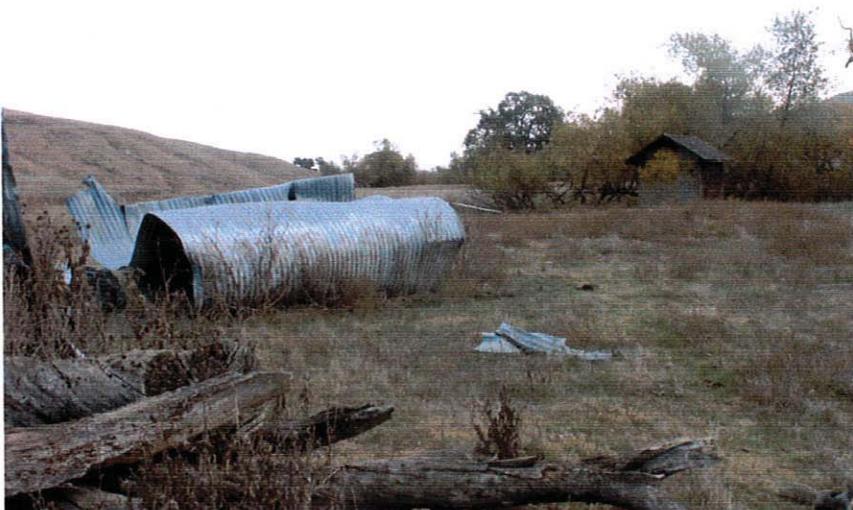
Location #6  
Photograph #6  
Bearing: 135°

Metal debris and ~ 100 sq ft shed near eastern Property line.

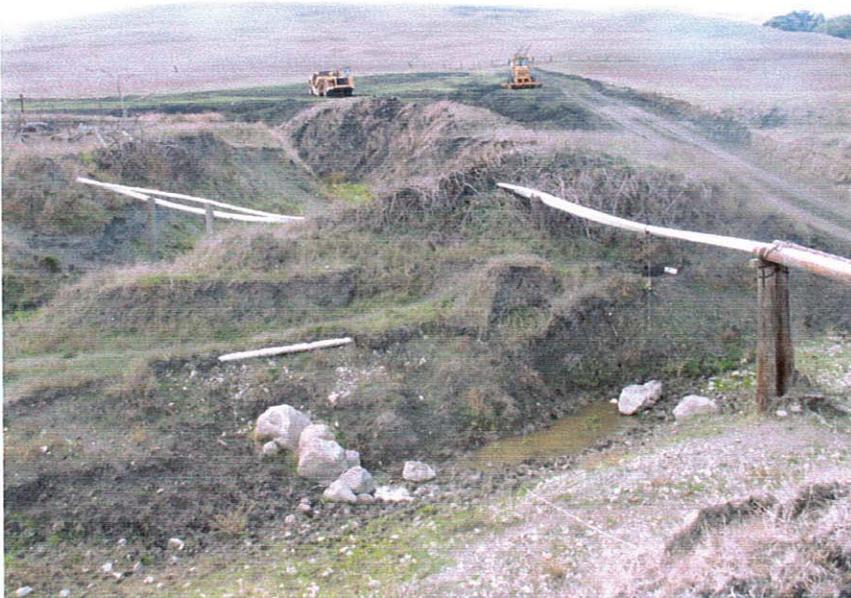
Location #7  
Photograph #7  
Bearing: 255°

Eroded confluence of Tolley Creek with SW tributary with exposed PVC pipe. Note tractors in background associated with ongoing grading activity.

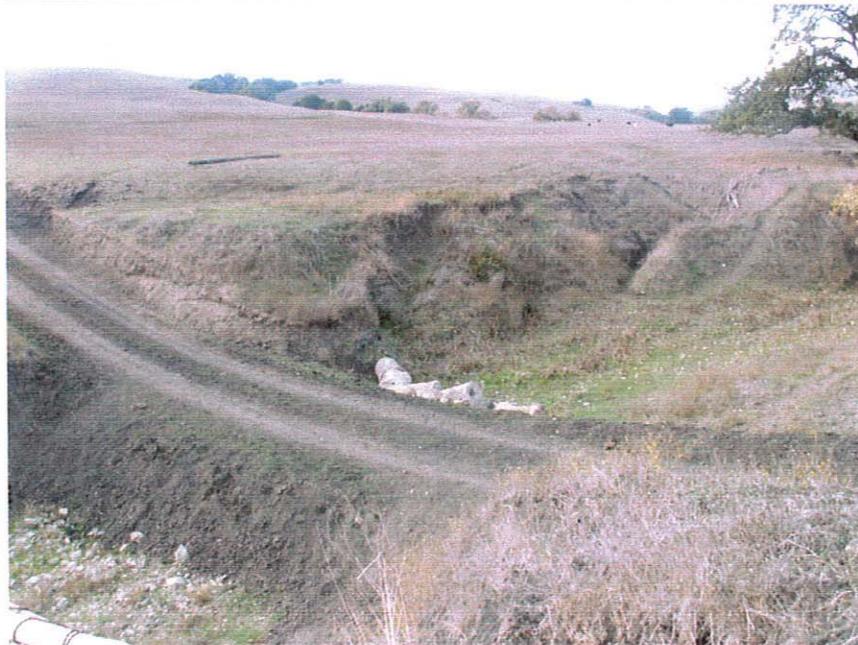
Location #8  
Photograph #8  
Bearing: 275°

Crossing constructed on fill through Tolley Creek channel (no culvert).

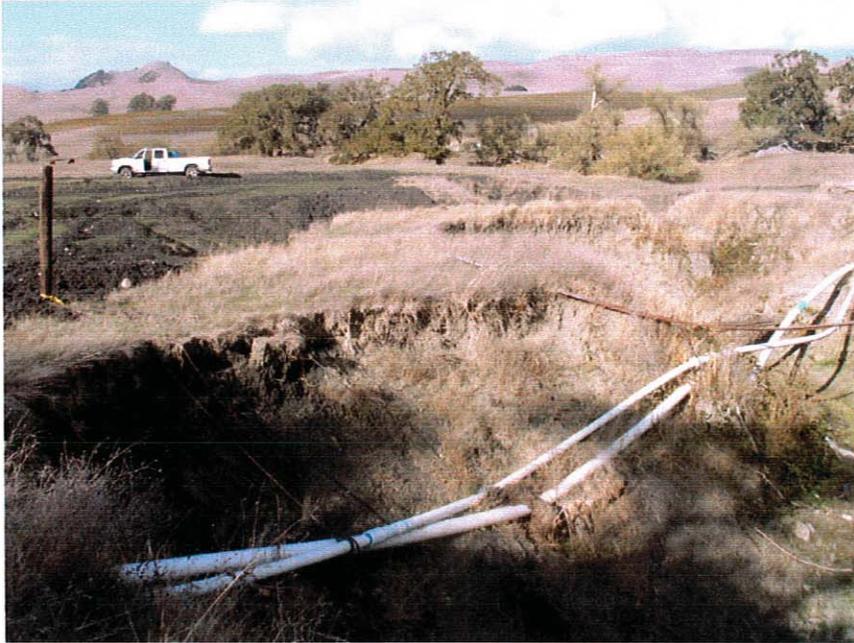
Location #9  
Photograph #9  
Bearing: 355°

Exposed PVC pipe in channel of tributary to Tolay Creek with recent grading to left. Valley oaks in background.

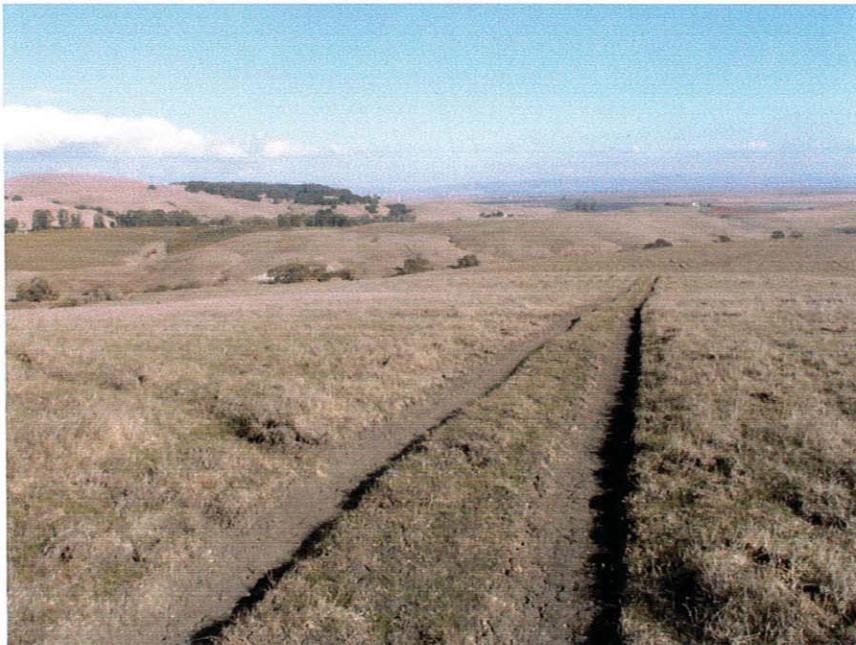
Location #10  
Photograph #10  
Bearing: 85°

Rutted, unimproved seasonal dirt ranch road with Tolay Creek, Roche vineyard, Hwy 121, and Sonoma Baylands in background.

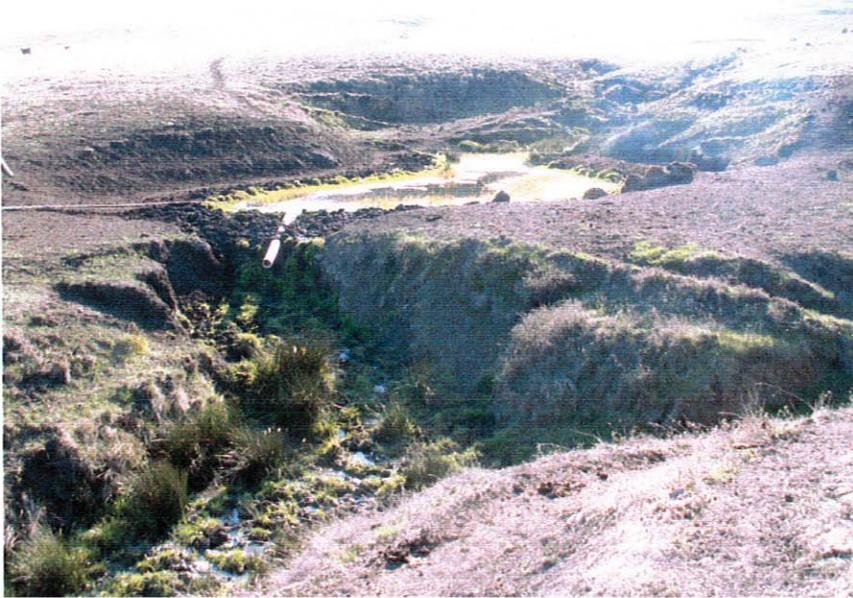
Location #11  
Photograph #11  
Bearing: 205°

Developed spring accessible to cattle.

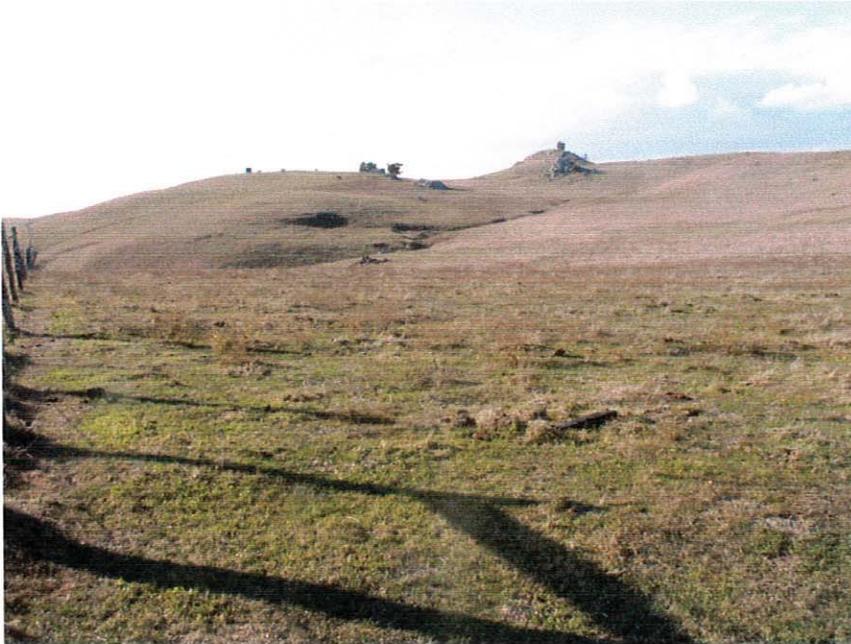
Location #12  
Photograph #13  
Bearing: 285°

Eastern portion of Property with rocky knoll in background. Annual grassland habitat type.

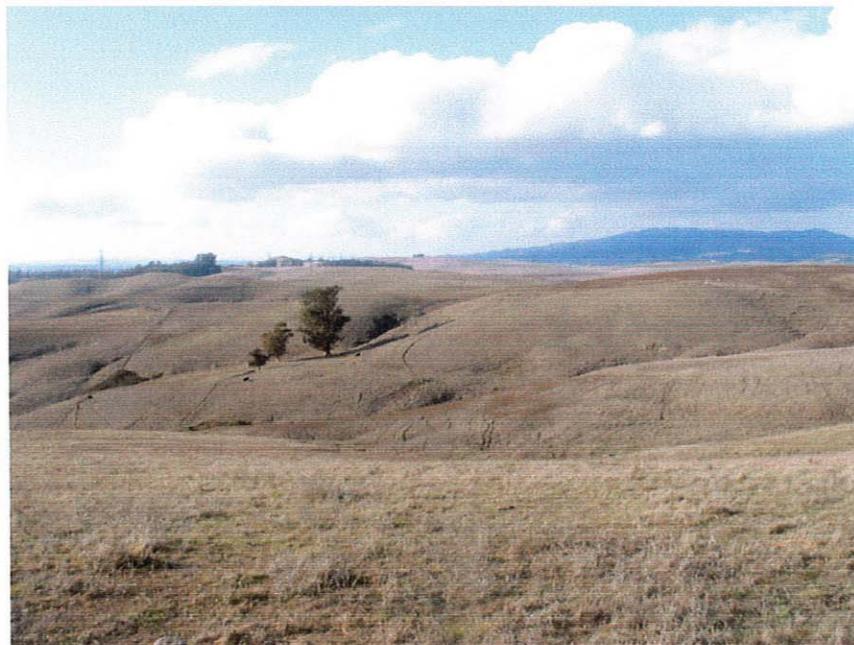
Location #15  
Photograph #16  
Bearing: 315°

Northwestern portion of Property with  
Tolay Lake in background, developed  
spring, possible historic homestead site in  
center of photo.

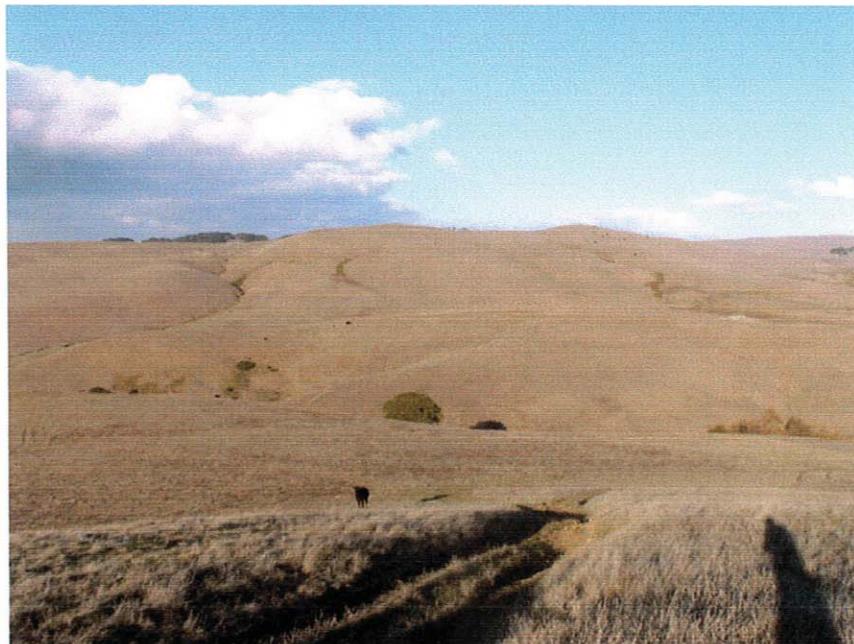
Location #17  
Photograph #21  
Bearing: 25°

Southwestern facing slope with seeps on northern portion of Property (note green "ribbons" extending from seeps – Wet Meadow habitat type).

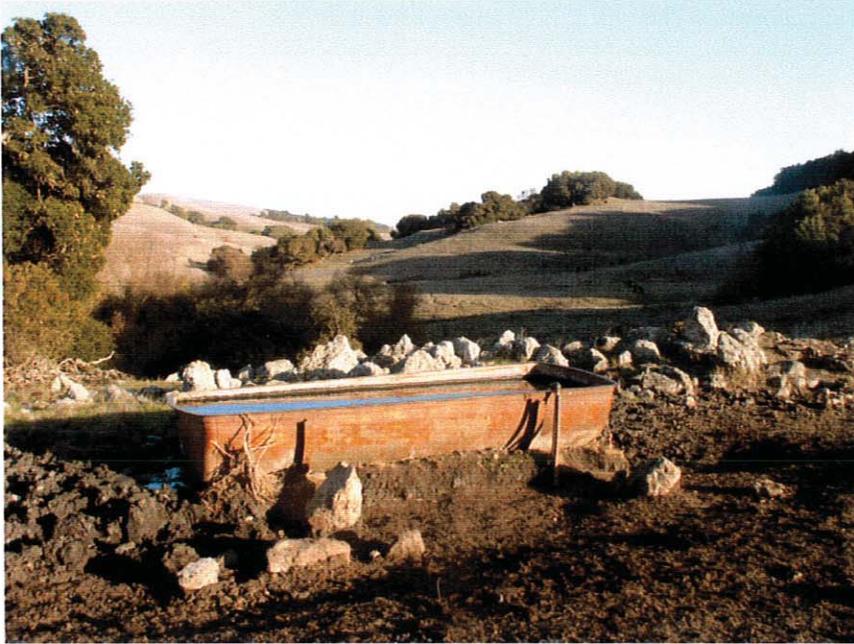
Location #18  
Photograph #22  
Bearing: 105°

Developed spring.

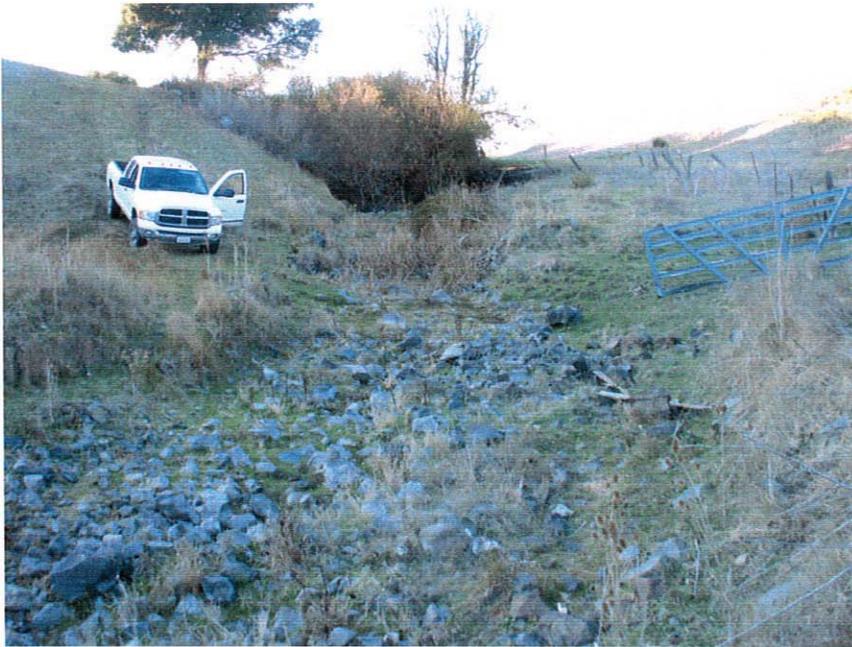
Location #20  
Photograph #24  
Bearing: 325°

Rocked ranch road crossing of Tolay  
Creek near NW Property boundary  
(abutments of Mangel Ranch Rd bridge in  
background).

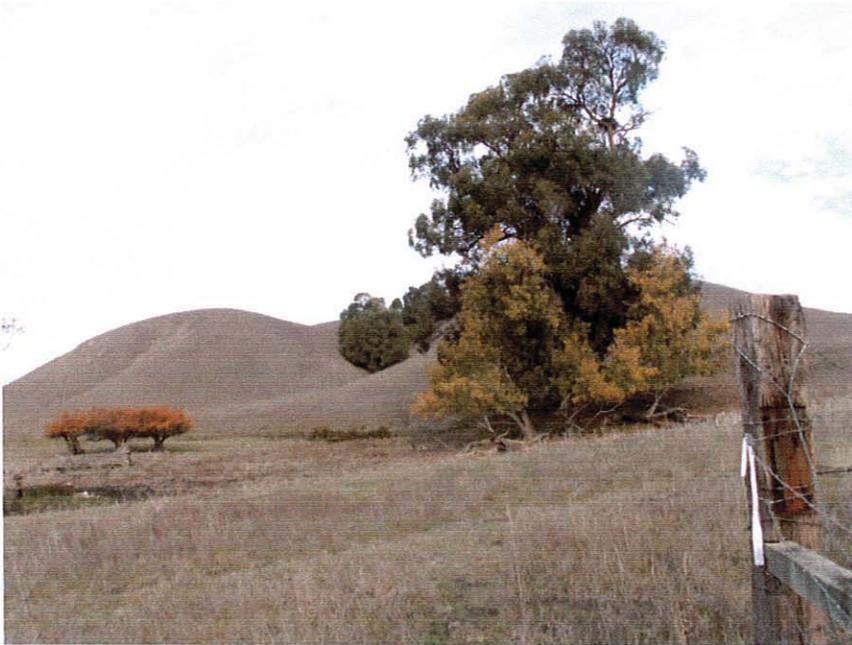
Location #22  
Photograph #28  
Bearing: 315°

Possible historic home site with developed spring and large eucalyptus with golden eagle nest.

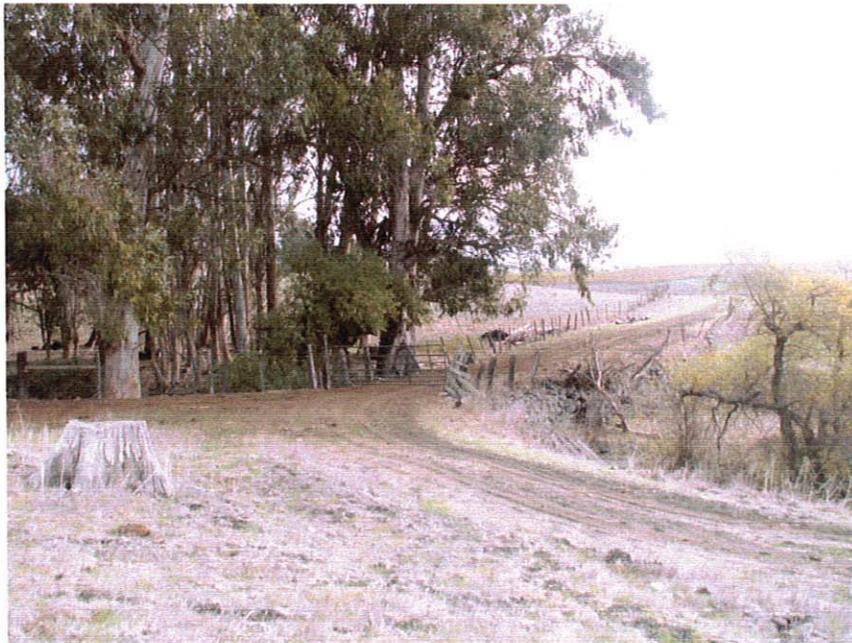
Location #23  
Photograph #29  
Bearing: 80°

Mangel Ranch Rd. right of way easement (off Property) over a northern tributary to Tolay Creek.

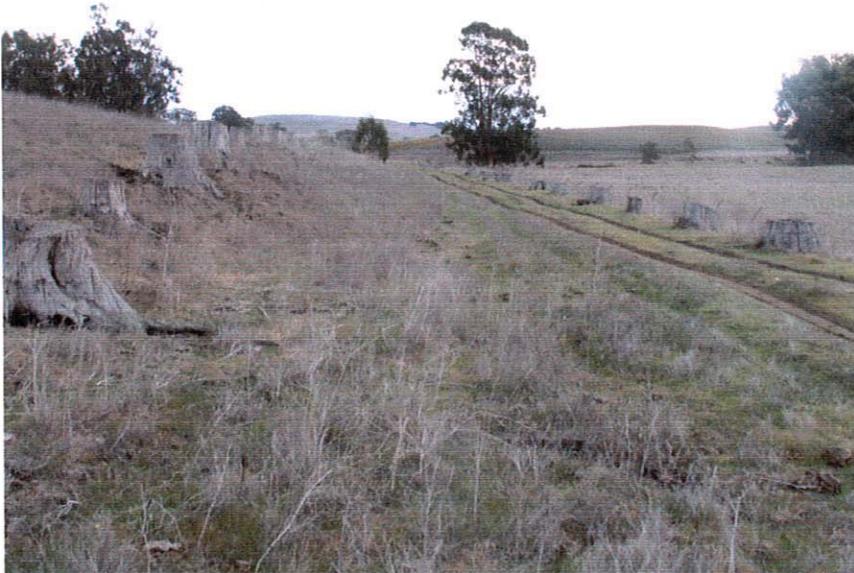
Location #24  
Photograph #30  
Bearing: 95°

Eucalyptus stumps along Mangel Ranch Rd.

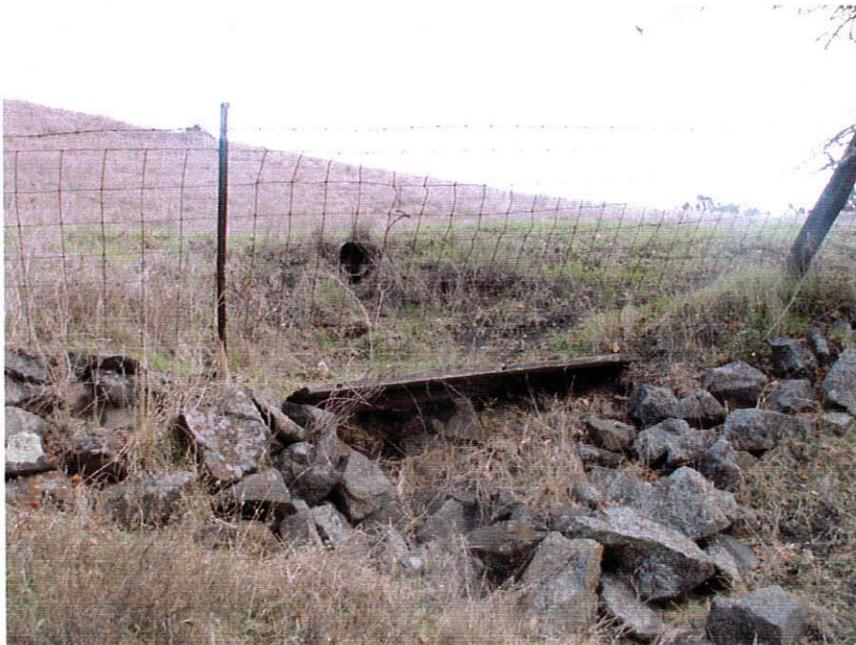
Location #25  
Photograph #31  
Bearing: 35°

10" culvert on Mangel Ranch Rd. draining toward Tolay Creek.

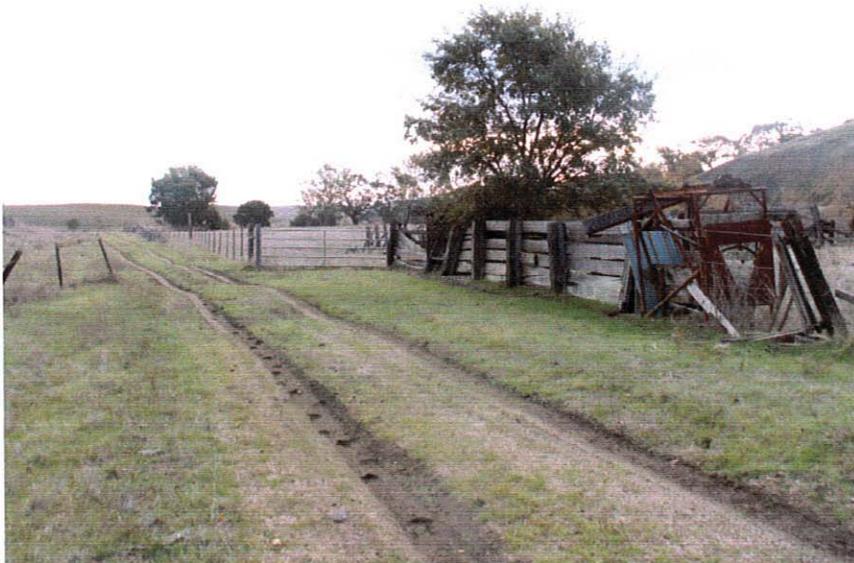
Location #26  
Photograph #32  
Bearing: 125°

Mangel Ranch Rd. along Tolay Creek and  
old corral fencing.

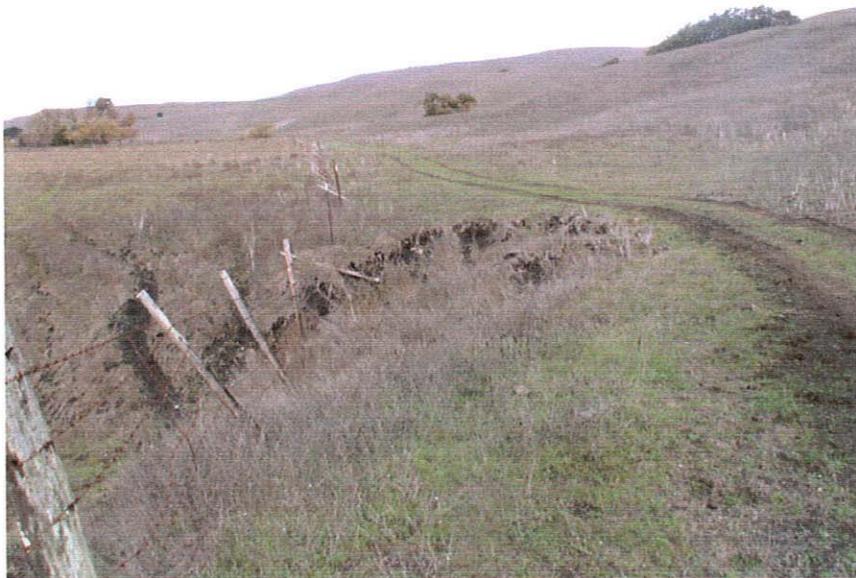
Location #27  
Photograph #33  
Bearing: 305°

Eroded area along interior fenceline,  
Mangel Ranch Rd. along Tolay Creek.

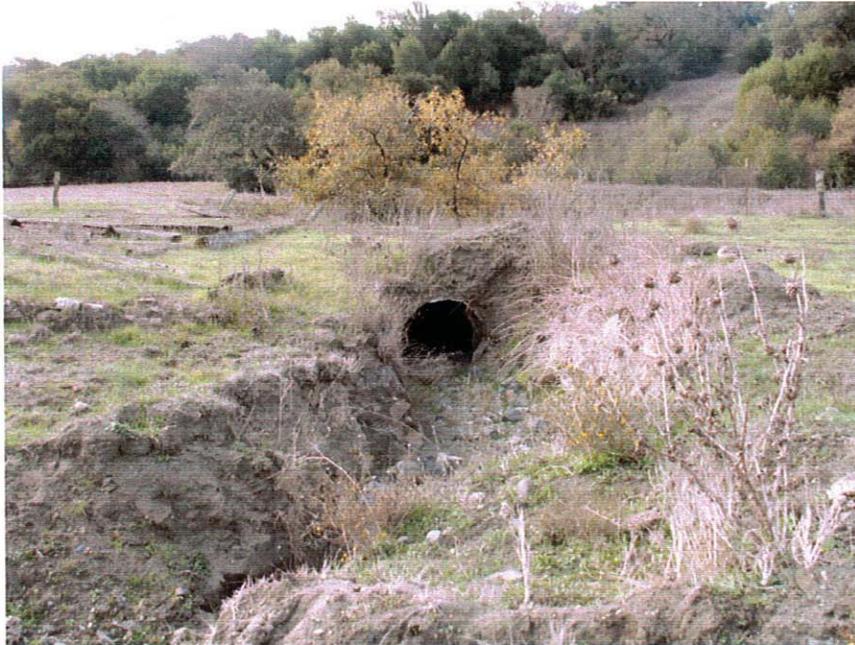
Location #28  
Photograph #34  
Bearing: 195°

48" culvert on Mangel Ranch Rd. draining toward Tolay Creek.

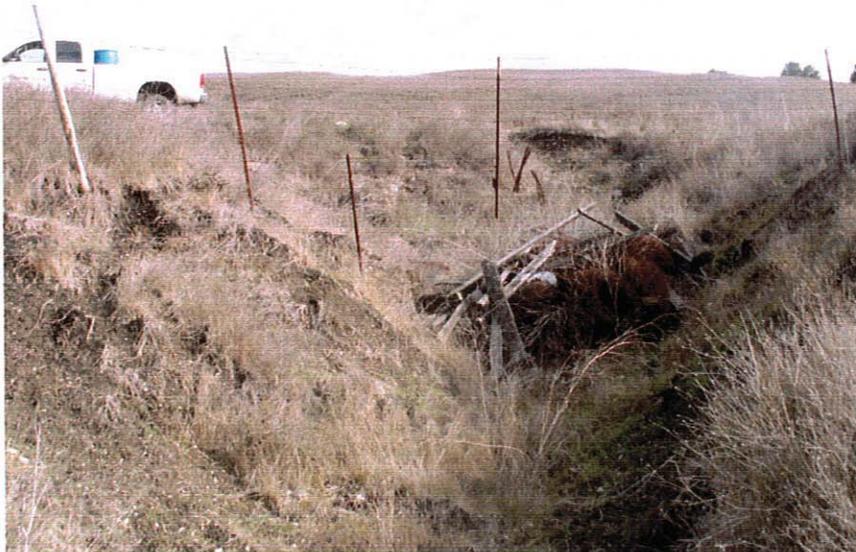
Location #29  
Photograph #35  
Bearing: 25°

Eroded bank along interior fence/Mangel Ranch Rd. with old fencing debris.

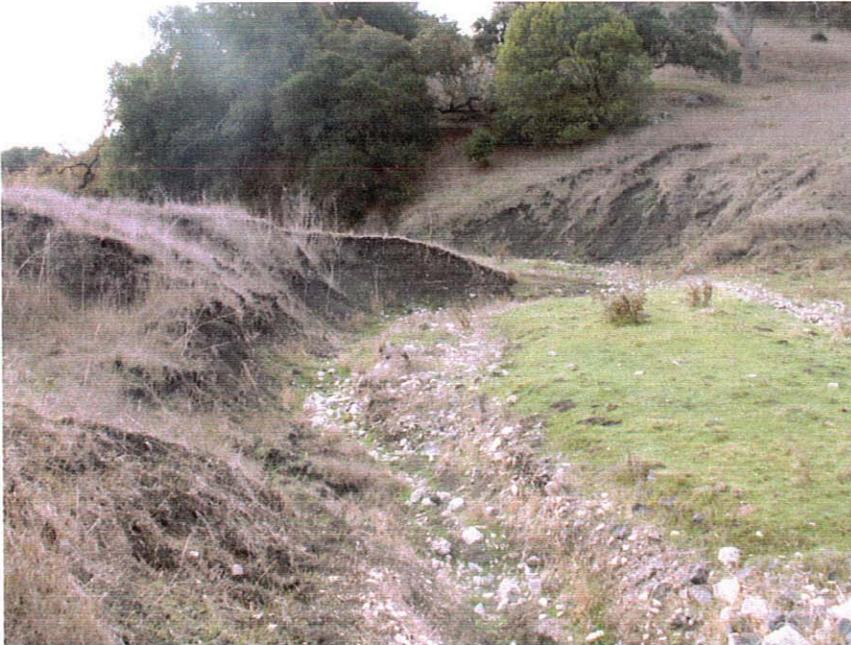
Location #30  
Photograph #36  
Bearing: 155°

Some segments of Tolay Creek on the Property are severely eroded, with exposed, nearly vertical banks. Gullying is occurring on many of the drainages on the slopes draining into Tolay Creek. The New Years Day 2006 flood event in the area caused extensive erosion on the Property as well as other watersheds in the area (B. J. Roche, pers. comm., 2007).

Eroded portion of Tolay Creek.

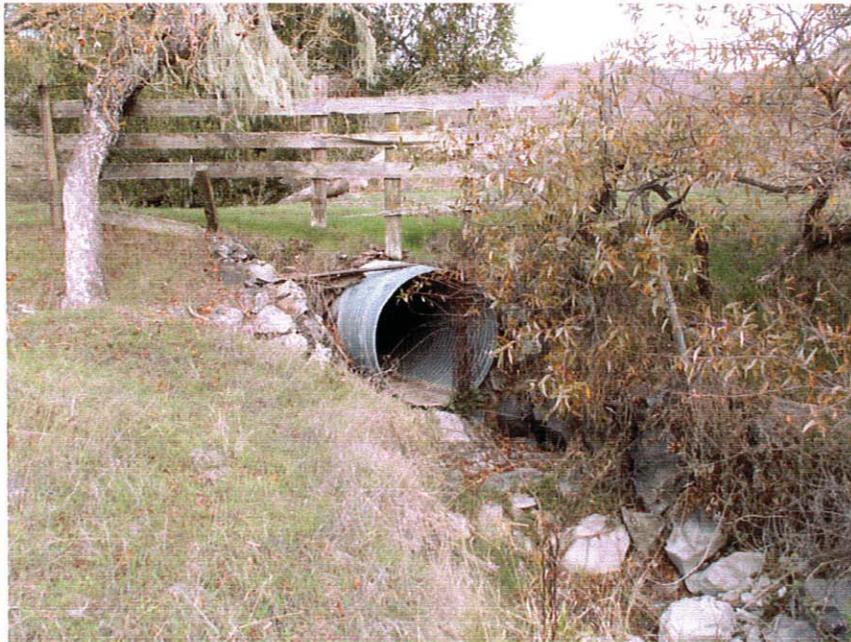
Location #31  
Photograph #37  
Bearing: 335°

48" culvert on Mangel Ranch Rd. draining  
toward Tolay Creek.

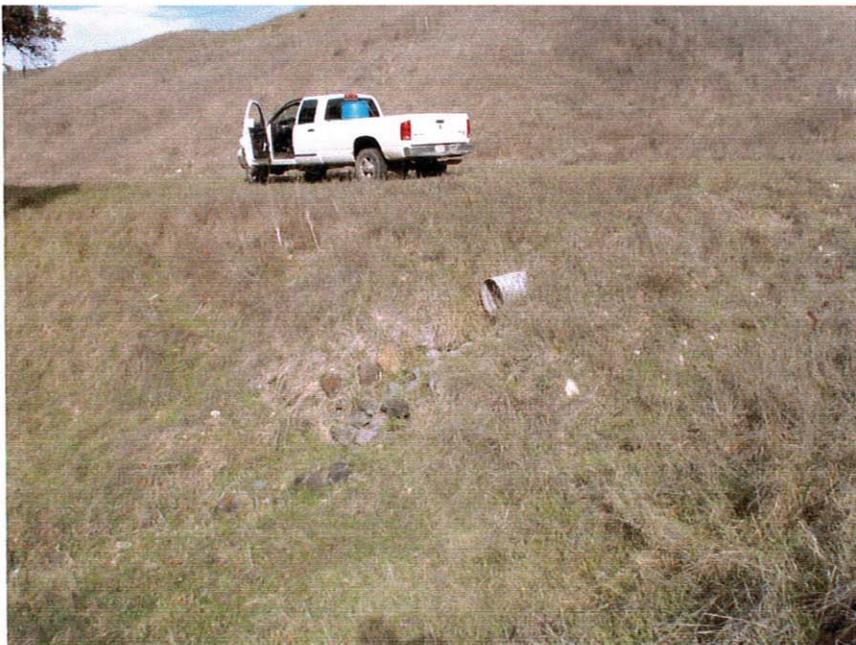
Location #33  
Photograph #39  
Bearing: 315°

14" culvert on Mangel Ranch Rd. draining toward Tolay Creek.

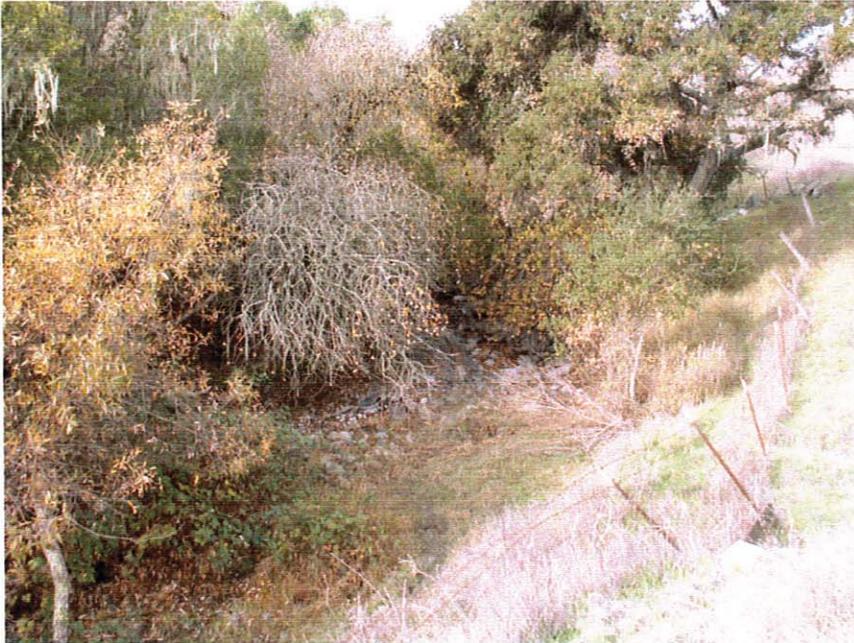
Location #33  
Photograph #40  
Bearing: 275°

Portion of Tolay Creek channel dominated by bedrock. Montane Riparian habitat type with Himalayan blackberry at lower left.

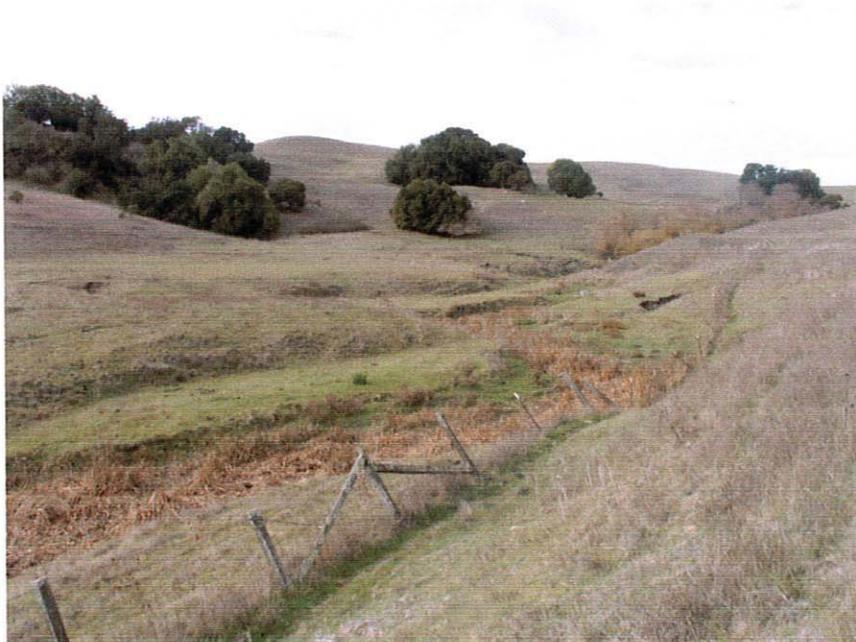
Location #34  
Photograph #41  
Bearing: 255°

The Fresh Emergent Wetland habitat type on the Property is located in the portions of the upper Tolay Creek corridor largely devoid of woody riparian vegetation. Cattle have open access to graze along the riparian corridor (see Photo #41). The presence of a variety of “obligate wetland plants” (OBL) indicates that a continuous and steady source of water is present either above or below ground during all seasons. “Facultative wetland plants” (FACW) also occur abundantly in this habitat. The following is a list of commonly found plants, along with their wetland designation in parentheses.

Grazed tules in Fresh Emergent Wetland habitat along Tolay Creek.

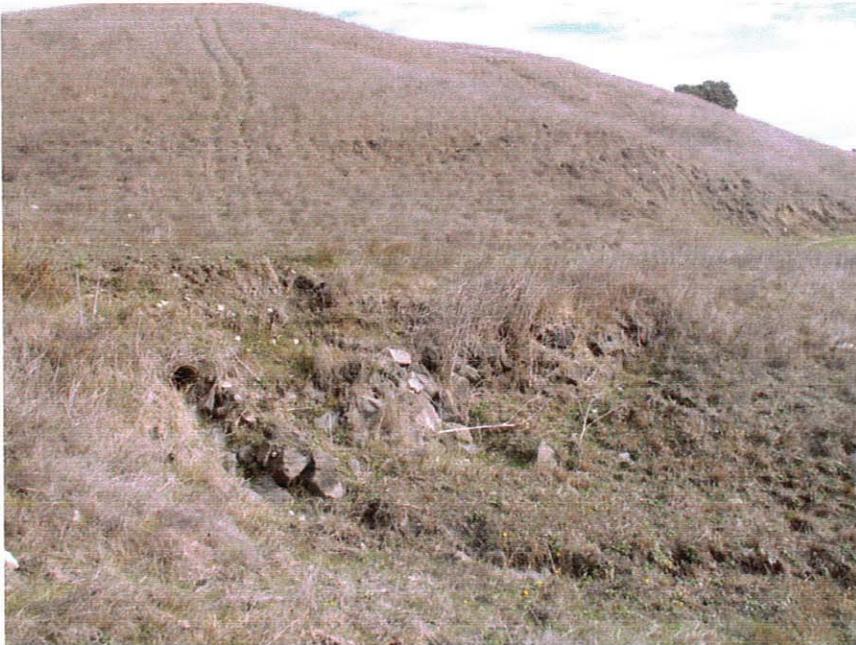
Location #35  
Photograph #42  
Bearing: 55°

14" culvert on Mangel Ranch Rd. draining toward Tolay Creek.

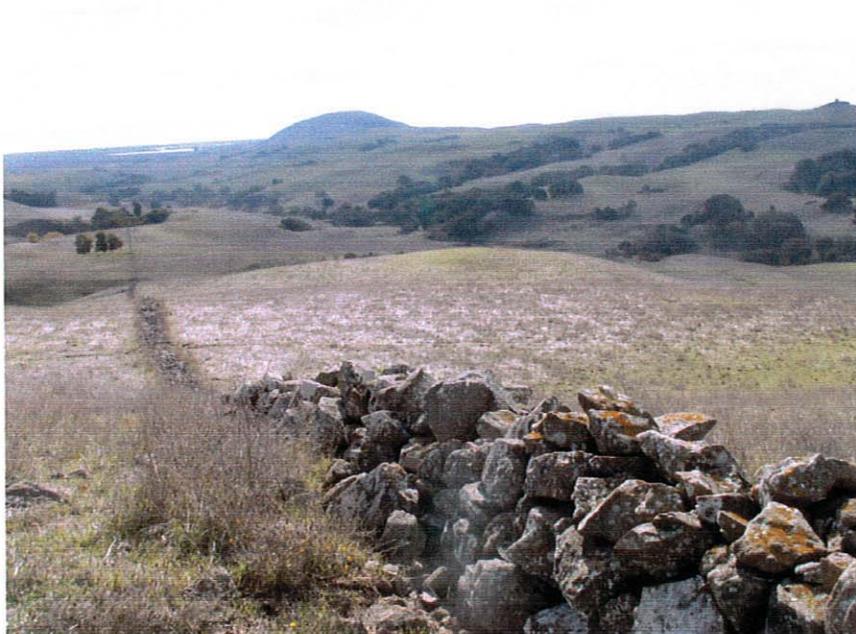
Location #36  
Photograph #43  
Bearing: 135°

Historic ruins of rock wall with San Pablo Bay, Sears Point in background.

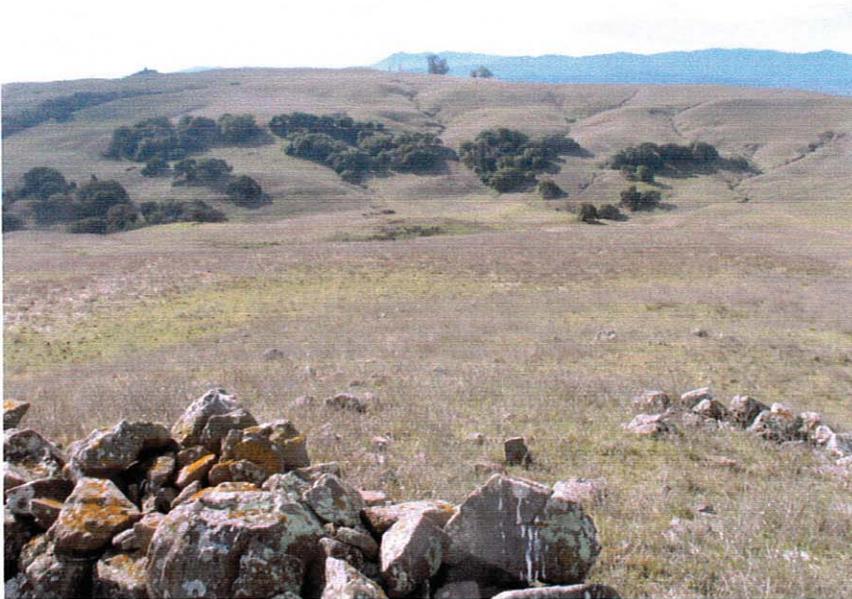
Location #36  
Photograph #44  
Bearing: 175°

Rock wall in foreground, southern portion of Property / Mt. Tamalpais in background with Coastal Oak Woodland habitat type.

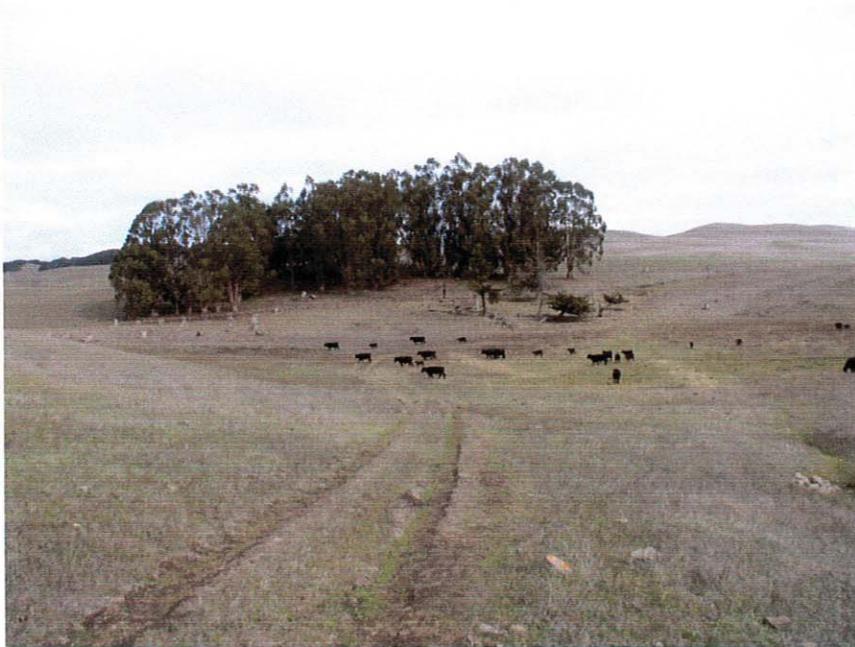
Location #38  
Photograph #46  
Bearing: 15°

Ranch road, cattle in foreground; possible historic homestead and eucalyptus/Monterey cypress grove in background.

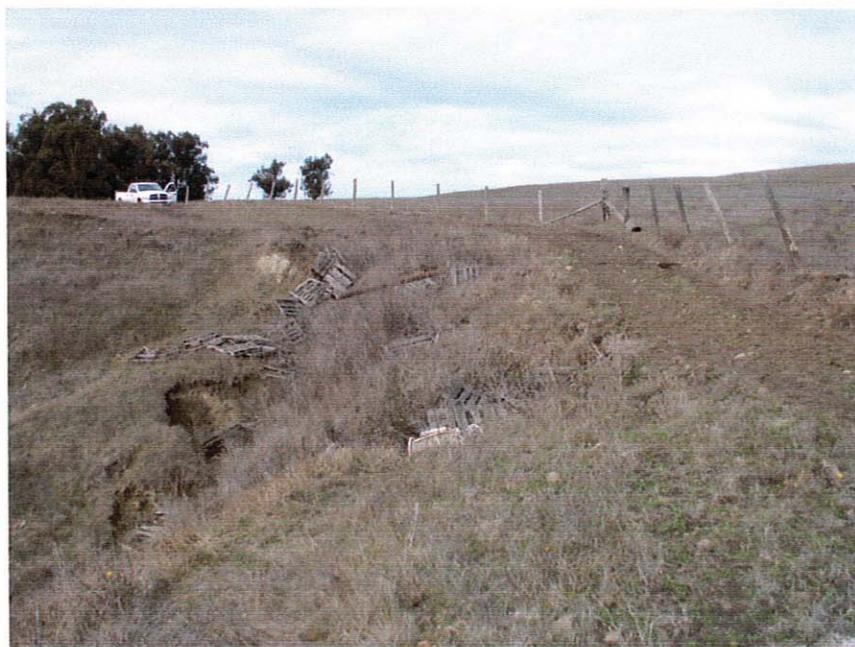
Location #39  
Photograph #47  
Bearing: 305°

Eroded portion of ranch road along northeast property line with wood debris (old pallets).

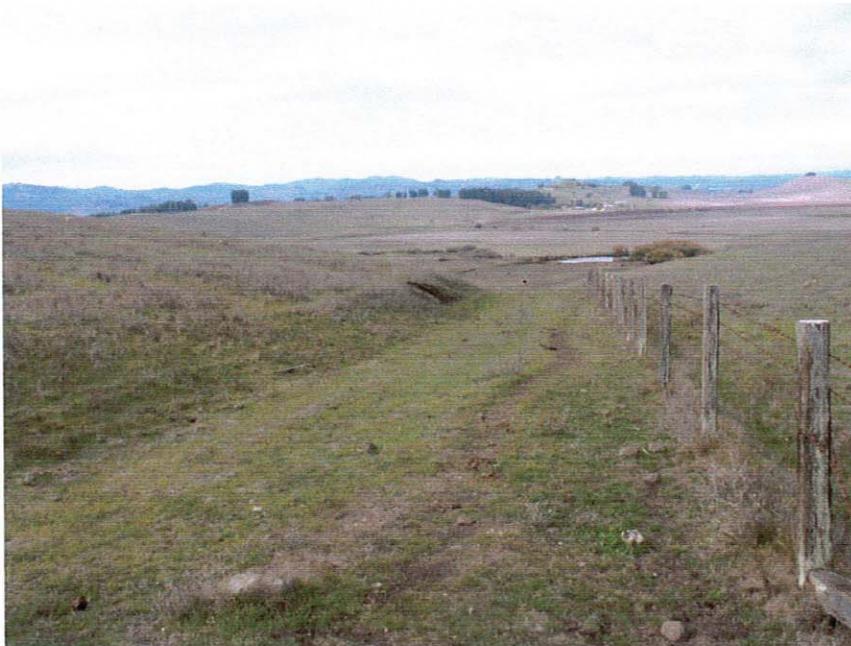
Location #40  
Photograph #48  
Bearing: 265°

Northern property line fence with Tolay  
Lake Regional Park property in  
background.

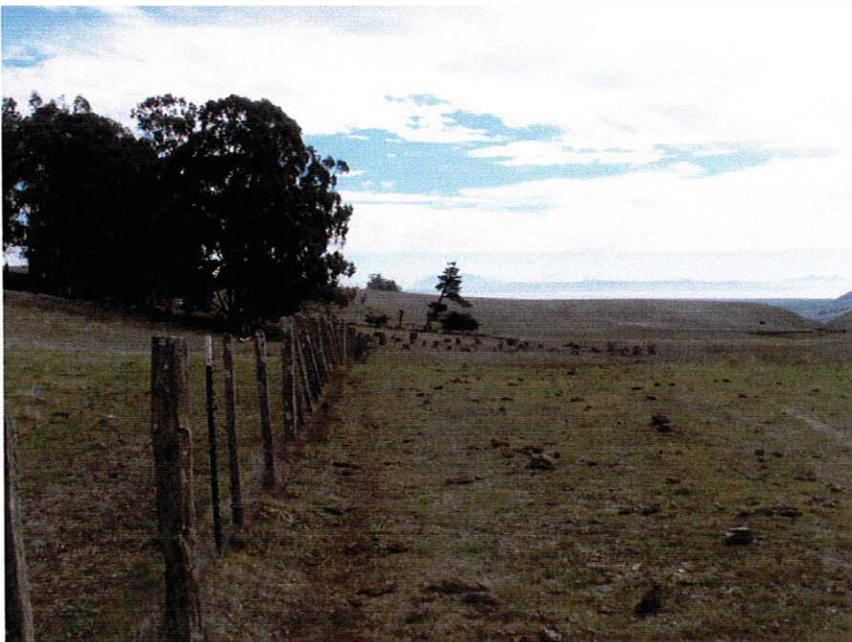
Location #41  
Photograph #49  
Bearing: 95°

Northern property line fence and possible  
historic homestead, Monterey cypress in  
center of photo.

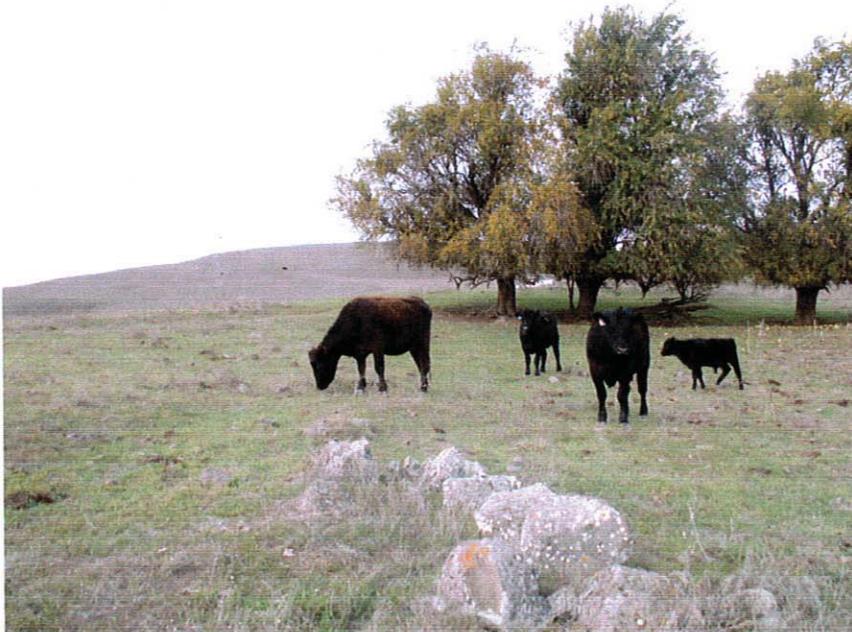
Location #43  
Photograph #51  
Bearing: 315°

Possible historic homestead with osage  
orange grove. Historic rock wall in  
background at left.

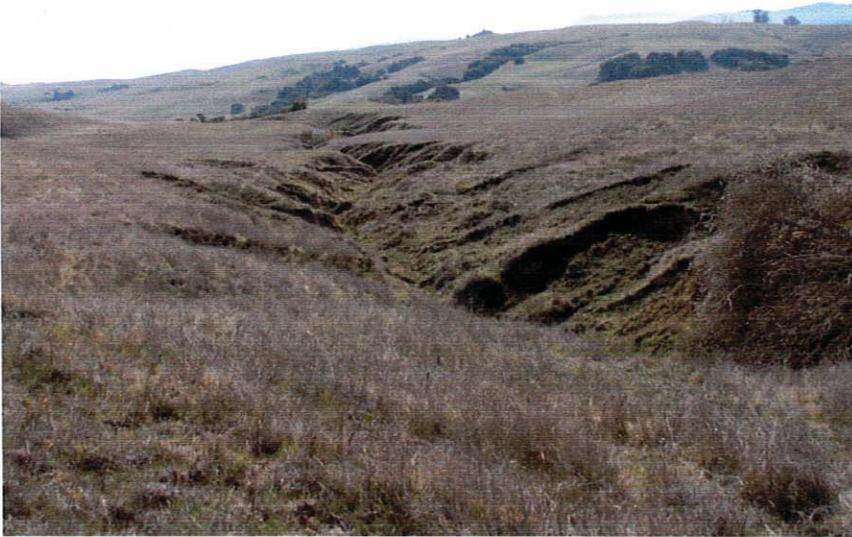
Location #44  
Photograph #52  
Bearing: 175°

Eroded drainage near northern property line.

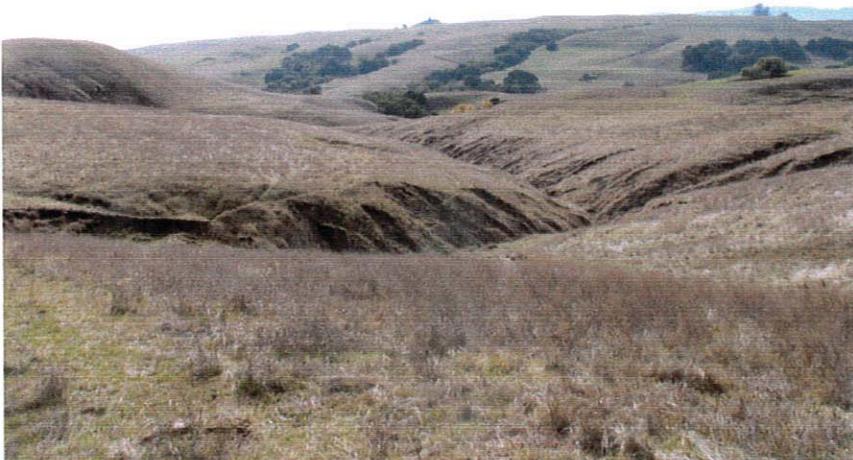
Location #45  
Photograph #53  
Bearing: 195°

Eroded drainage near northern property line.

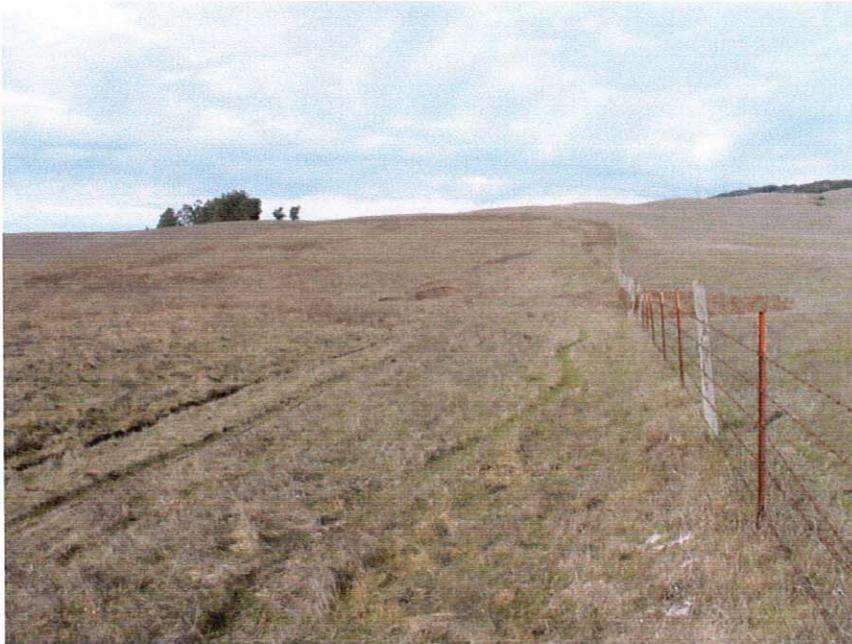
Location #46  
Photograph #54  
Bearing: 315°

Northern property line and unimproved  
seasonal dirt ranch road.
