**Roche Ranch  
Conservation Easement  
BASELINE DOCUMENTATION**

### ROCHE RANCH CONSERVATION EASEMENT BASELINE DOCUMENTATION

## **BASELINE DOCUMENTATION**

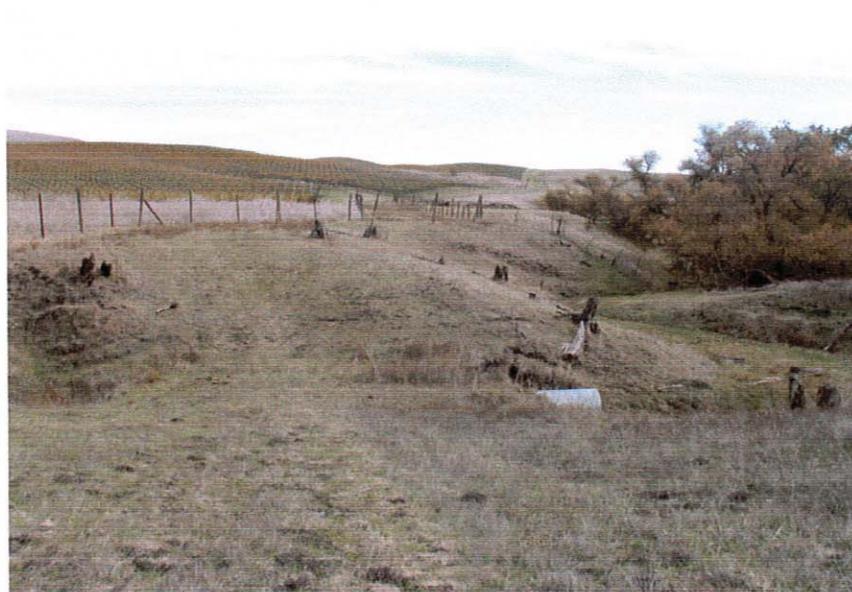
Location #47  
Photograph #55  
Bearing: 105°

Former ranch road crossing over 36"  
culvert near riparian easement boundary;  
vineyard on left, Tolay Creek on right.

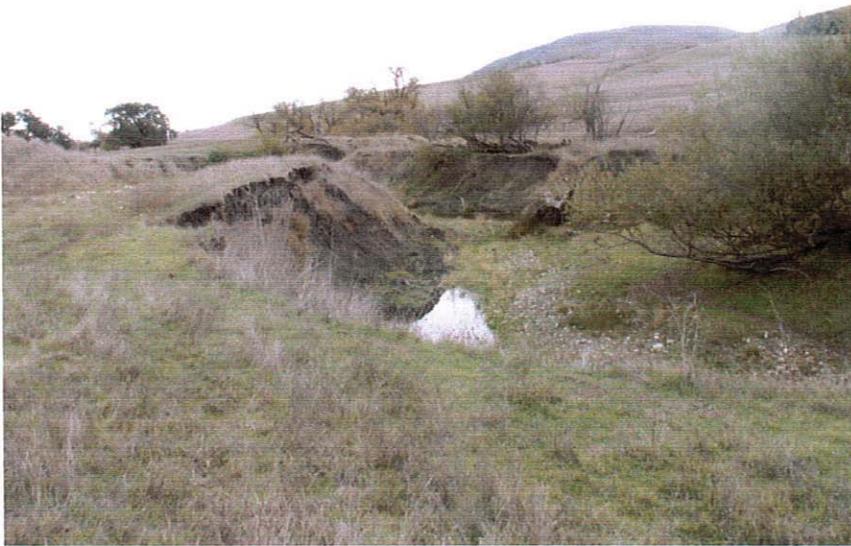
Location #48  
Photograph #56  
Bearing: 135°

Tolley Creek with riparian easement at left.

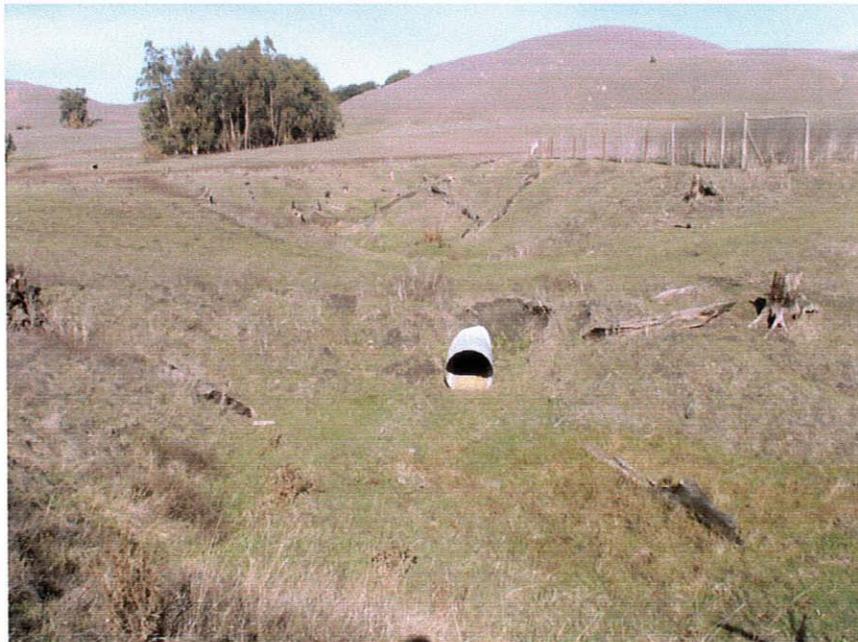
Location #49  
Photograph #57  
Bearing: 10°

Former ranch road with 36 "culvert in  
stump lined tributary draining from the  
northeast.

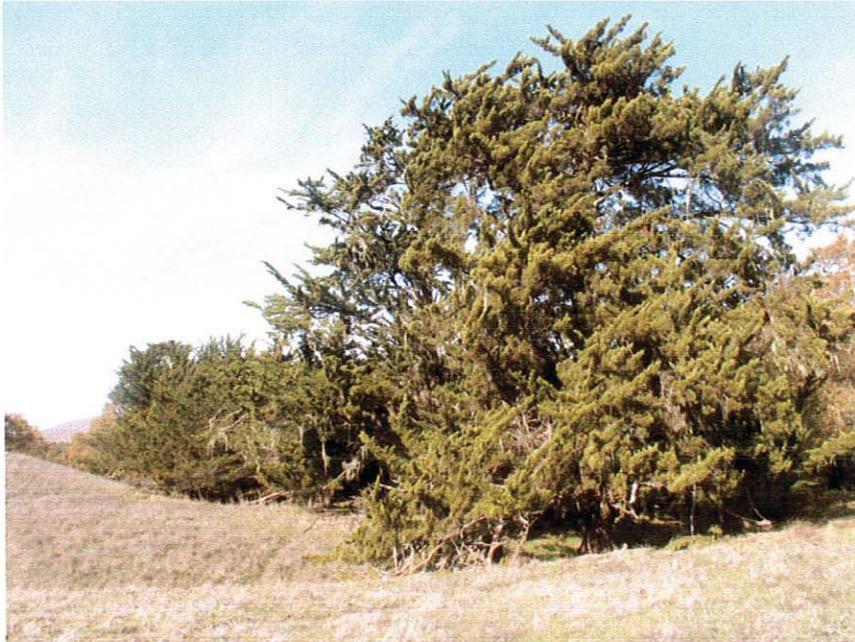
Location #50  
Photograph #58  
Bearing: 340°

Monterey cypress grove within Montane  
Riparian habitat on SW side of Tolay  
Creek.

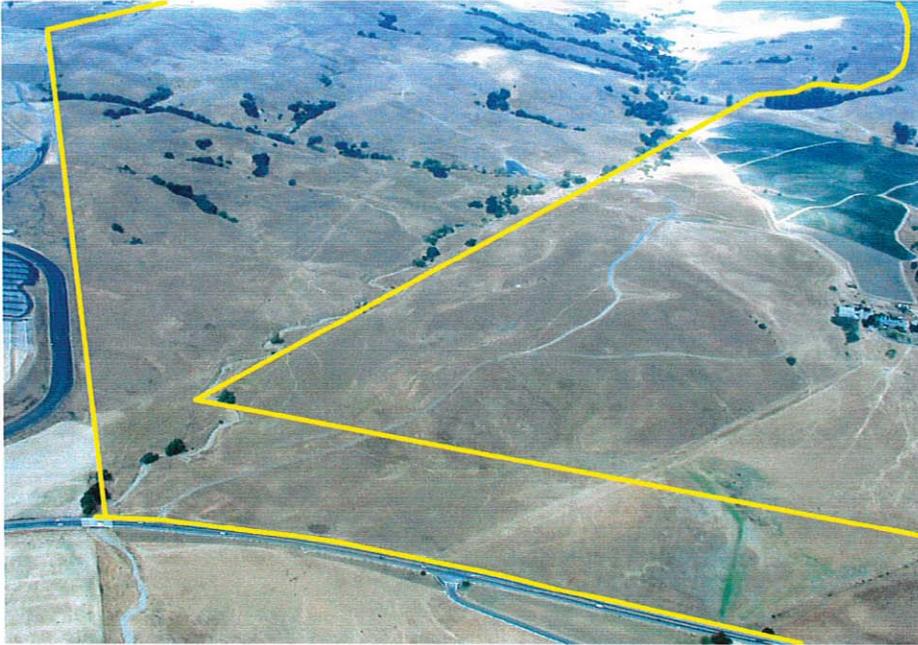
Location #51  
Photograph #59

Aerial photo of eastern portion of Property looking west, including a portion of Hwy 121 and Infineon Raceway.
