WATSON SCHOOL

Core Historic Structures Report

Prepared for
County of Sonoma
Department of Parks and Recreation

Core Historic Structure Report
Final Report
12 DECEMBER 2008

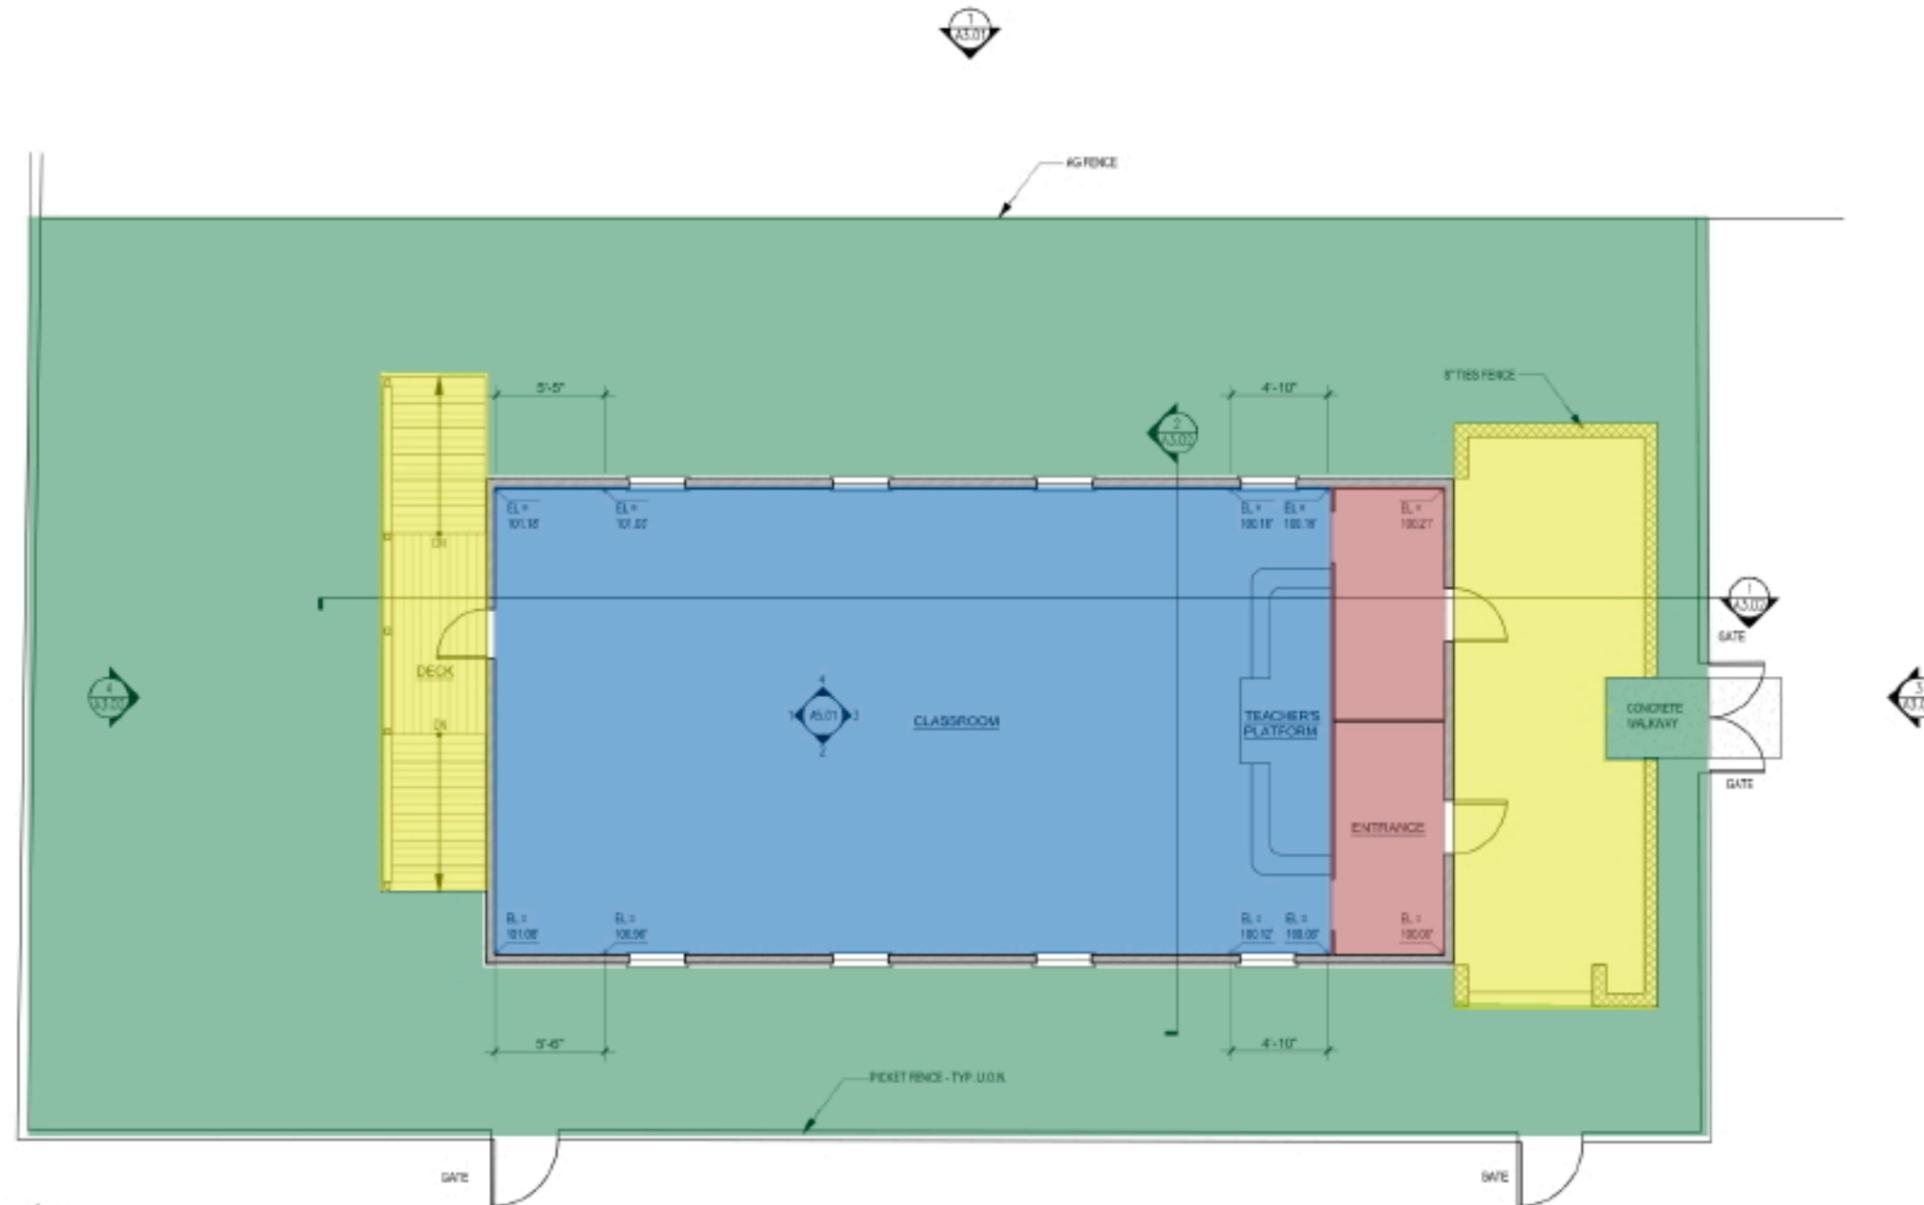
1 CLASSROOM FLOOR PLAN
 SCALE: 1/4"=1'-0"

Therefore, when prioritizing spaces, it is important to consider a relative balance of priorities to effectively and responsibly guide the programming of new uses and associated architectural modifications, within the building. The categories are similar to those used for individual features used above, but the interpretation is slightly different when applied to overall spaces. For Watson School, the prioritization of spaces is shown on the following diagram.

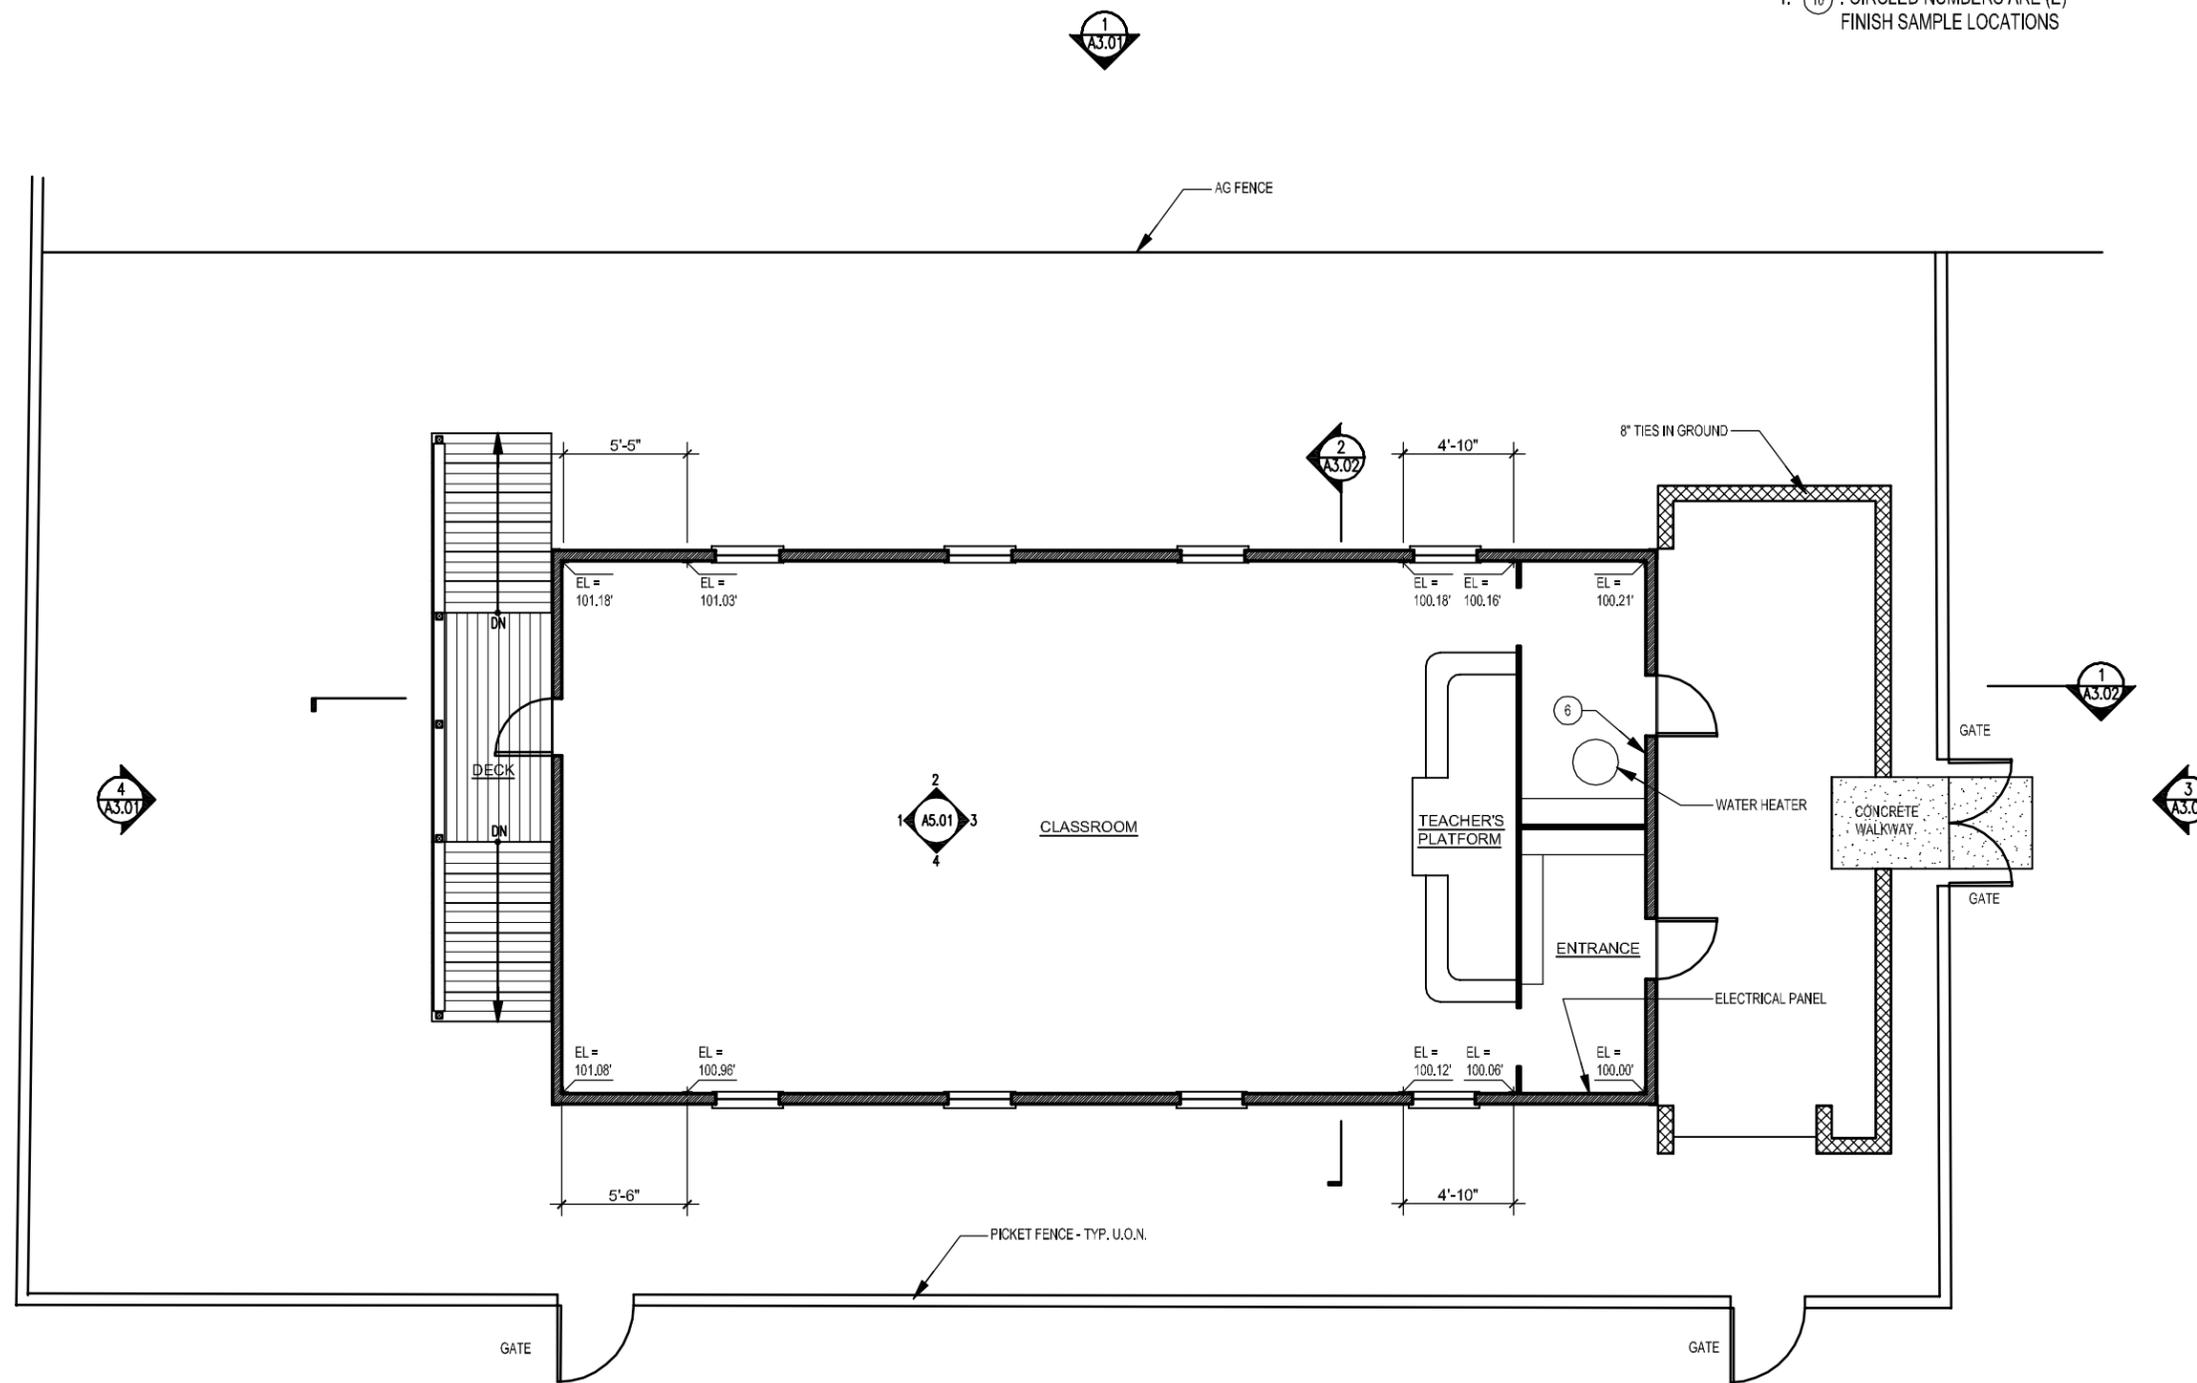
1 CLASSROOM FLOOR PLAN
 1/8" = 1'-0"

1. CHINKING BETWEEN SOME BOARD ENDS
2. STAPLES FOR FOUNDATION SCREEN ARE RUSTING
3. TRIM/ WINDOW PAINT FADED, WOOD WEATHERED BUT STILL SERVICEABLE, AND SOME PATCH FAILURE
4. (10) : CIRCLED NUMBERS ARE (E) FINISH SAMPLE LOCATIONS

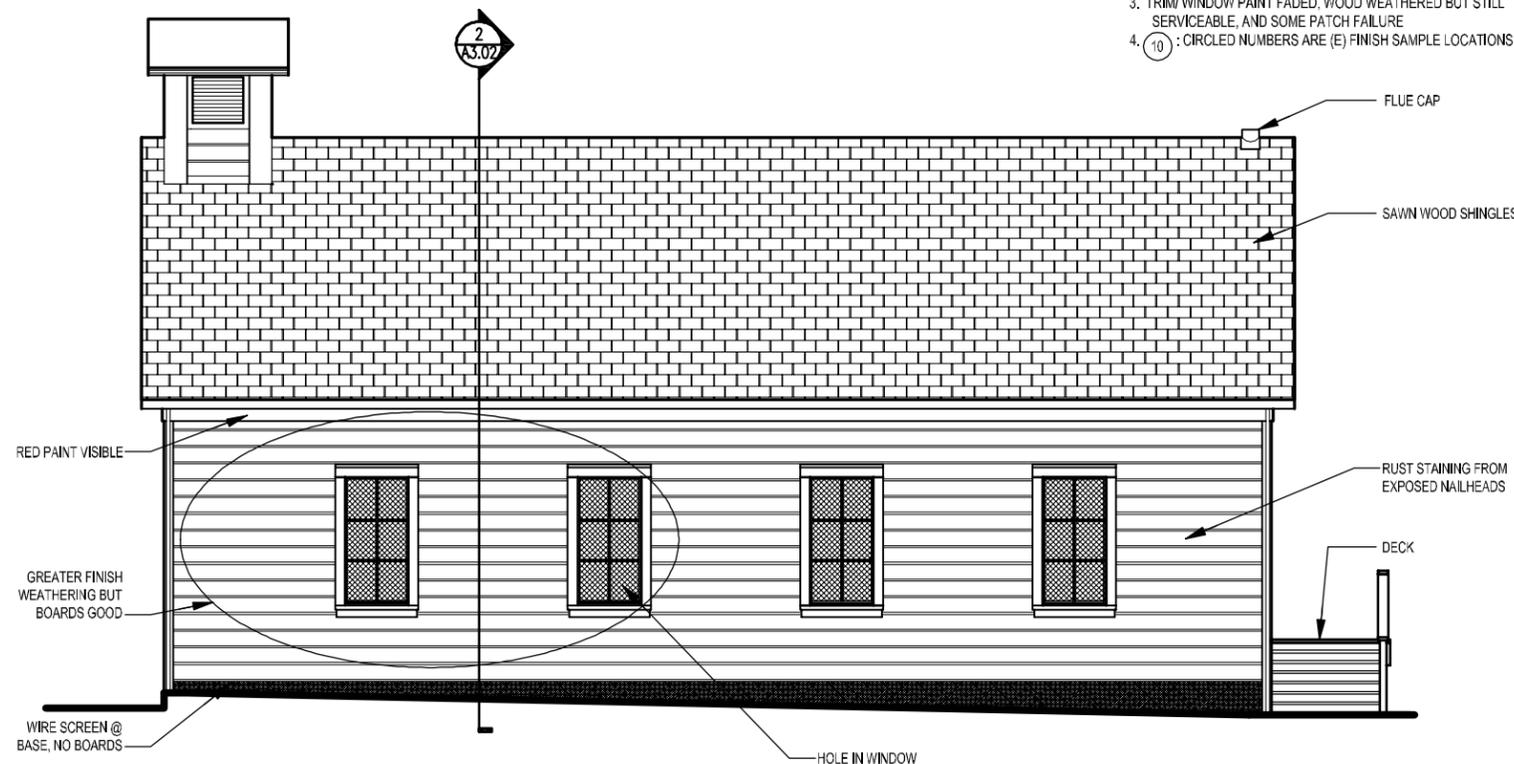
1 WEST ELEVATION

In this environment, the western side of the building receives the harshest weather. It is consistently buffeting by strong winds and unrelenting sun exposure. As a consequence, the siding on the west of the building is more weathered than that on the other three facades. The surface finish is slightly more uneven but continual paint coverage has limited the material degradation from weather-related causes. At the ends of the siding lengths, however, there is evidence of material shrinkage. This has opened up gaps in the siding. Many of these gaps have been repeatedly filled with plaster or flexible caulking. This material should be entirely removed so the extent of the damage can be more fully assessed. Partial replacement of siding on this elevation may be necessary.

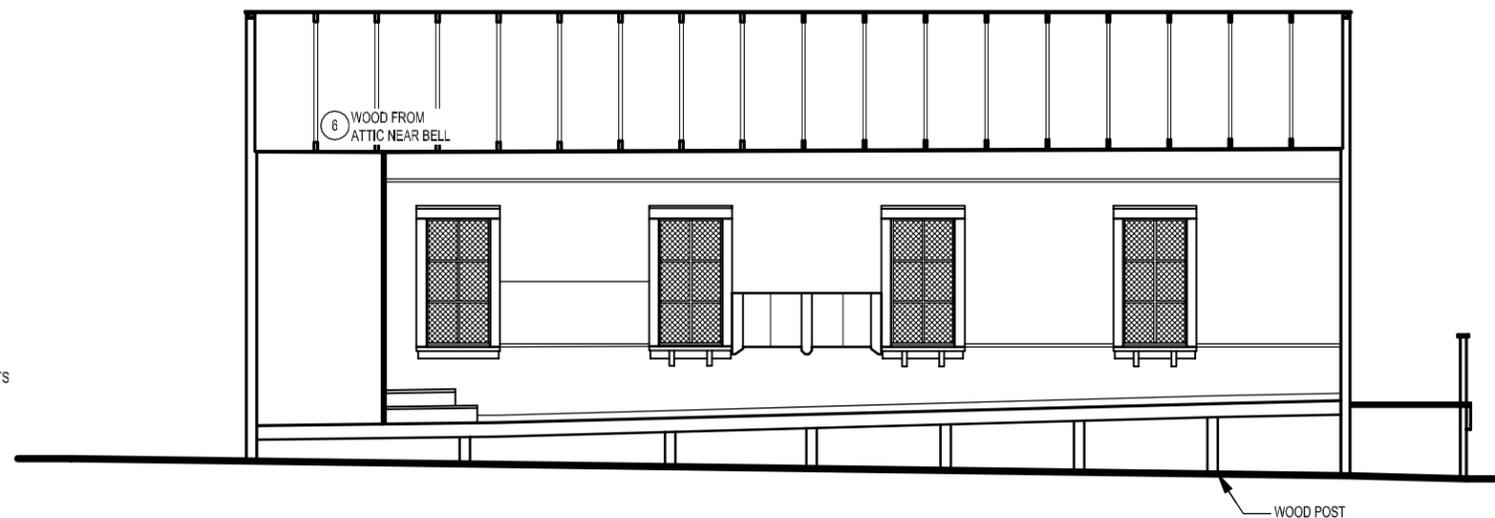
1 BUILDING SECTION
 1/8" = 1'-0"

The framing is in good condition. There are some signs of past water intrusion but the current roof appears in good repair. In addition there are a few rafters where previous damage has been repaired. There is no sign of distress due to vertical load, the framing appears to be performing adequately.

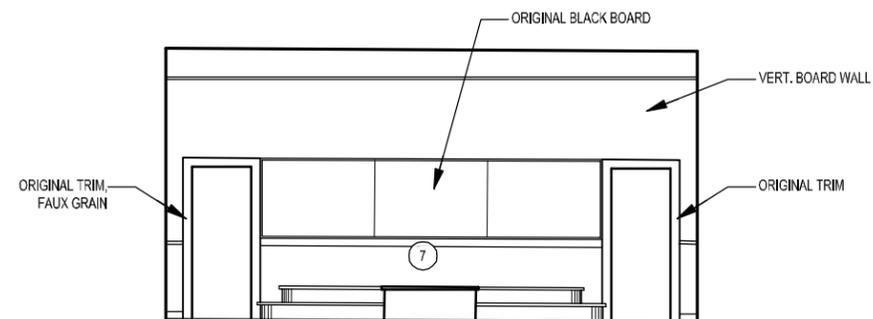
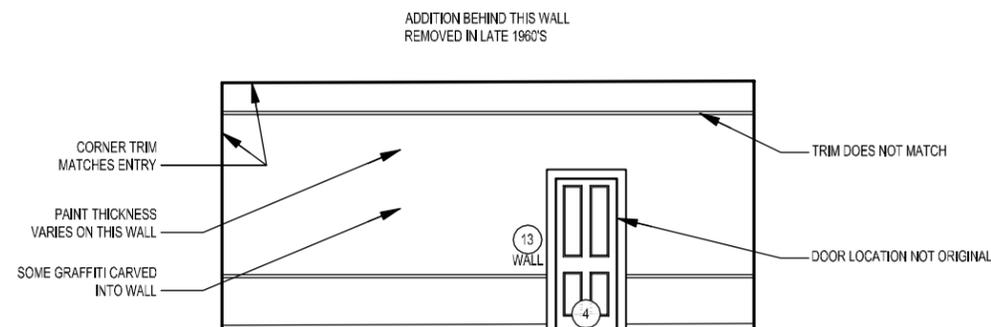
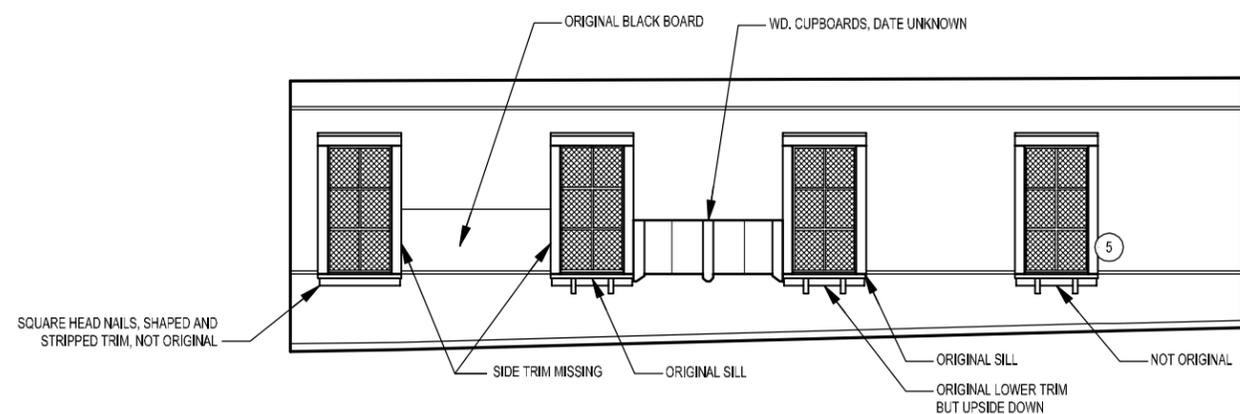
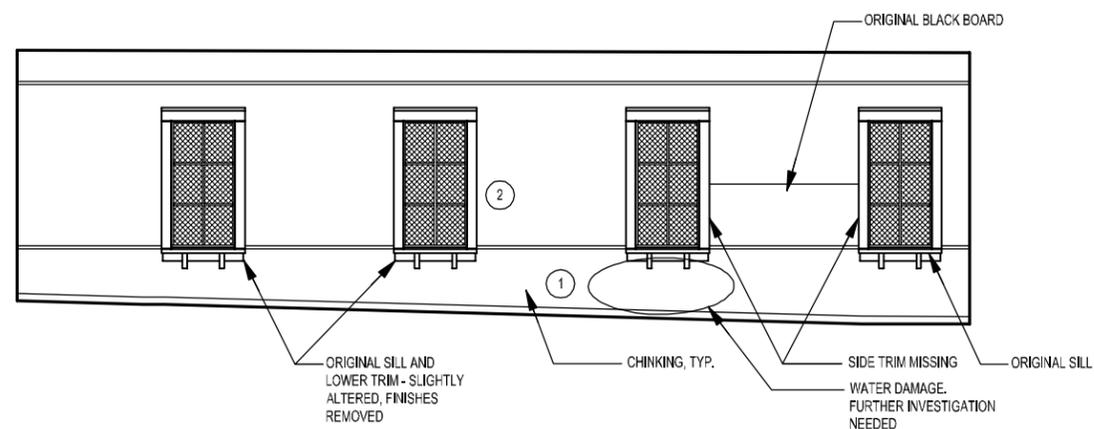
- GENERAL NOTES**
1. WALLS ARE CHINKED
 2. SOME WEATHERING (UV) ON SILLS
 3. WALLS ARE T&G BLIND NAILED
 4. SOME GRAFFITI CARVED INTO WALLS
 5. (10) : CIRCLED NUMBERS ARE (E) FINISH SAMPLE LOCATIONS

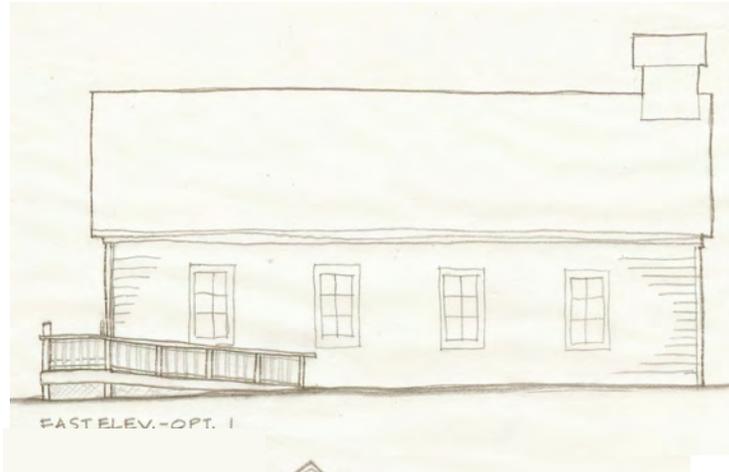
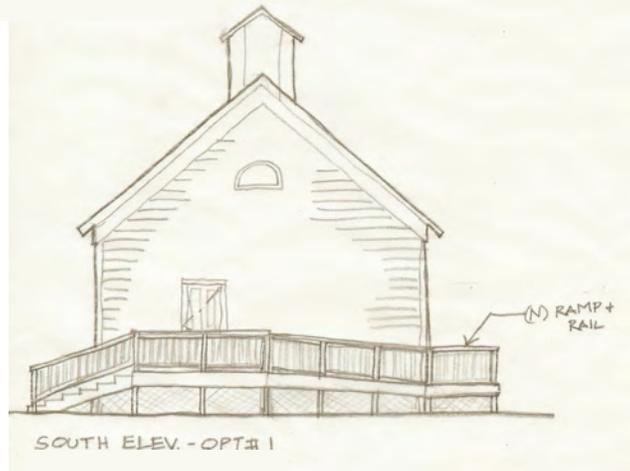
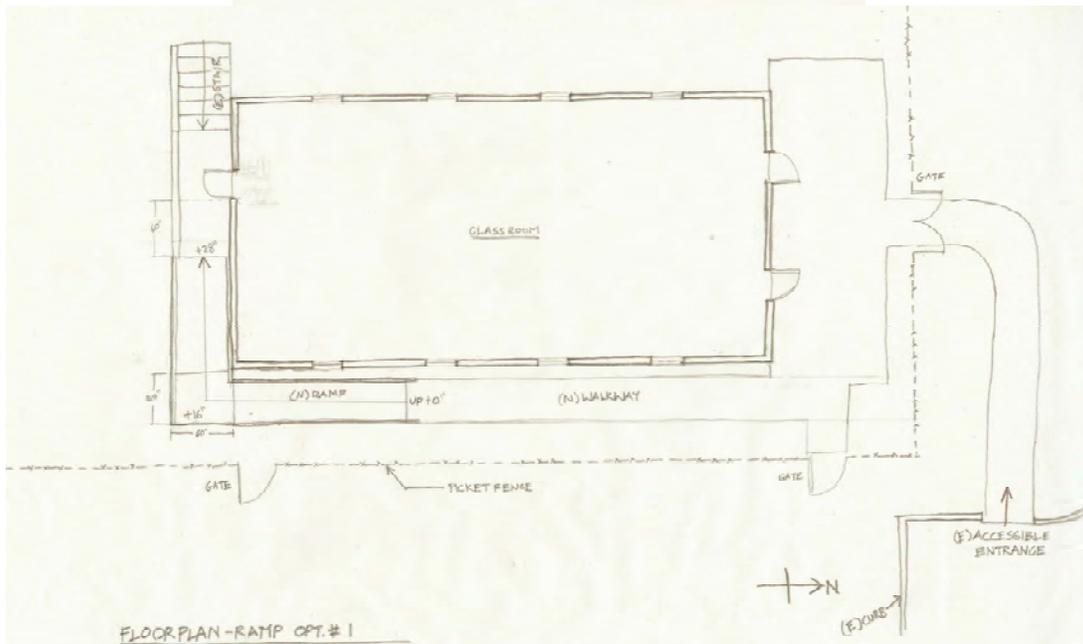
This sketch illustrates first preferred option for the accessible ramp location and configuration.

A new accessible entry will have to be constructed. This will require the construction of an accessibility ramp as well as a properly sized entryway. It is recommended that the ramp be located along the east side of the building, ramping from grade near the northeast corner up to the rear wood deck. (See following sketches for current preferred ramp locations.) The current south entry is non-historic and is the most appropriate entry point to modify for universal access. This will provide access to all interior spaces. No further access-related modification to the interior is required by current code standards.

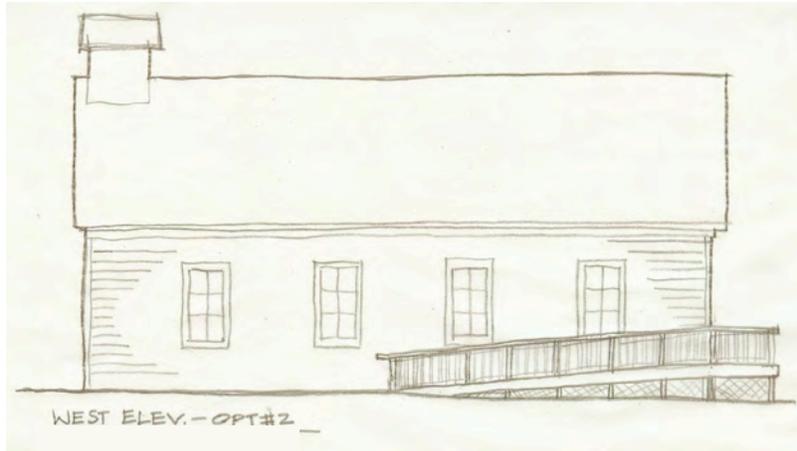
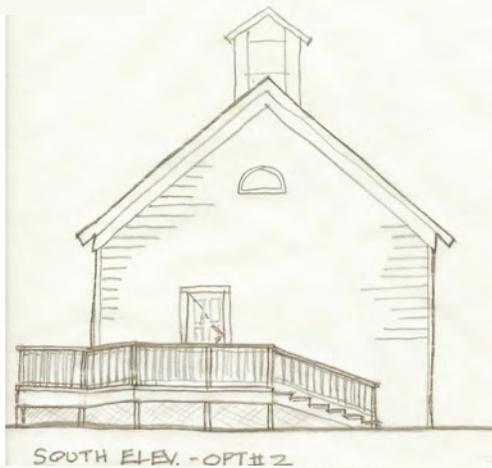
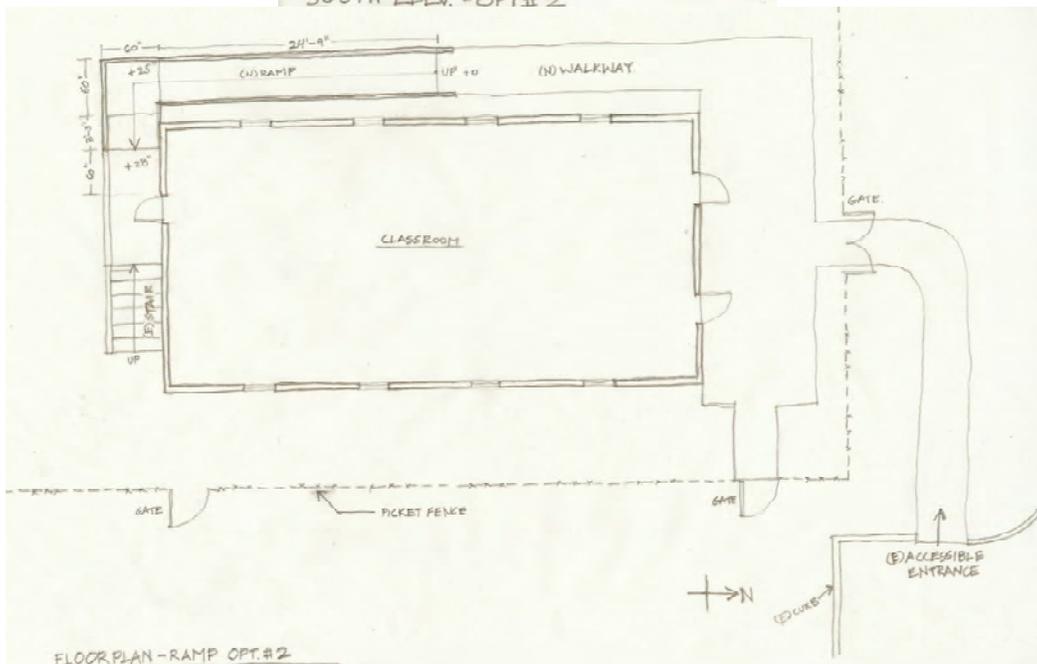
This sketch illustrates second preferred option for the accessible ramp location and configuration.

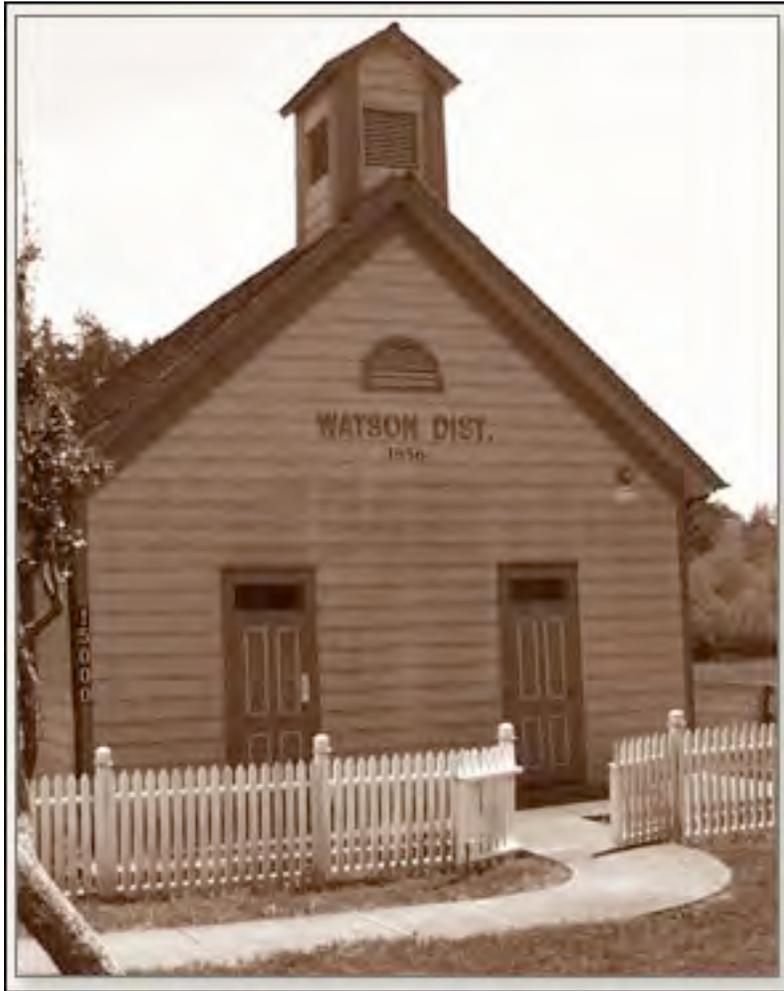
This historic photograph was reprinted in the sesquicentennial celebration newsletter distributed by Sonoma County Regional Parks Department in 2006. The original date is unknown but the concrete walk and porch landing are clearly visible.

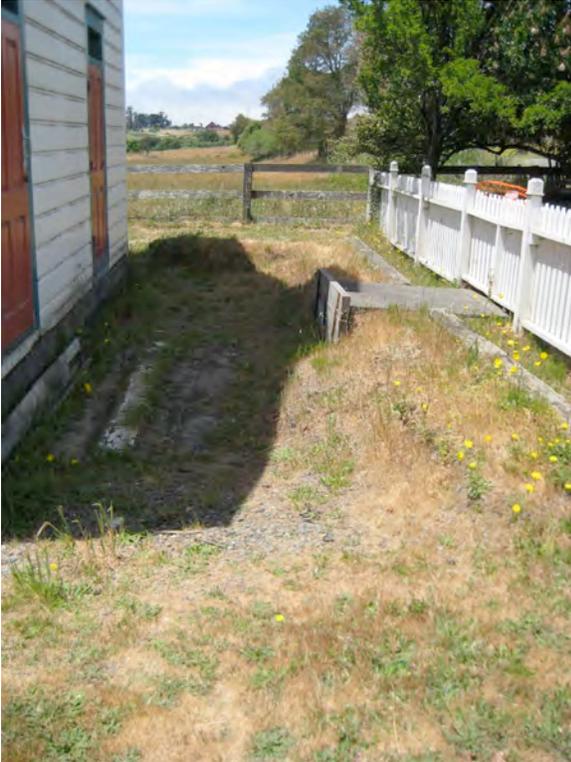
Front porch where concrete slab has been removed, June 2008. A new concrete or wood platform is recommended.

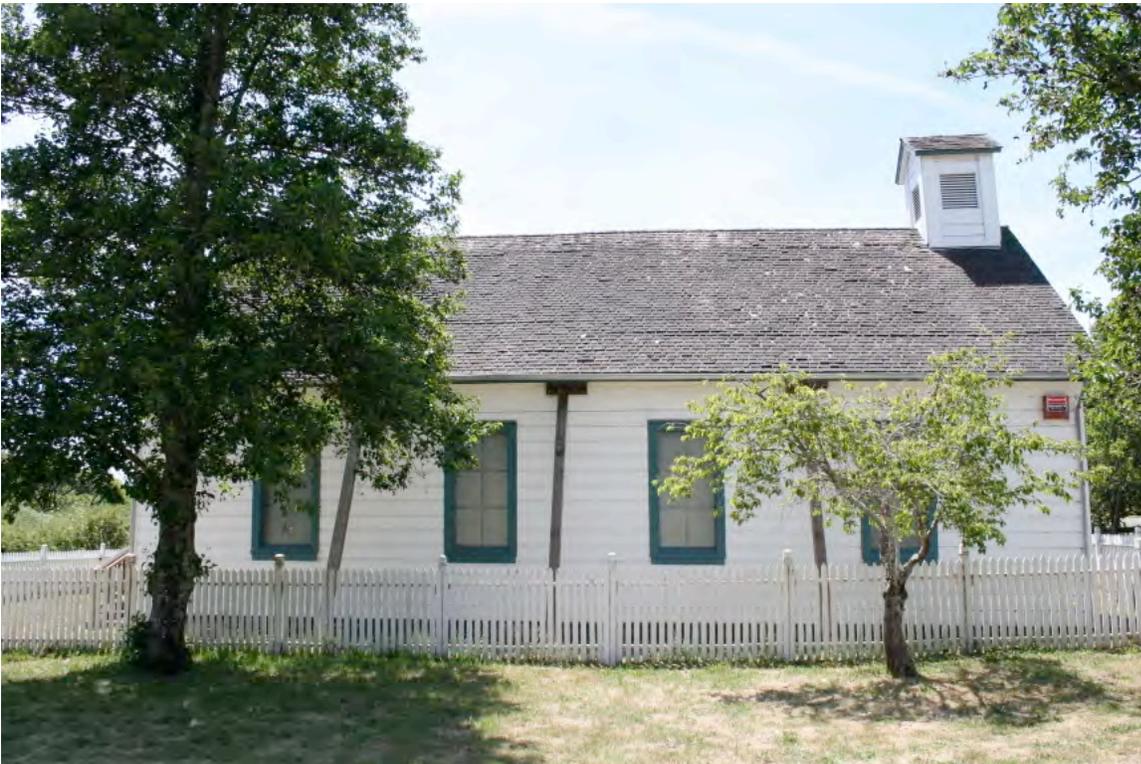
East elevation with braces, June 2008.

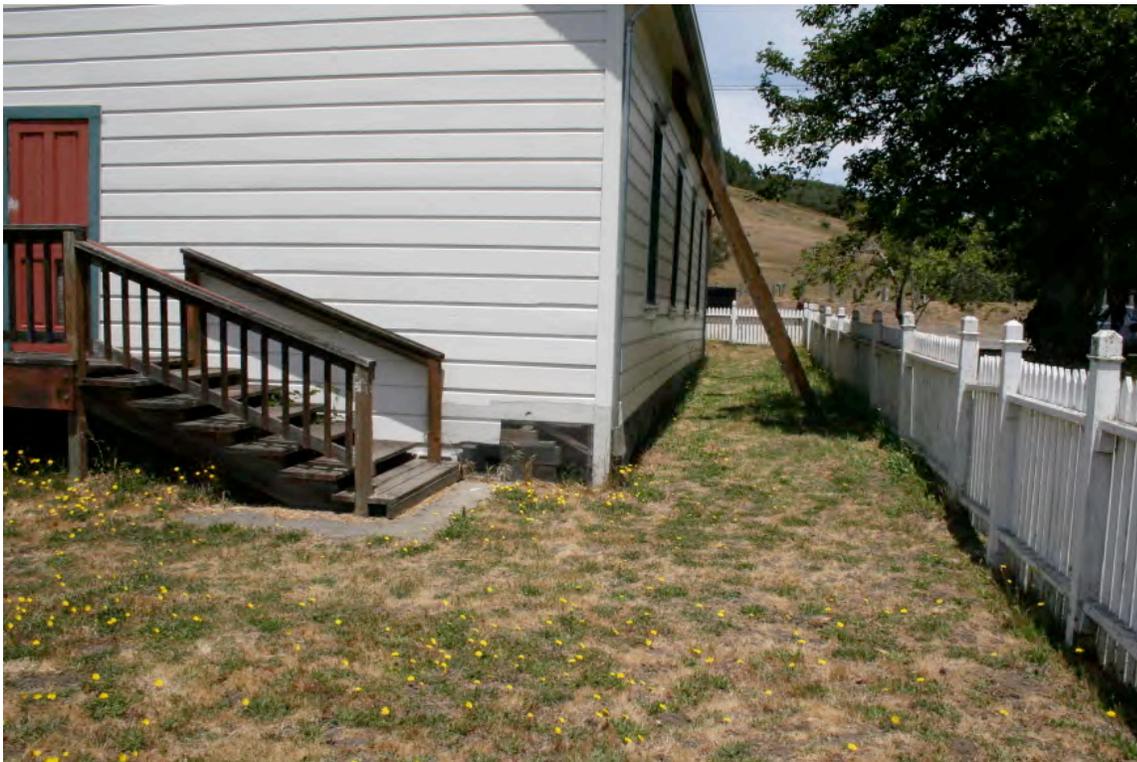
The floor is framed with 2"x5-3/4" joists at an average of roughly 24" o.c. supported on 6"x7-3/4" girders at approximately 6'-0" o.c. The girders are supported on 6"x6" posts and mud sills set directly onto soil without concrete foundations. Overall, the building is twisting in a clockwise direction to the northeast. This is most likely due to a lack of concrete foundations and inadequate shear strength in the walls. There is inadequate earth-to-wood separation at all post/footing junctions. This wood-on-grade foundation has been replaced several times. The most recent work was completed c.1990. Each time it was repaired in kind utilizing traditional methods. While this is an accepted and typically desirable preservation methodology, it has not addressed the inherent inability of the wood foundation to evenly support the building. Presently, the foundation requires complete replacement to accommodate seismic strengthening work, as well as to bring the building into a more vertical position.

Detail of the southeast corner, June 2008. Note how the siding curves down near the northeast corner. The building is twisting and has dropped in the northeast corner. The framing should straighten out when the building is made true.

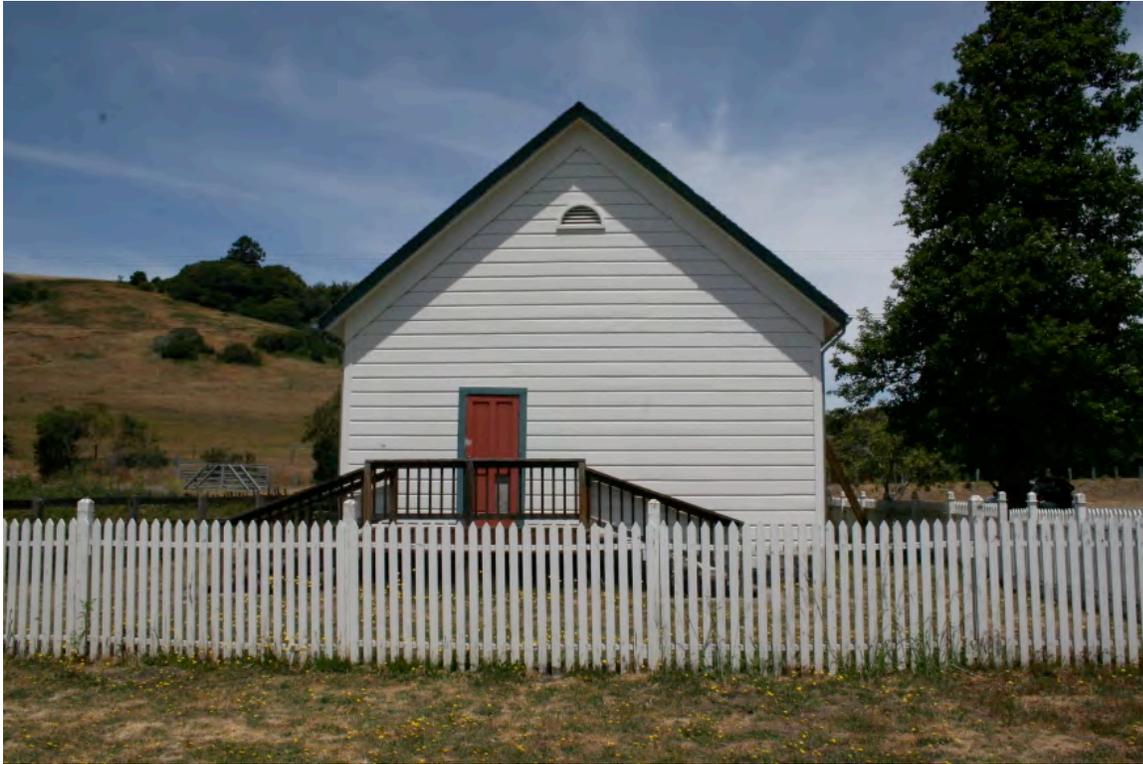
Rear (south) elevation, June 2008. This is the most historically appropriate location for the new accessible entry and ramp.

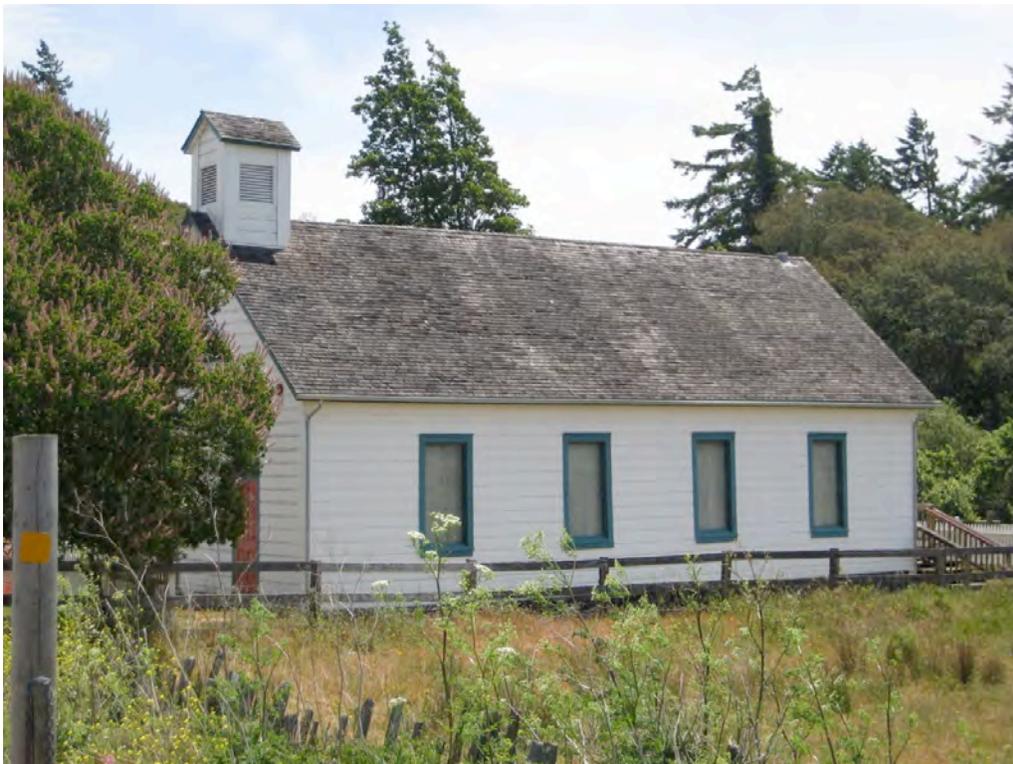
West elevation, June 2008.

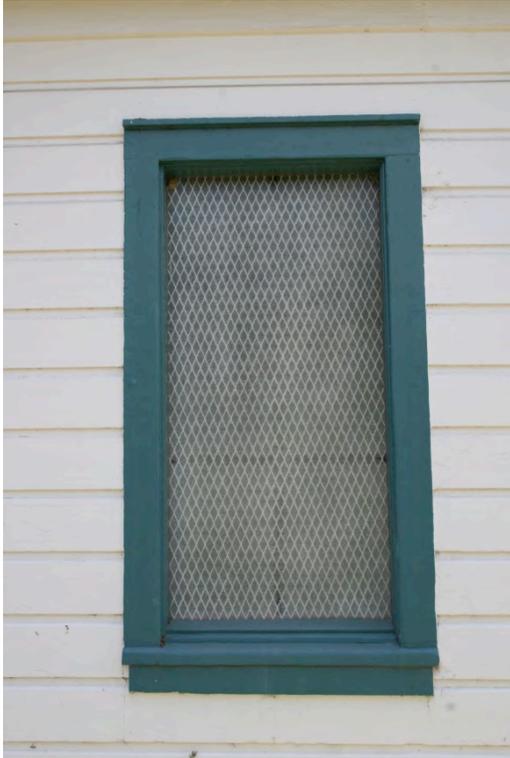
The original six-over-six double-hung wood windows were removed around 1990 and replaced with the current diamond wire plastic panels. These panels sit in the original window frames and are fixed in place. Most have gaps between the window frame and the wall sheathing. The trim has been largely replaced with unfinished flat sawn wood boards. The exception to this is the lower trim below the sill. Some of these trim elements appear to date to the period of significance, although they have been modified. These boards are hand beveled along their sides and lower edges. For seven of the eight windows, two vertical narrow wood pieces have been added. They don't appear to provide any support function and their crude nature does not suggest a design choice. Their purpose is unknown at this time.

Overall the windows appear to be adequately weathertight and in fair condition. The sashes have been replaced and some modifications to the frames and trim have occurred, but they retain enough clues to inform recreation of their original appearance if necessary.

Detail of a window, June 2008. The original six-over-six wood double-hung windows were replaced with shatter-resistant reinforced polycarbonate sheeting. The original framing appears to remain in at least some locations.

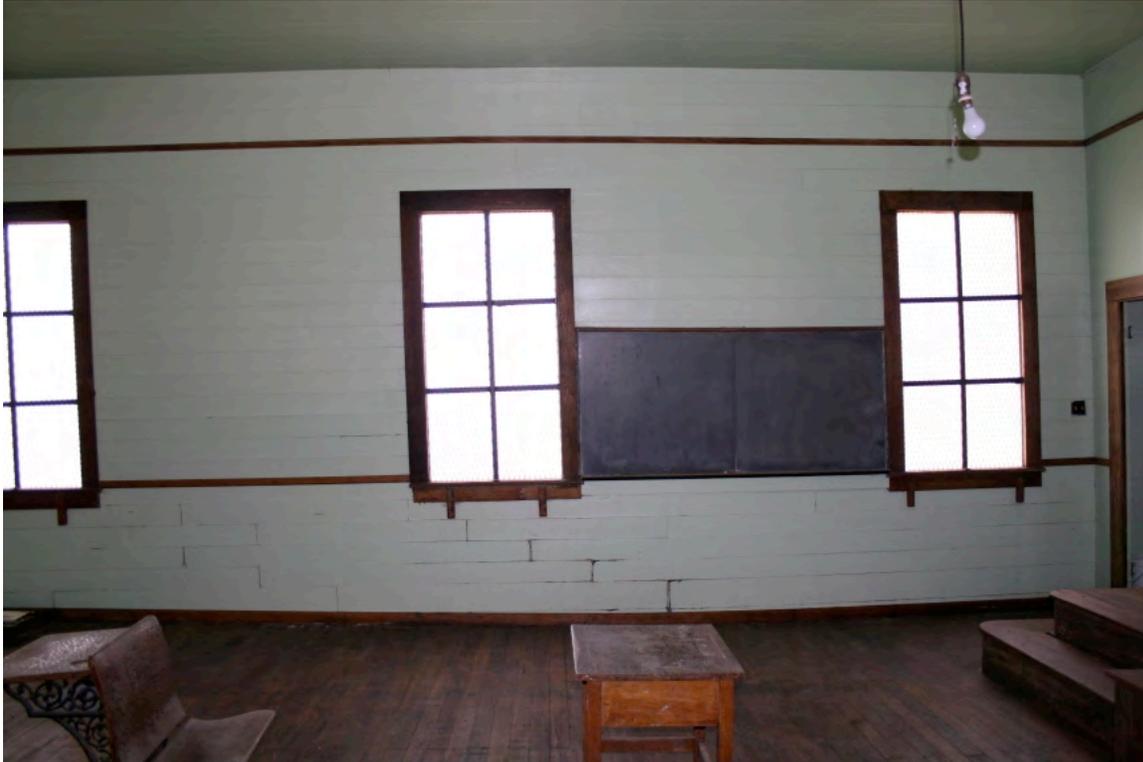
West classroom wall showing gaps where moisture has penetrated through the exterior siding, June 2008. These gaps have been historically filled with a plaster-like substance. Repairing the exterior siding should eliminate the moisture condition.

Limited replacement of interior wood finishes will be required to address those areas on the west wall that have sustained moisture damage. Beyond this minor material replacement, there does not appear to be extensive work involved to return Watson School to a weather-tight building, ready for future restoration phases.

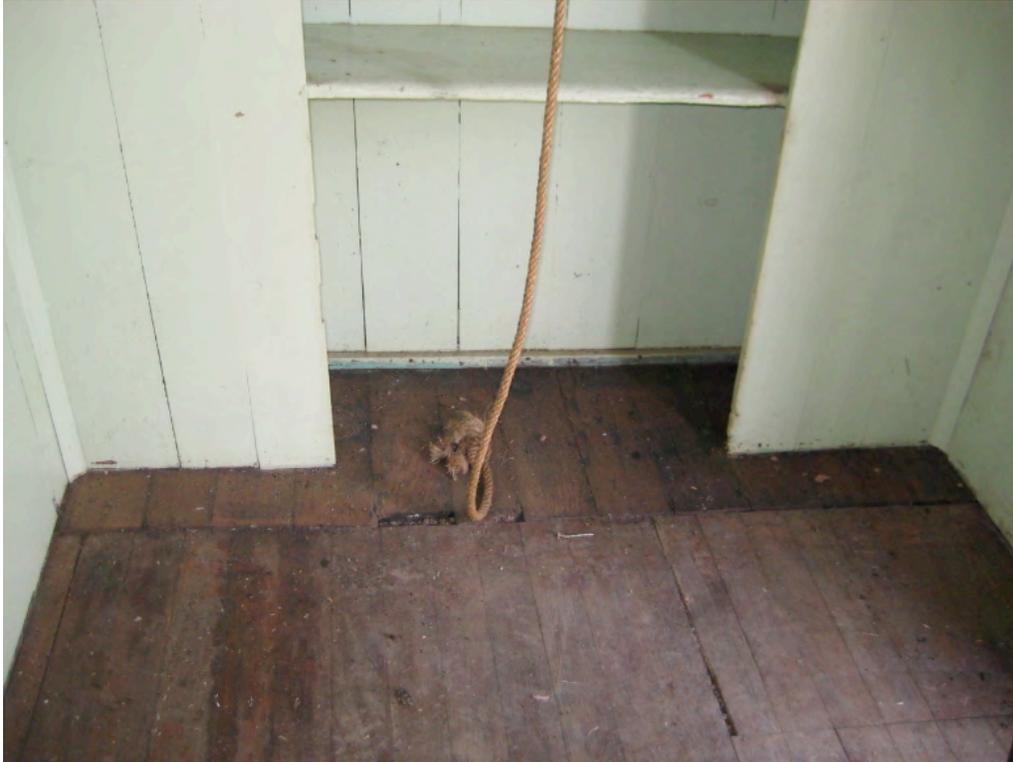
Floor of the front entry showing the original (pre-1900) floor and the current (post-1900) floor. The dates of installation for the “new” floor are unknown. Dating is approximate and is based on general nail manufacturing technology history.

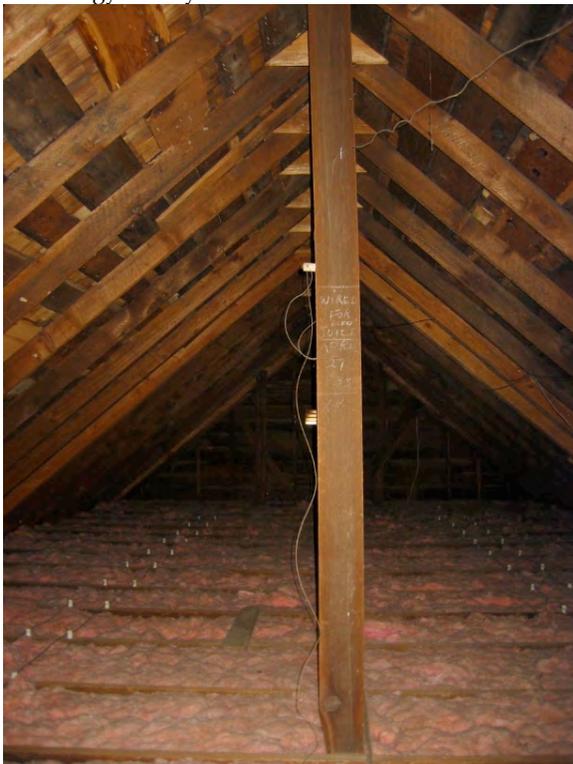
Photo of attic framing, June 2008. The c.1920s knob and tube wiring is still visible.
