TOLAY LAKE REGIONAL PARK

MASTER PLAN

DRAFT EIR APPENDICES

JANUARY 2017

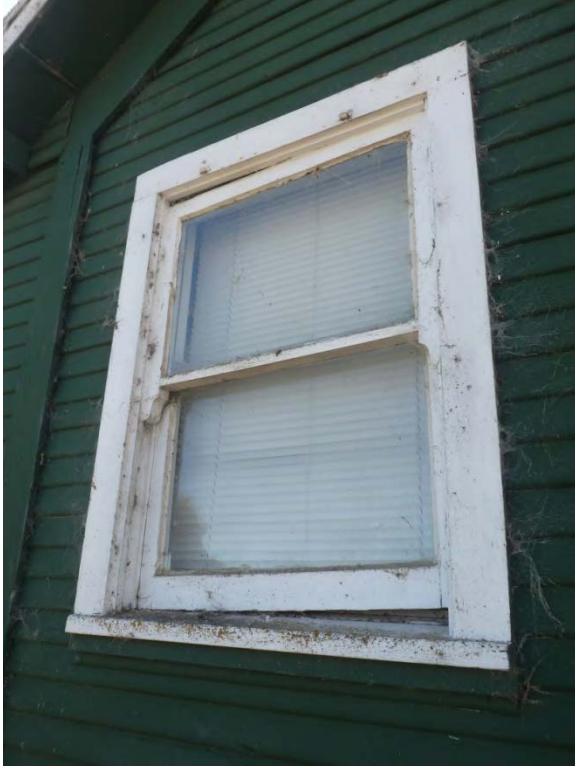
The front door, likely a replacement, is in good condition. Both the wood and aluminum windows are in poor condition. Settlement has caused wracking of some window frames.

**Image 7 - Window at east wall showing frame
warped due to settlement**

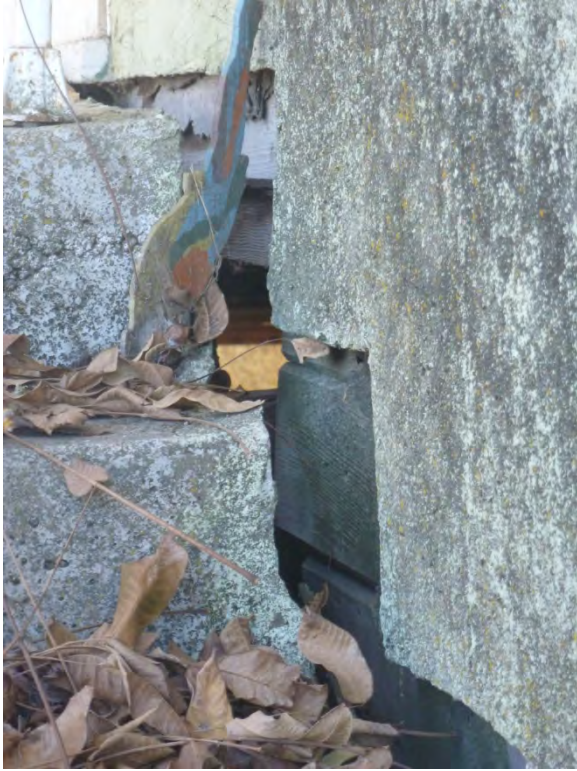
Image 19 - Front porch separated from wall of house

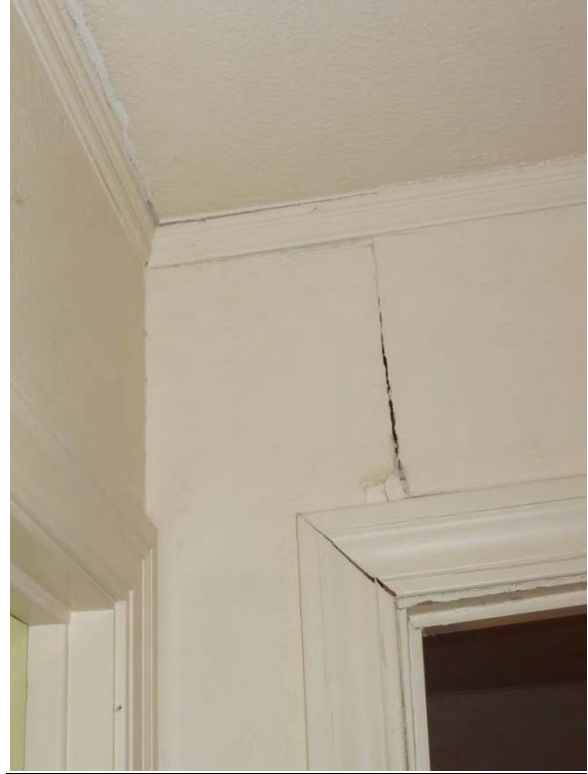
Image 23 - Settlement damage

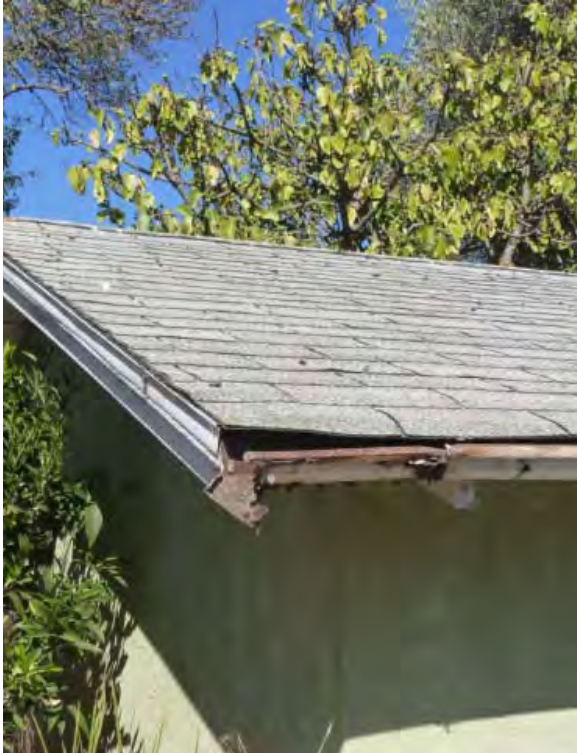
The asphalt shingle roofing is in poor condition; the gutters are badly corroded and partially missing. In addition to the structural crack in the north wall, the stucco finish has numerous cracks, mainly at the lower part of the walls. The door, overhead garage door, and windows are in fair condition. The higher grade outside the south door allows water to enter the building. Wood trim is in fair condition.

Image 25 - Garage roof and corroded gutter

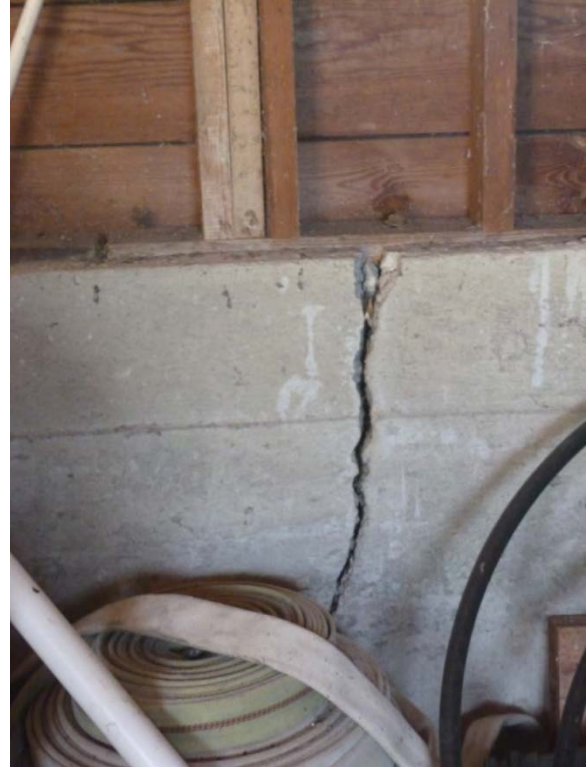
Image 26 - Structural crack in north wall

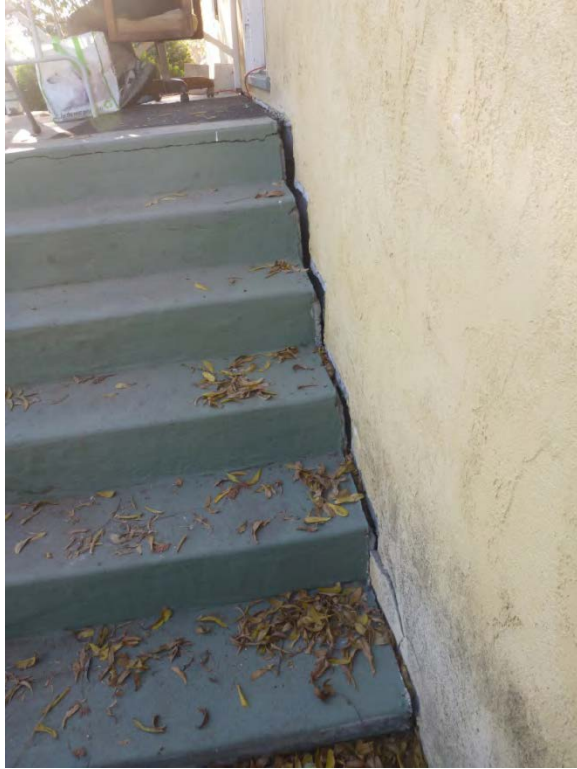
Image 37 - Front porch stair separated from house wall

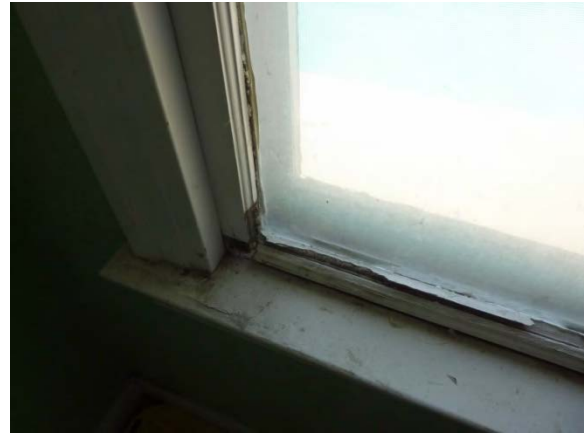
Image 42 - Deteriorated window at west wall

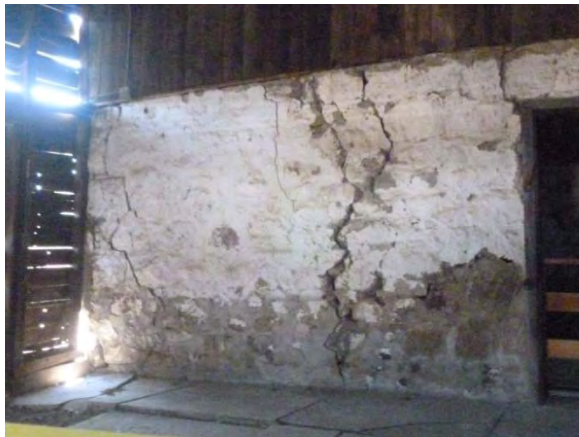
The stone masonry and the concrete walls appear to have been constructed without reinforcement. This type of construction is considered hazardous in seismically-active areas.

Image 69 - Severe cracking of masonry wall

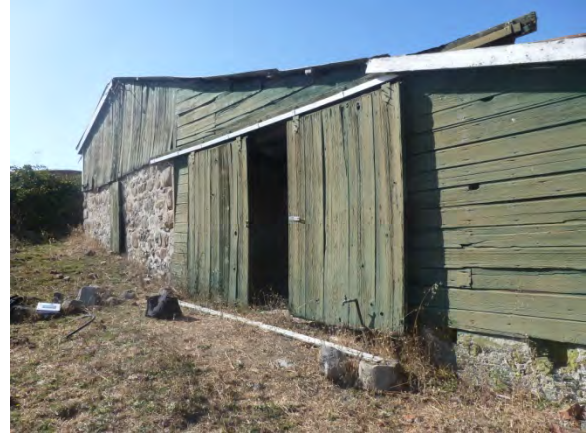
Image 74 - South wall showing poor overall condition of siding and doors

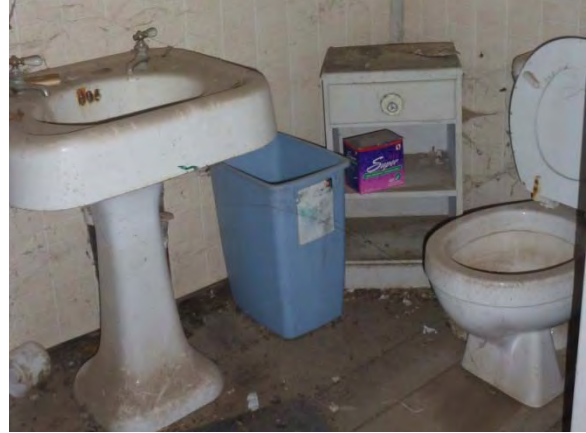
Image 95 - Deteriorated plumbing fixtures.

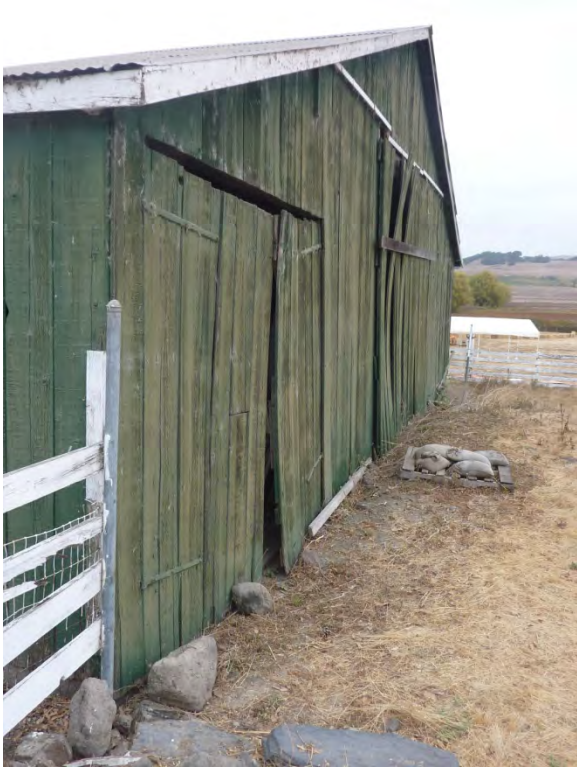
Image 118 - Deteriorated doors at south end of building

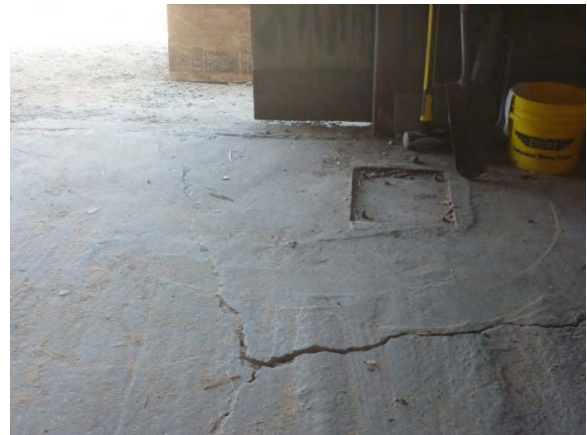
Image 130 - Cracked concrete slab

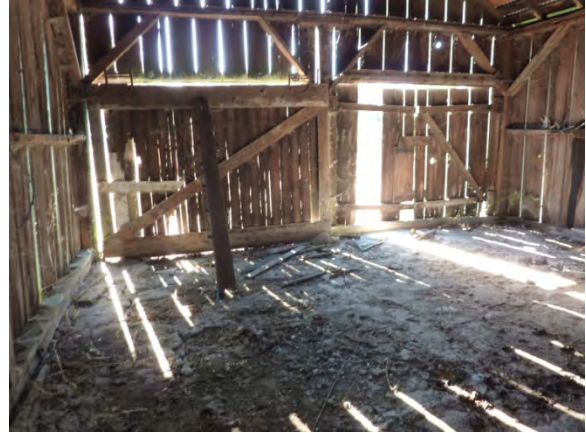
Image 139 - General deteriorated condition of slab and siding.

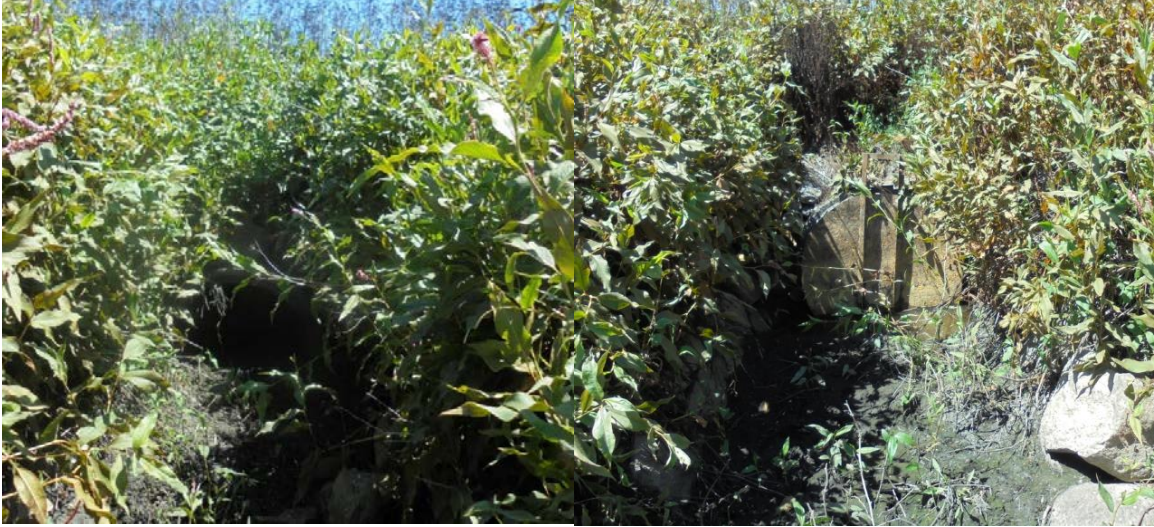
2. Downstream from the causeway is a small horseshoe-shaped berm (horseshoe). This feature conveys drainage from the western and eastern contributing watersheds to a point downstream from the horseshoe. Tolay Creek would have been conveyed through the horseshoe via a 42-inch diameter culvert (Figures 2 and 4), but again that culvert is blocked and has insufficient conveyance for significant flows, such as those generated by large precipitation events.

Figure 4. Closed gated culvert in horseshoe berm, inlet shown on left, outlet shown on right.
