Initial Study North Coast Trails Plan

September 2021

Prepared for: Sonoma County Regional Parks Department

Prepared by: Leonard Charles and Associates

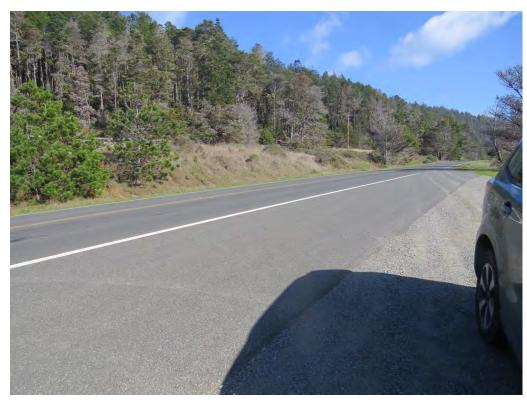
Photo 2
View Looking South from the Kashia Parking Lot Area

Further north the Kashia parking area with associated amenities would be visible. The parking lot would parallel the highway with a one-way entry at the north end and one-way exit at the south end. Cars would be parked in three parking bays plus an ADA parking space next to the restroom. The restroom would be located immediately south of the parking area. This area would include the restroom, an ADA parking space, three picnic tables, two benches and trail signing. Preliminary design plans indicate that trees and shrubs would be planted around these facilities. Large rocks would be placed between the parking area and the highway to confine vehicles to the lot and the designed entrance and exit. The final design for this parking area including, where warranted, new plantings to provide screening has not been completed at this stage. It is assumed, as recommended by the LCP, that these improvements will be screened as far as feasible from highway vantage points. Even if not fully screened, views would be of up to nine cars parked in an area near the highway edge. A view of a few cars parked along or near the highway edge is common along Highway 1 as it passes through State and County parks to the south. Drivers travelling north would have views of these improvements for about 500 feet (about 6 seconds at 55 mph.

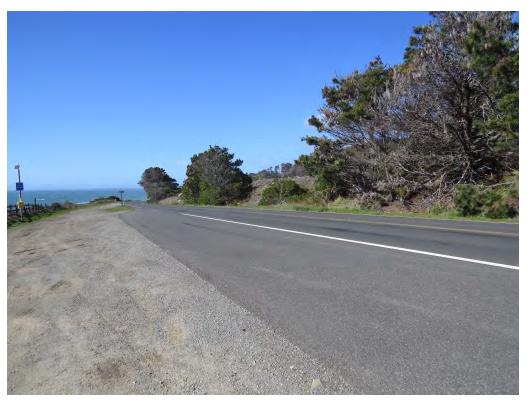
Photo 3
View Looking North from the Kashia Parking Lot Area

One vantage point where the trail could be noticeable is just north of the historic barn where the trail would travel into the highway right-of-way in order to avoid the deteriorating historic bridge and unstable bluff edge on the Project site. Here, a driver traveling on the highway might see an occasional trail user on the trail. The historic bridge would remain visible to the west. North of this vantage point the trail; would be located to the west. As it approached the northern terminus, it would be at a lower elevation than the highway and not visible from most vantage points on the highway. The northern terminus of the trail will intersect the highway just south of a large rock outcropping. The trail would switchback up from the lower terrace and be visible only at the intersection with the highway. Again, this intersection design would be coordinated with Caltrans and likely would be signed to prohibit parking near the trail intersection.

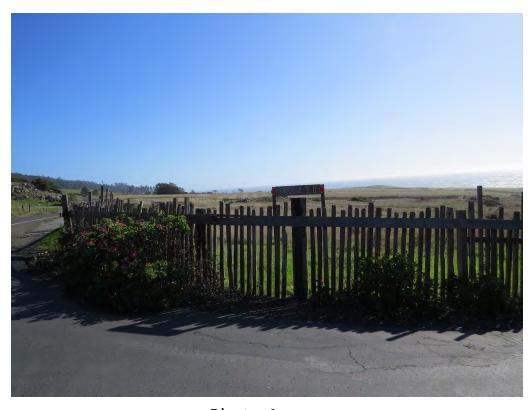
Photo 4
View from Access to Private Driveway
Location of Stewart Point Staging area

For the Stewarts Point Ranch trail, starting at the Stewarts Point Store at the intersection of Highway 1 and Skaggs Springs Road, the southern trail terminus is adjacent to a small cottage. The trail intersection with the highway would have, at most, a sign here, but there would be no parking at this entrance. Travelling north the trail would be located nearer the ocean bluff distant from the highway. The parking lot and up to nine cars parked in that lot will first become visible approximately 750 feet south of the lot. As the driver gets nearer, the parking lot amenities, including parked cars, two benches and signage, would become increasingly evident until one passes the lot. The lot will be located immediately south of the private driveway to the private residence that is located north of the Project site (see photo below). It will be located about 20-50 feet from the highway. Access will be off the driveway to the private residence. Existing picket fencing where this driveway intersects the highway will provide some screening of the lot and parked cars, especially from the north.

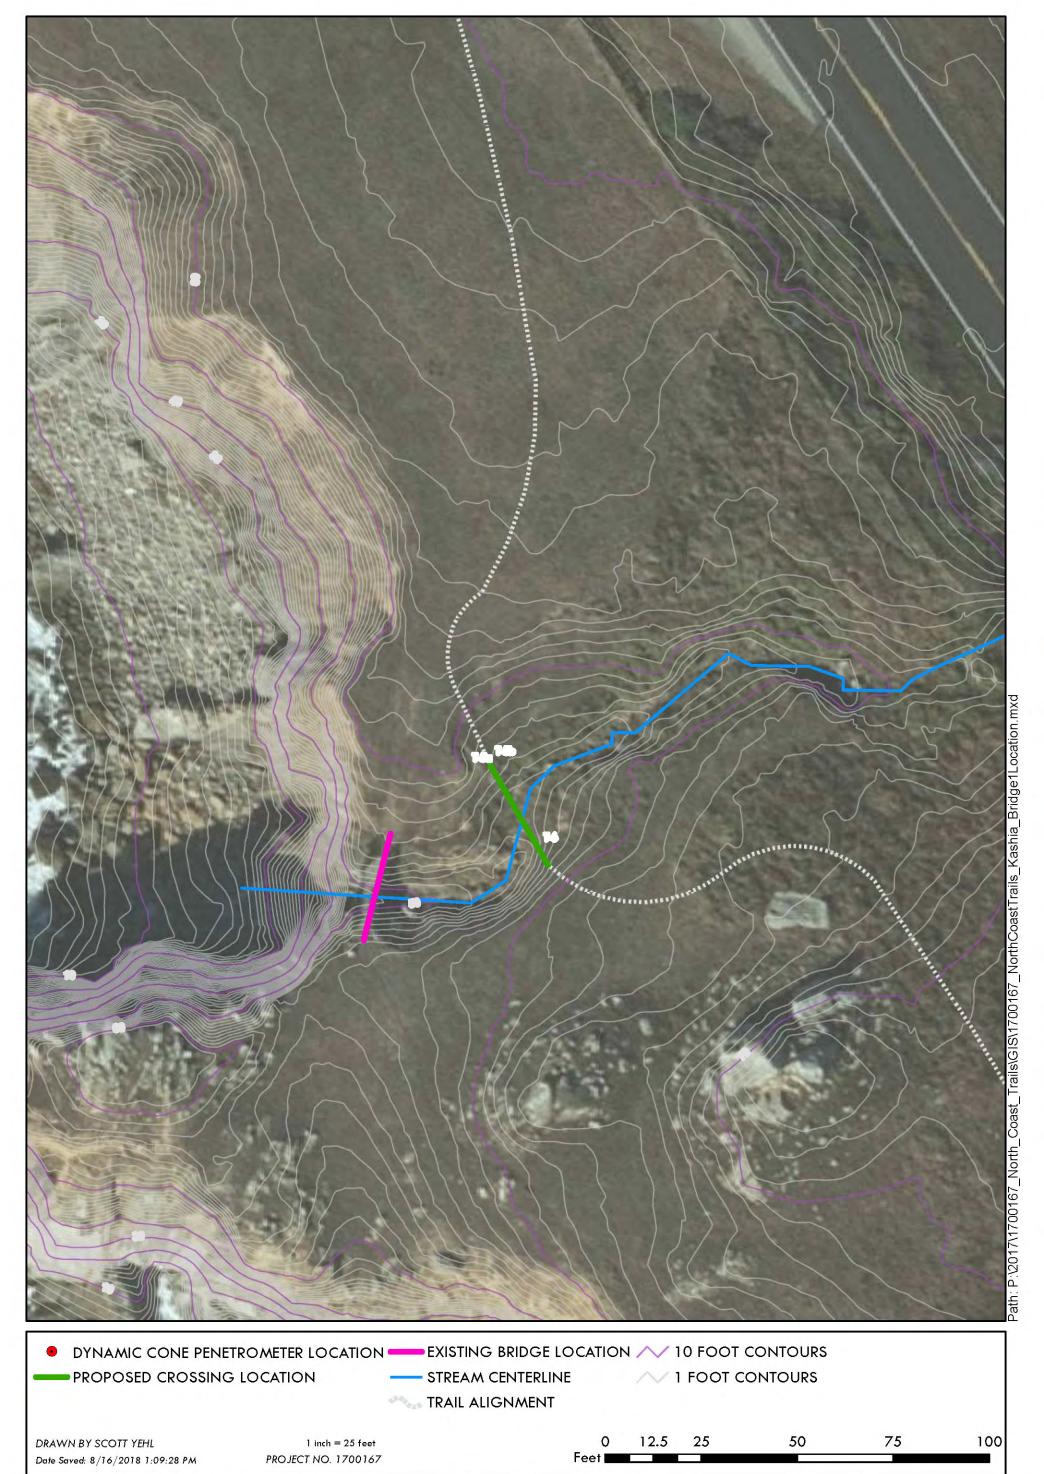
FIGURE 2

BRIDGE 1 GEOTECHNICAL INVESTIGATION

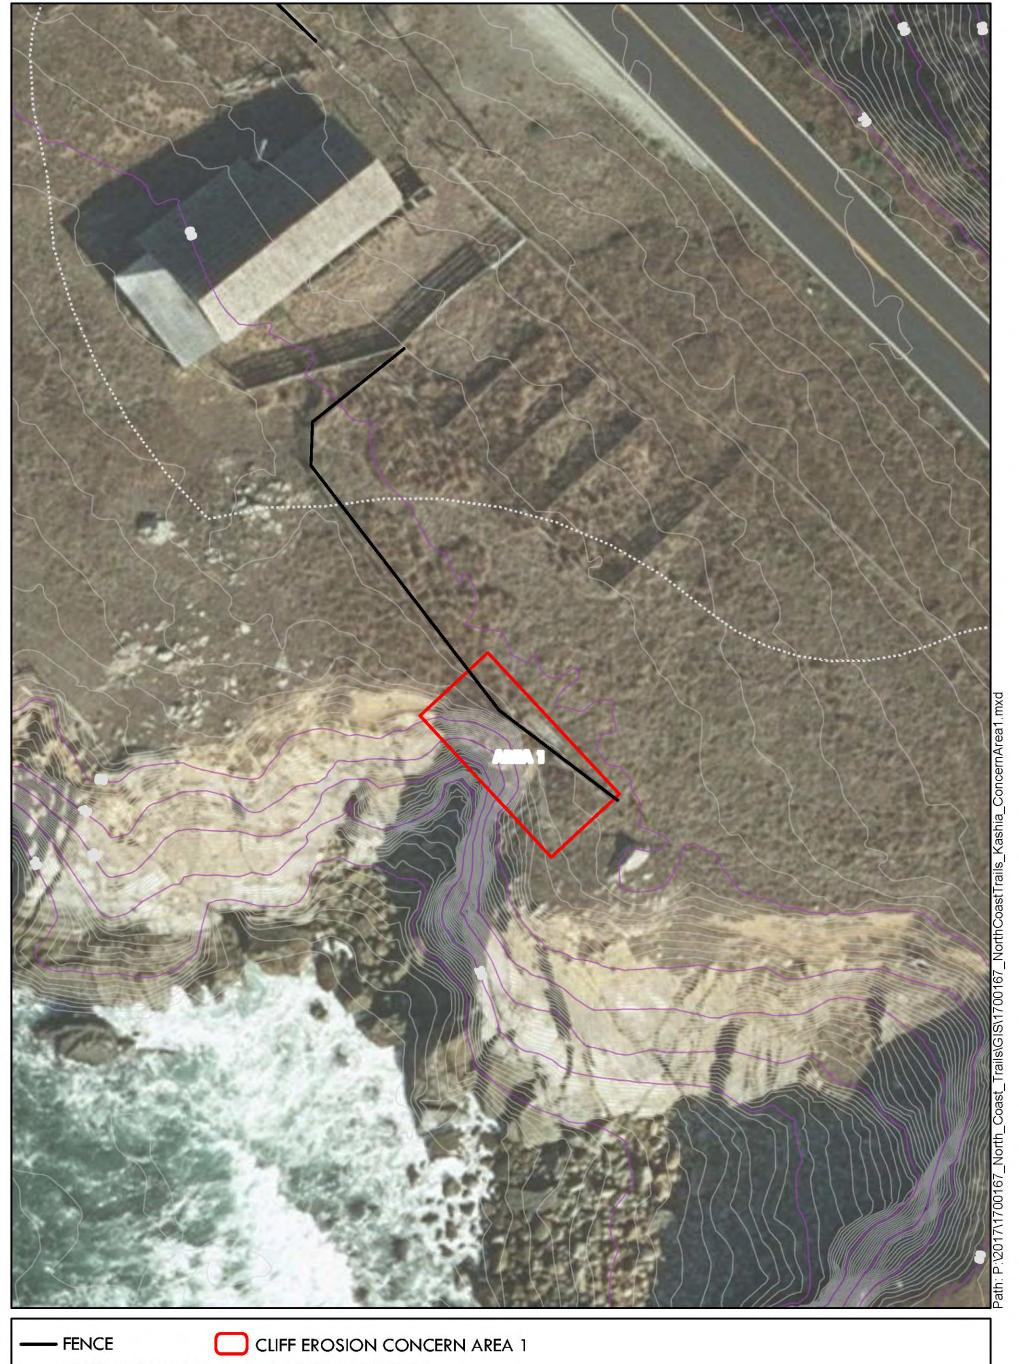
FIGURE 5

KASHIA COASTAL RESERVE CLIFF EROSION CONCERN AREA 1
