TOLAY LAKE REGIONAL PARK MASTER PLAN SUMMARY OF PHASE 1 COMMUNITY QUESTIONNAIRE RESULTS

Introduction.....	1
Purpose of the Historic Structures Report.....	1
Methodology.....	1
Summary of Findings.....	2
Development History.....	3
Historical Overview and Context.....	3
Chronology of Development and Use.....	8
Significance and Integrity.....	10
Physical Descriptions, Conditions, & Treatment Recommendations.....	11
Site.....	11
Building 1: Cottage/Julie’s House/Little Green House.....	13
Building 4: George and Vera’s House/Green House.....	20
Building 5: John Jr. and Beatrice’s House/Yellow House.....	31
Building 6: Hay Barn/Old Stone Floor Barn.....	41
Building 7: Old Dairy Barn.....	48
Building 8: Creamery/ Wine Storage.....	52
Building 9: Granary/Museum.....	59
Building 10: Line Shack.....	67
Building 12: Old Shop/Workshop.....	71
Building 13: Tractor Barn/ Equipment barn.....	78
Building 14: Storage Shed/ Equipment Shed.....	84
Building 15: Slaughterhouse.....	90
Additional Recommendations.....	95

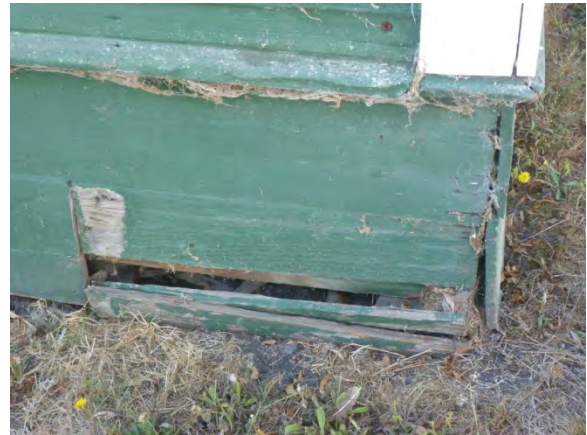
Image 6 - Typical wood to earth contact

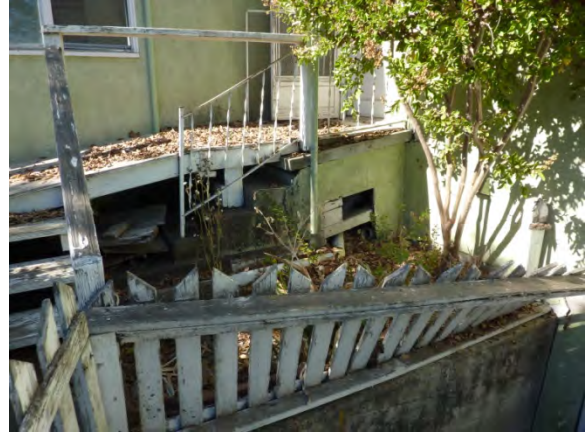
Image 20 - Poorly constructed ramp and stairs at south entrance

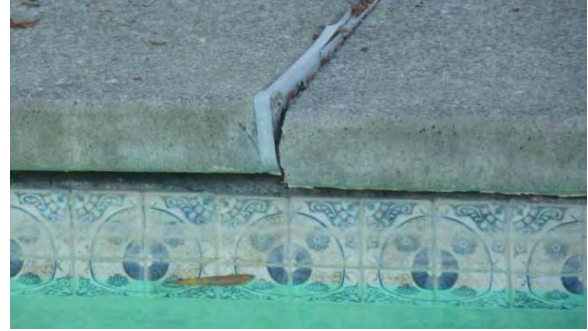
Image 38 - Misaligned paving at pool

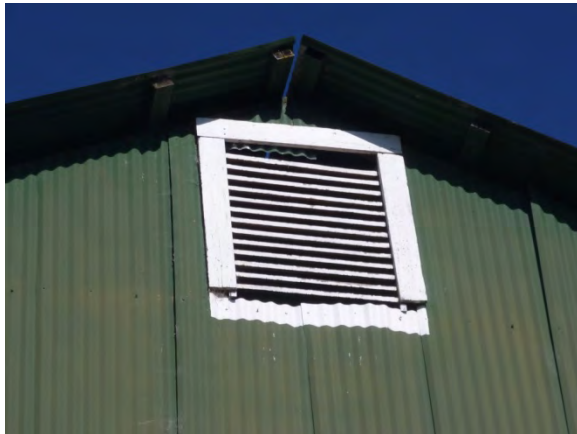
Image 53 – Gable vent with missing trim

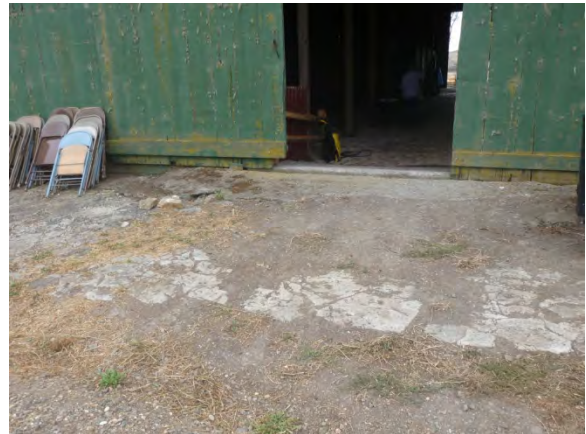
Concrete poured to allow access over the concrete perimeter foundation is poorly installed, poses a trip hazard, and does not provide an even slope from grade. This concrete covers the barn's stone pavers where they extend outside the north end of the building.

Image 54 – Stone and concrete paving at north entrance

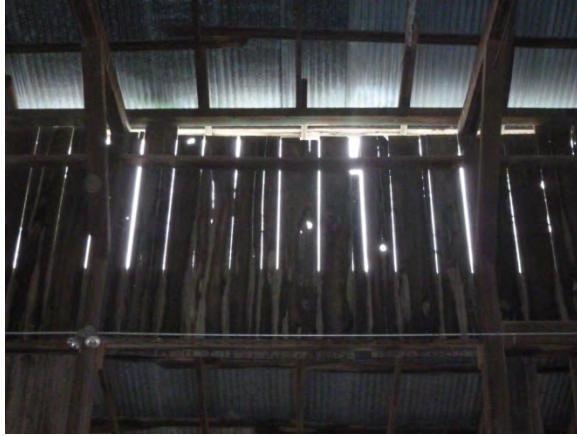
Image 55 - Interior view showing condition of siding

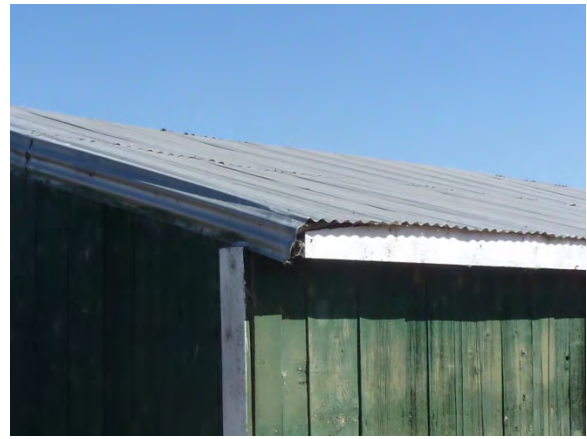
Image 71 - Metal Roofing, wrapped at gable end

The corrugated metal roofing is in poor condition. Some panels are bent, have missing fasteners and small holes, and rust staining on the exterior. The panels do not meet at the ridge, but there is no ridge cap covering the space between them.

- Cut back overgrown vegetation and re-grade around building to provide positive drainage away from perimeter.
- Replace corrugated metal roofing.
- Reattach loose wood siding and trim; replace severely deteriorated boards.
- Repair wood doors, replacing damaged boards; secure in place.
- Paint all wood elements.
- Provide interpretive signage nearby building.

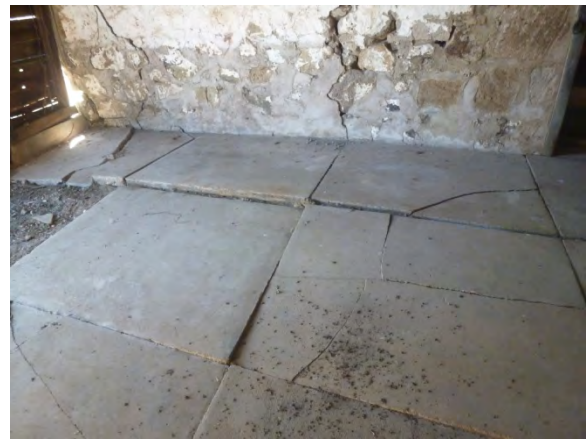
The concrete floor of the original, west portion of the building is in fair condition. Both levels of the east portion of the building are in very poor condition, becoming extremely poor at the lower level, with settlement/heaving and large structural cracks. Conversely, the concrete stair between the two levels is in good condition.

Image 76 - Floor slabs at mid-level of building

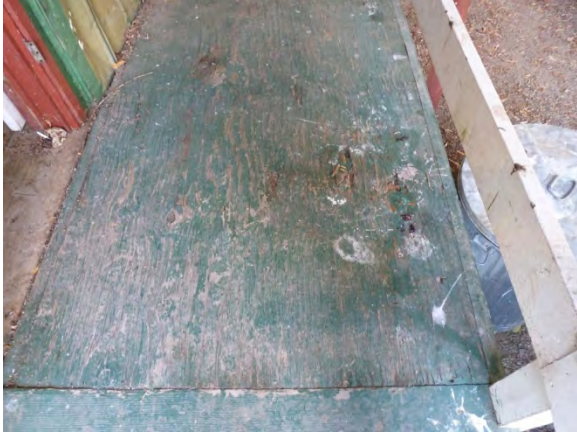
The porch along the west side is in poor condition; the non-compliant plywood ramp and deck are rotting and in contact with the ground. Wood stairs to the north entrance are in fair condition but also have direct wood to earth contact. Trim throughout the Granary is in poor condition: worn, split and rotted.

Image 92 - Deteriorated plywood at ramp to west entrance.

- Provide secure enclosure of space below building.
- Repair entrance doors, including hardware.
- Demolish entrance ramp and porch on west side; reconstruct new porch, possibly larger and with access at both ends, including a code-compliant ramp.

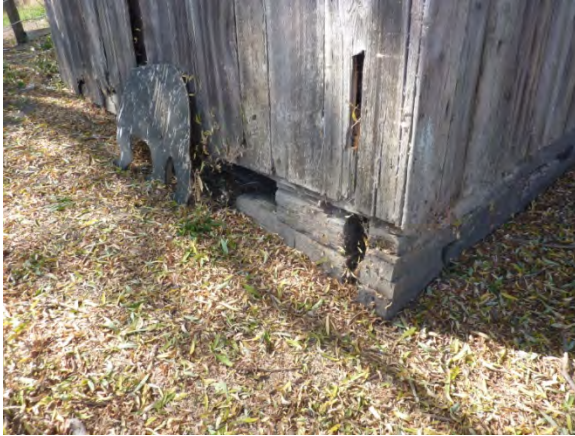
The line shack lacks a foundation and is rests directly on the ground. It lacks diagonal sheathing or structural sheathing at the walls, and lacks structural sheathing at the roof.

Image 99 - Building set on wood skids directly on ground

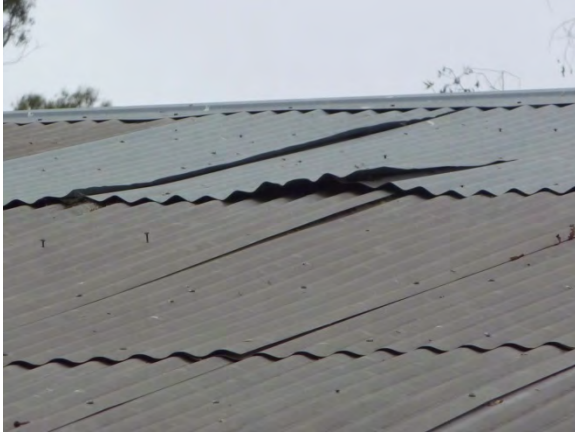
Image 116 - Typical condition of roofing
