Biological Resources Assessment
North Harbor Coastal Trail and Harbor Coastal Trail
Bodega Bay, Sonoma County, CA
September 2011 – revised April 2013

Prepared for: Sonoma County Regional Parks 2300 County Center Drive, Suite 120A Santa Rosa, CA 95403

> Prepared by: Prunuske Chatham, Inc. 400 Morris Street, Suite G Sebastopol, CA 95472

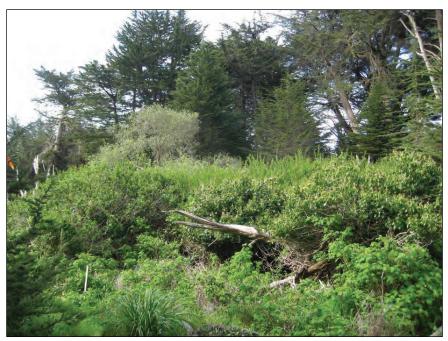
Area of proposed trail alignment at northern limits of the project near Ranch Road; non-native forest is in the background with low-growing shrubs in the foreground.

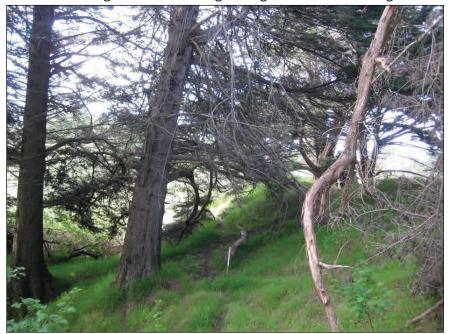
View within the non-native forest; stake represents the proposed trail alignment.

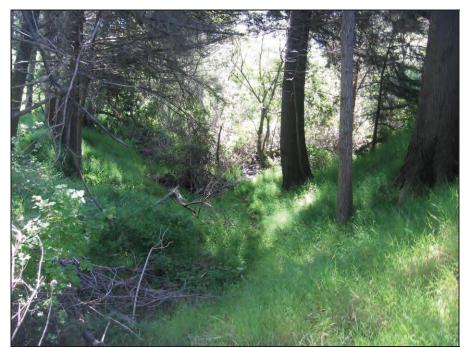
Stream channel under canopy of non-native forest near the end of Ranch Road.

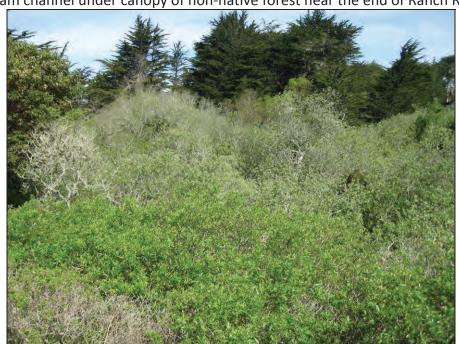
Riparian thicket downstream of Ranch Road.

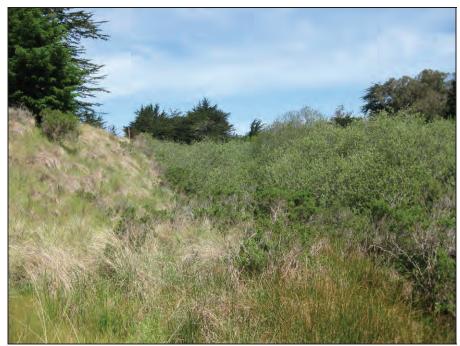
Riparian thicket (right) and small patch of coastal dune habitat (left) within area of proposed trail alignment.

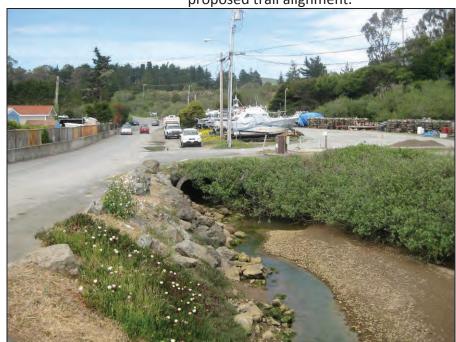
Outlet of Johnson Gulch, looking upstream. Trail will follow existing paved road.

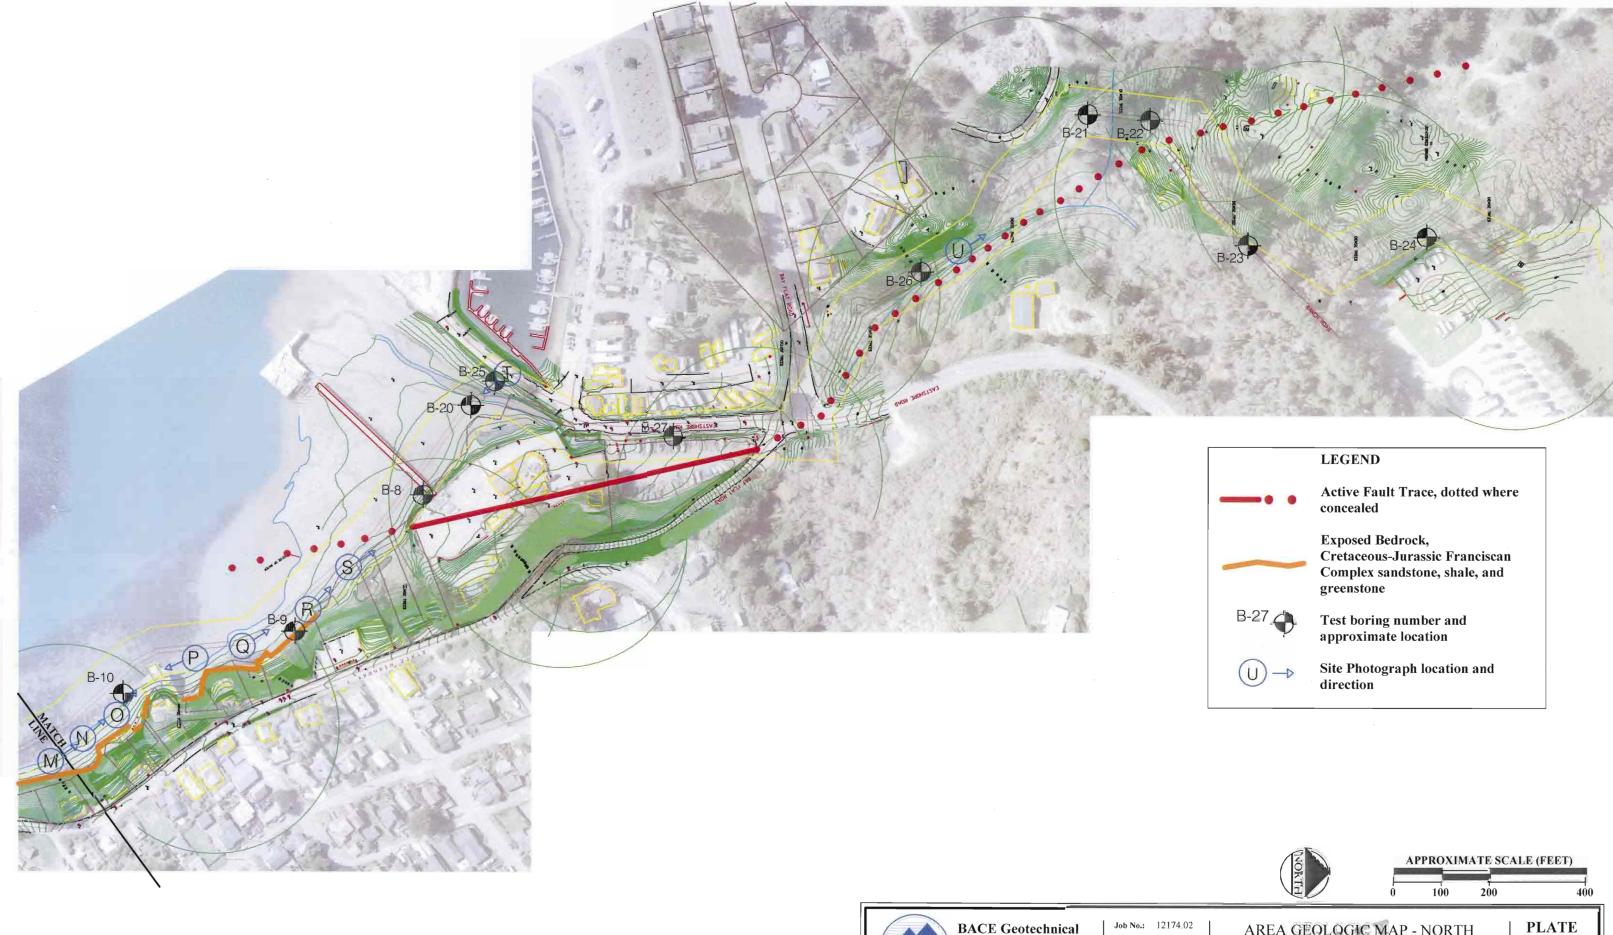
AREA GEOLOGIC MAP - NORTH
BODEGA HANBON COASTAL TRAIL
Bodega Bay
Sonoma County, California

REFERENCE: Harbor Coastal Trail Topographic Site Map Figure 1, by Sonoma County Regional Parks Department

*** Elevations interpolated from Area Geologic Map - North, - Central, and - South, See Plates 2A, 2B, and 2C.

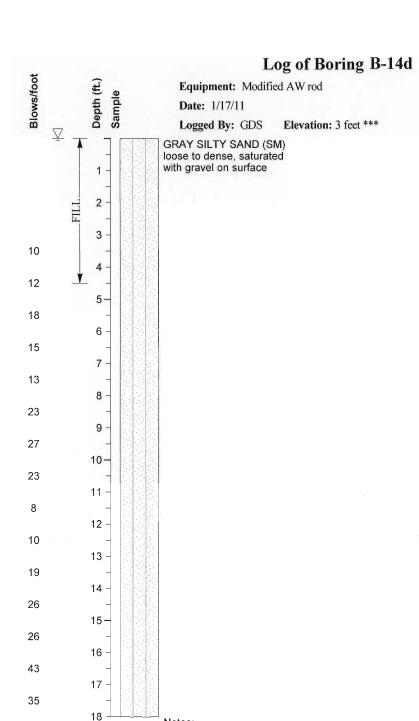
Notes:
1. Water level at surface during low tide

2. Hole closed to about 3 feet after rods pulled

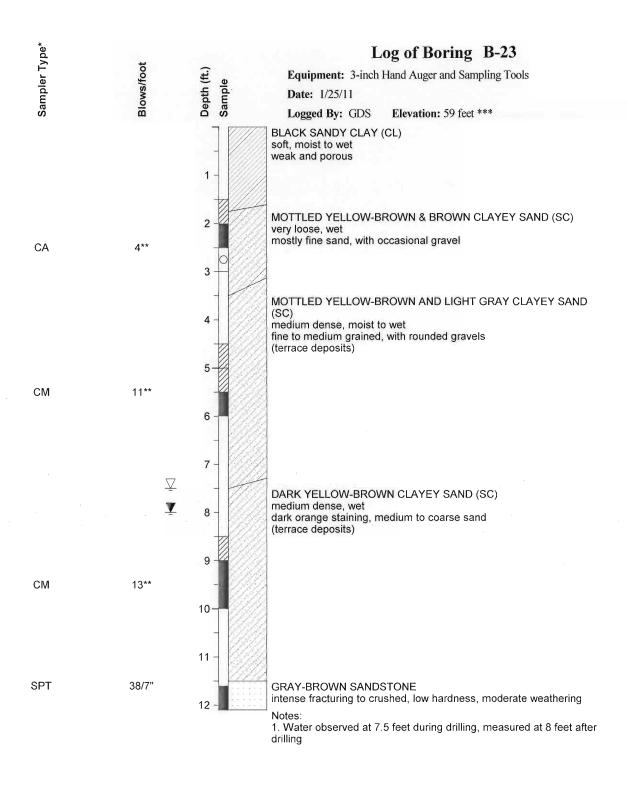
PLATE

BODEGA HARBOR COASTAL TRAIL Bodega Bay Sonoma County, California

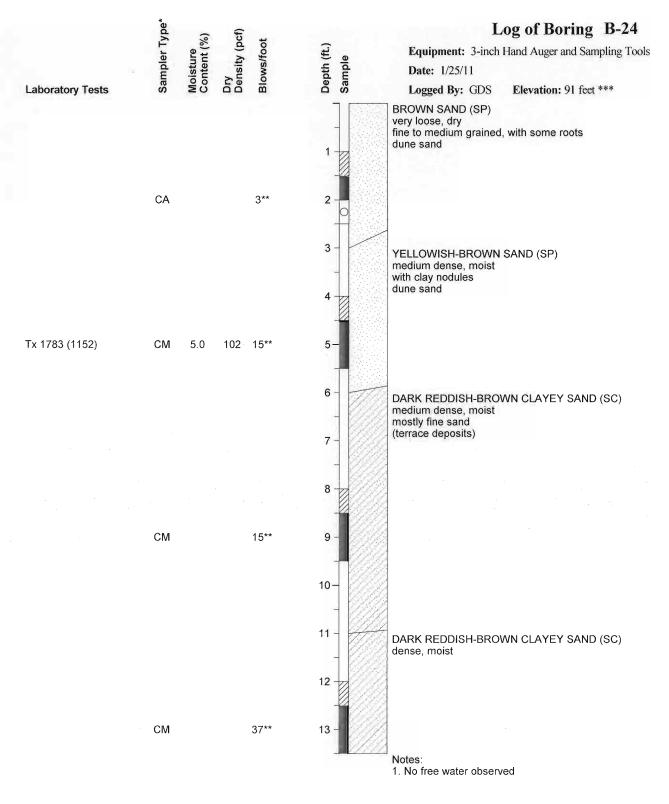
PLATE

BODEGA HARBOR COASTAL TRAIL Bodega Bay Sonoma County, California

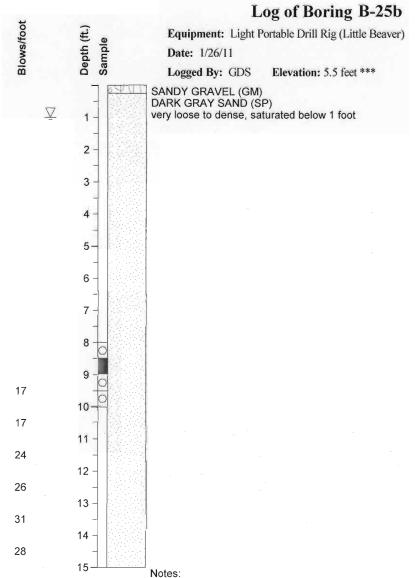
PLATE

BODEGA HARBOR COASTAL TRAIL Bodega, Bay Sonoma County, California

1. Water observed at 1 foot during drilling

2. Caving to 4 feet

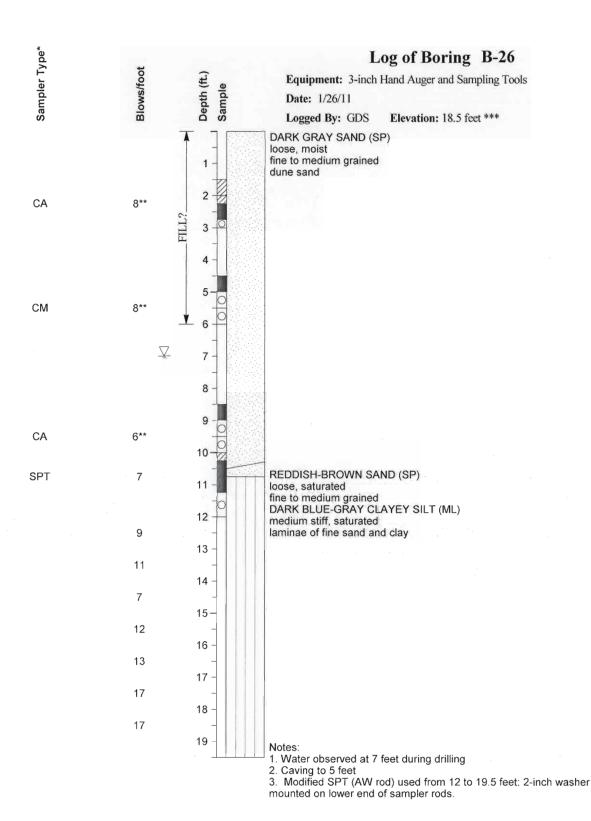
PLATE 31

Sonoma County, California

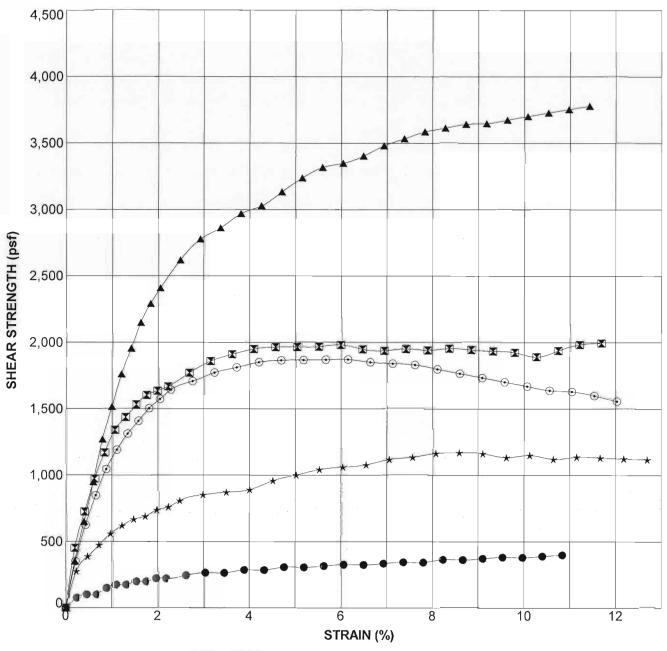
Sample Source	Classification	Confining Pressure (psf)	Yield Strength (psf)	Strain (%)	Dry Density (pcf)	Moisture Content (%)
B-4 at 6 ft	DARK GRAY SANDSTONE	720	149	0.9	106	19.9
■ B-5 at 1 ft	DARK GRAY SANDSTONE AND SHALE	720	1669	2.2	133	6.3
▲ B-6 at 2.5 ft	DARK GRAY SHALE	720	2778	2.9	141	7.9
★ B-9 at 5 ft	DARK GRAY SHALE	720	738	2.0	134	8.5
⊙ B-11b at 10.5 ft	MOTTLED DARK YELLOW-BROWN SANDSTONE	1296	1643	2.3	111	12.9

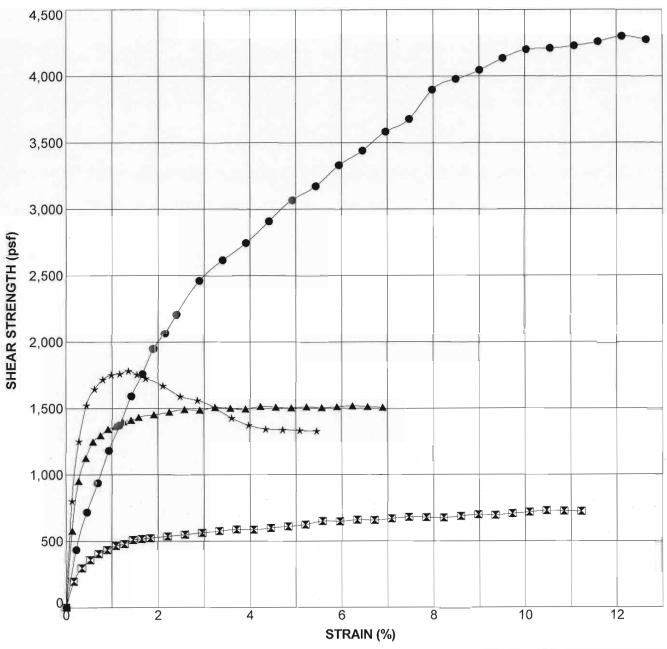
UNCONSOLIDATED UNDRAINED TRIAXIAL COMPRESSION
TEST RESULTS
BODEGA HARBOR COASTAL TRAIL
Bodega Exy
Sonoma County, California

Sample Source	Classification	Confining Pressure (psf)	Yield Strength (psf)	Strain (%)	Dry Density (pcf)	Moisture Content (%)
● B-16 at 4 ft	GRAY SANDSTONE	864	2744	3.9	124	14.3
▼ B-18 at 5.2 ft	MOTTLED BROWN GRAVELLÝ SANDY CLAY (CL)	1008	465	1.1	112	8.1
▲ B-22 at 5 ft	YELLOW-BROWN & GRAY-BROWN SAND (SP)	720	1410	1.4	91	5.3
★ B-24 at 5 ft	YELLOWISH-BROWN SAND (SP)	1152	1783	1.4	102	5.0

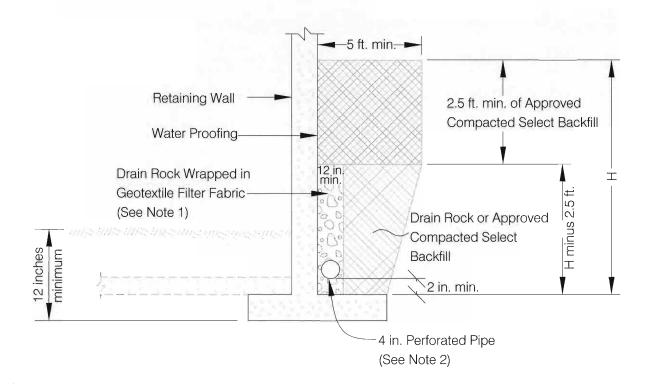
RETAINING WALL DRAINAGE DETAIL (Not to Scale)

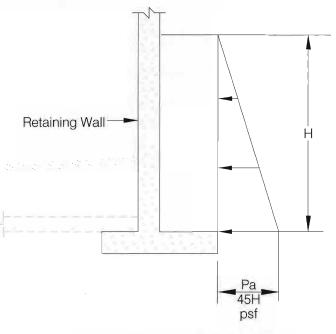
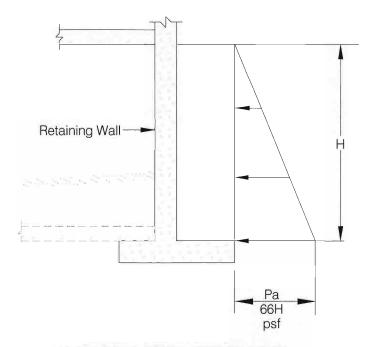
AT-REST SOIL PRESSURES DIAGRAM For braced walls of substantial rigidity (See Note 2)

- (1) The above are level backfill soil pressures only and do not include lateral loads resulting from other sources such as traffic, floor loads, adjacent foundations or other vertical loads.
- (2) If the wall at surface of the backfill cannot yield about 0.1% of its height, at-rest soil pressures should be used.
- (3) The above pressures assume a drained condition. See Plate 52 for drainage and backfill details.
- (4) The above pressures should be used where backfill slope is flatter than 3 horizontal to 1 vertical (3H:1V). Where backfill slope is between 3H:1V and 1.5H:1V, use active pressure of 55H psf and at-rest pressure of 87H psf, respectively.
- (5)For design seismic pressures see the Retaining Walls Section of this report.

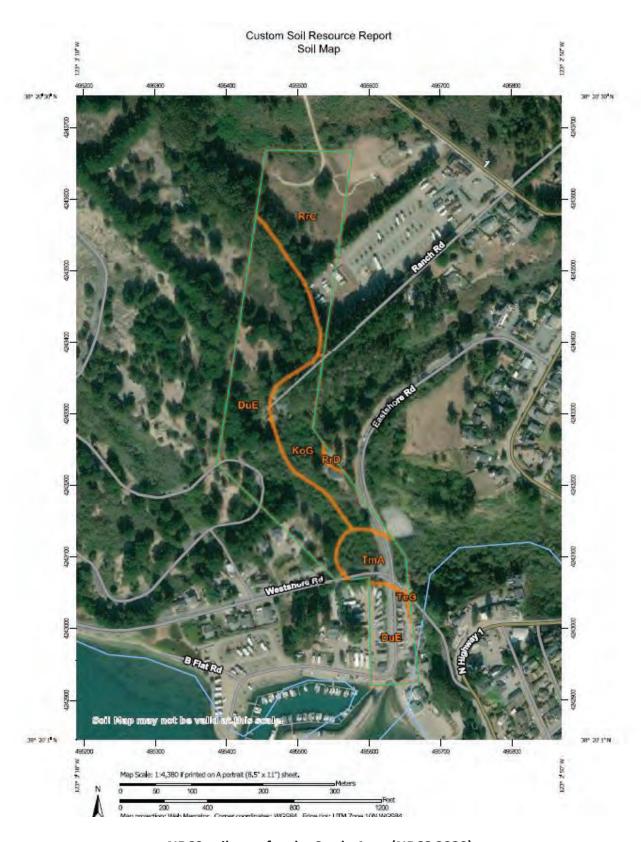
Soils within the Study Area are mapped as Rohnerville loam, 0-9% slopes (RrC), dune land (DuE), and tidal marsh (TmA) (NRCS 2020). Rohnerville loams occurs at the beginning of the trail near the parking lot and intersection with the Coastal Prairie Trail. This is a moderately well-drained soil found on terraces. The parent material is alluvium derived from sedimentary rock. The soil profile includes loam from 0-16 inches and sandy clay loam and sandy clay from 16 to 60 inches. It is more than 80 inches to a restrictive layer and the runoff class is high. Dune land is found along the majority of the trail alignment, along the drainage and adjacent to the campground. Dune lands are comprised entirely of loose, shifting sand. The corner of Bay Flat Road and Eastshore Road at the lower limits of the trail is mapped as tidal marsh. Historically, this area may have been a tidal flat and frequently inundated.

NRCS soil map for the Study Area (NRCS 2020).

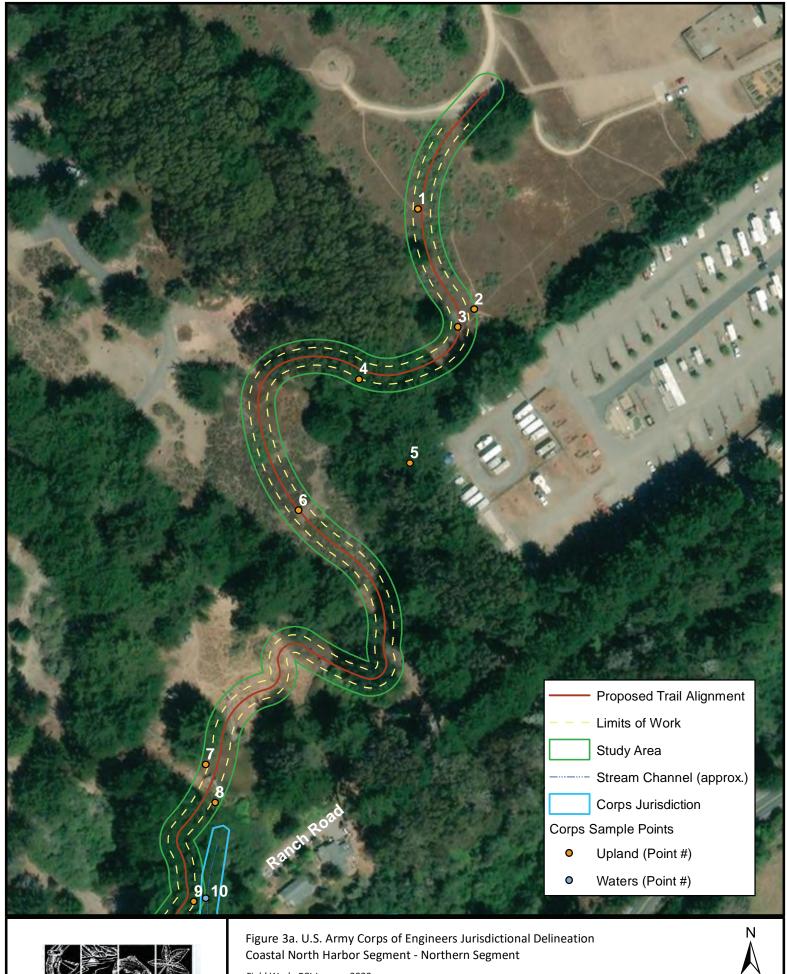
Hydrology indicators were observed at Sample Points #10, 12, and 16. These included inundation and saturated conditions. Redoximorphic features were observed in the floodplain adjacent to the channel at Sample Point #16; however, a formal data point was not collected at this location. All other sample points lacked positive hydrology indicators.

Table 1. Delineation Plots and Preliminary Determinations

Sample Point	Paired Point	Corps Preliminary Determination	CCC Preliminary Determination	Hydrophytic Vegetation?	Hydric Soils?	Hydrology?
1	-	Upland	Upland	No	No	No
2	-	Upland	Upland	No	No	No
3	-	Upland	Upland	No	No	No
4	-	Upland	Upland	No	No	No
5	-	Upland	Upland	No	No	No
6	-	Upland	Upland	No	No	No
7	-	Upland	Upland	No	No	No
8	-	Upland	Upland	No	No	No
9	10	Upland	Upland	No	No	No
10	9	Waters	Wetland/Waters	No	Yes	Yes
11	12, 13	Upland	Wetland	Yes	No	No
12	11, 13	Waters	Wetland/Waters	Yes	Yes	Yes
13	11, 12	Upland	Upland	No	No	No
14	-	Upland	Upland	No	No	No
15	16	Upland	Upland	No	No	No
16	15	Waters	Wetland/Waters	No	Yes	Yes

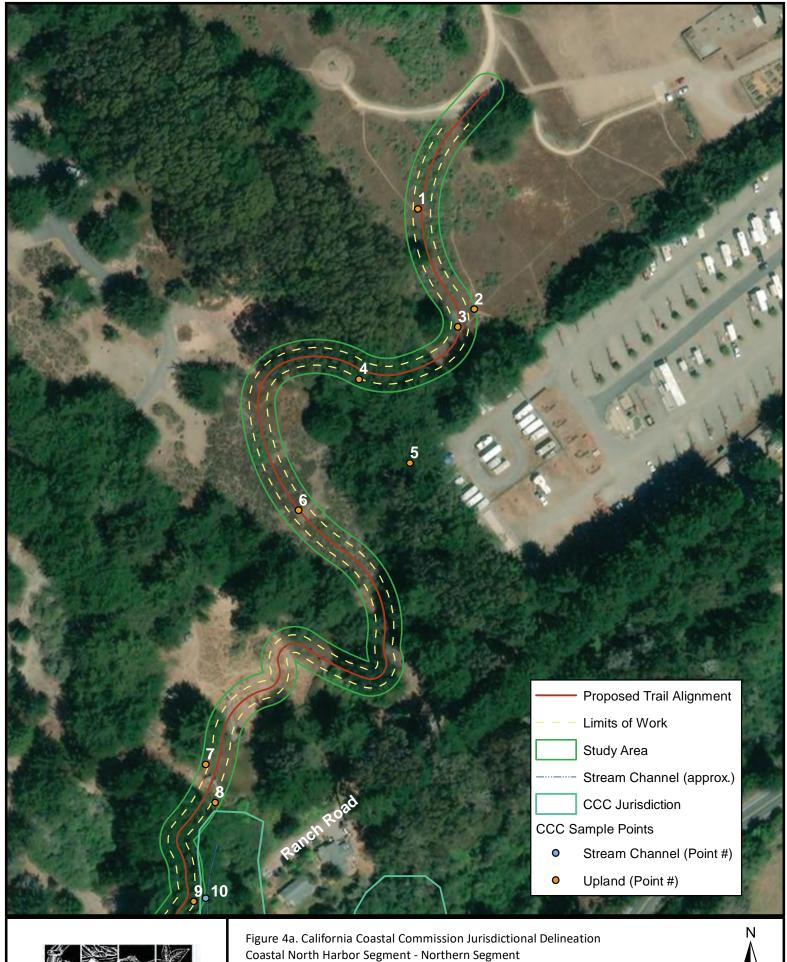
Coastal North Harbor Segment - Northern Segment

Trail Features: Questa Engineering Corp.

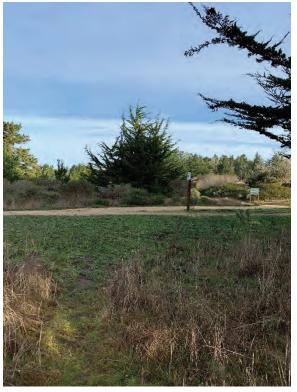
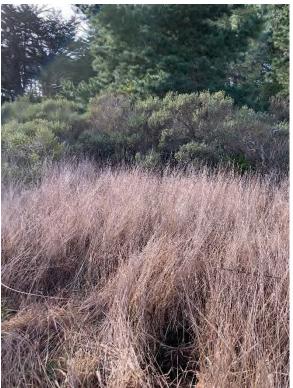
Trail entrance near Coastal Prairie Trail (top) and Sample Point #1 in coastal scrub (bottom).

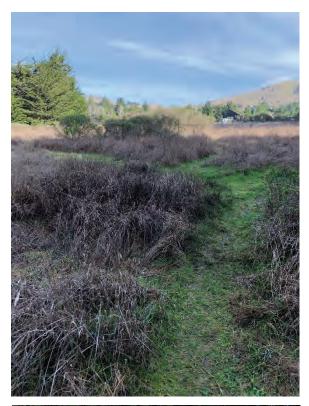
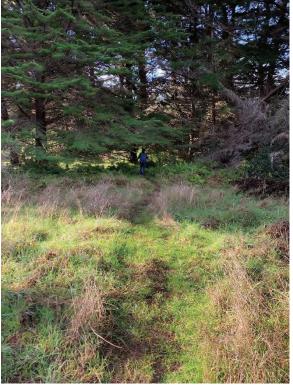
Sample point #2 (top) and trail alignment near Sample Point #3 before entering forested area (bottom).

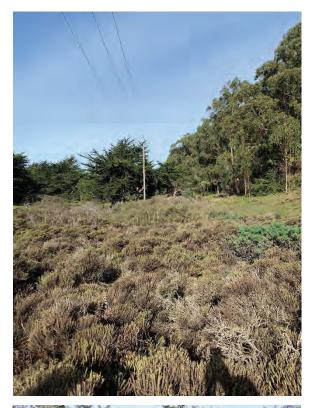
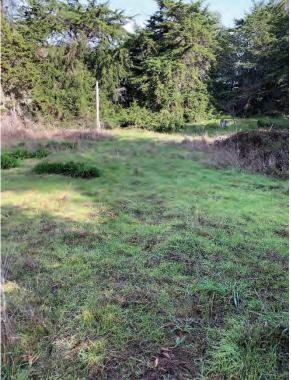
Trail alignment near Sample Point #6 in mock heatherdominated dune (top) and grassland near amphitheater, immediately north of Sample Point #7 (bottom).

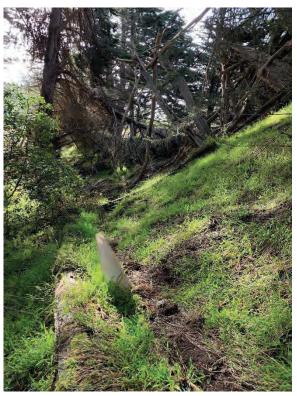
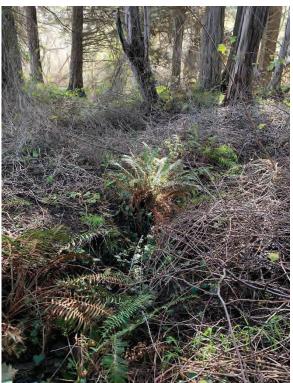
Trail alignment through cypress grove (top) and Sample Point #10 with channel (bottom).

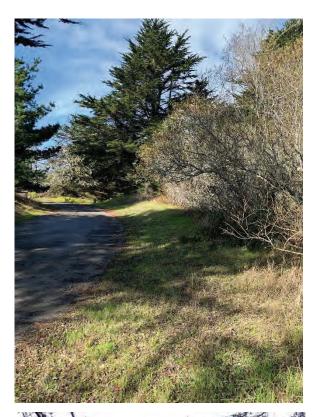
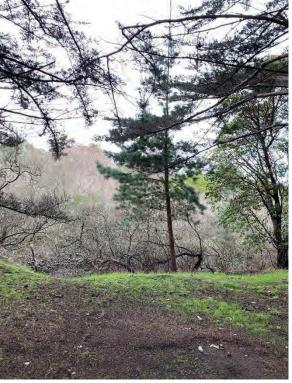
Trail alignment along edge of road through campground (top) and Sample Point # 13 and trail area adjacent to campground site # 86 (bottom).

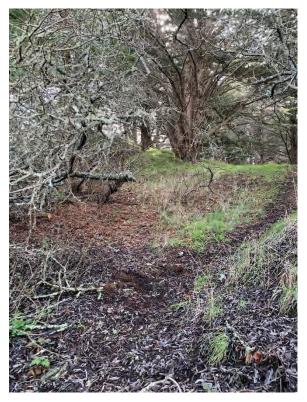
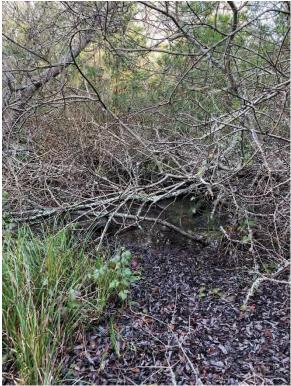
Sample Point #11 in willow thicket at edge of trail alignment (top) and #12, with channel (bottom).

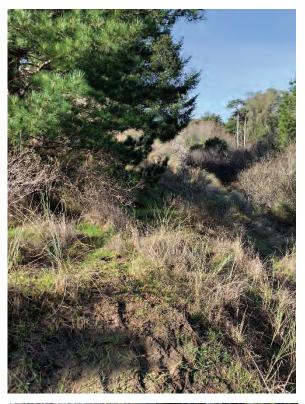
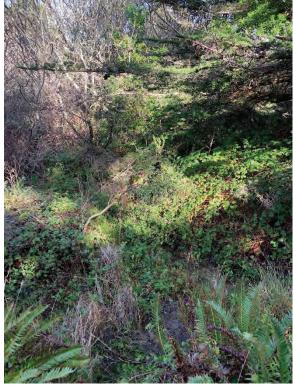
Trail alignment through dune and Sample Point #15 (top) and Sample Point #16 with channel bottom).

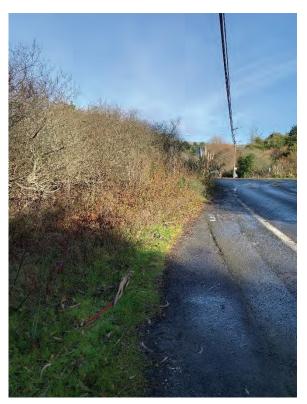
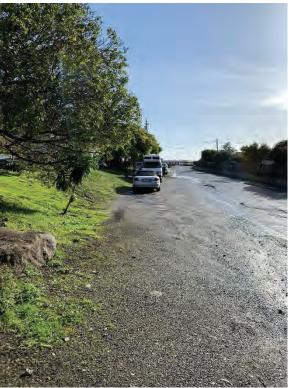
Trail alignment along Bay Flat Road (top) and terminating near Bodega Harbor (bottom).
