TOLAY LAKE REGIONAL PARK MASTER PLAN SUMMARY OF PHASE 1 COMMUNITY QUESTIONNAIRE RESULTS

Introduction.....	1
Purpose of the Historic Structures Report.....	1
Methodology.....	1
Summary of Findings.....	2
Development History.....	3
Historical Overview and Context.....	3
Chronology of Development and Use.....	8
Significance and Integrity.....	10
Physical Descriptions, Conditions, & Treatment Recommendations.....	11
Site.....	11
Building 1: Cottage/Julie’s House/Little Green House.....	13
Building 4: George and Vera’s House/Green House.....	20
Building 5: John Jr. and Beatrice’s House/Yellow House.....	31
Building 6: Hay Barn/Old Stone Floor Barn.....	41
Building 7: Old Dairy Barn.....	48
Building 8: Creamery/ Wine Storage.....	52
Building 9: Granary/Museum.....	59
Building 10: Line Shack.....	67
Building 12: Old Shop/Workshop.....	71
Building 13: Tractor Barn/ Equipment barn.....	78
Building 14: Storage Shed/ Equipment Shed.....	84
Building 15: Slaughterhouse.....	90
Additional Recommendations.....	95

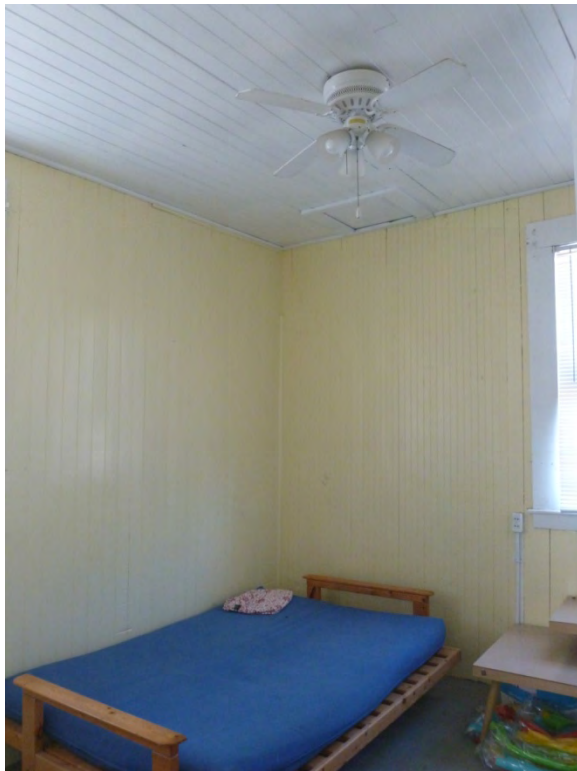
Image 3 - Bedroom with various types of wood paneling

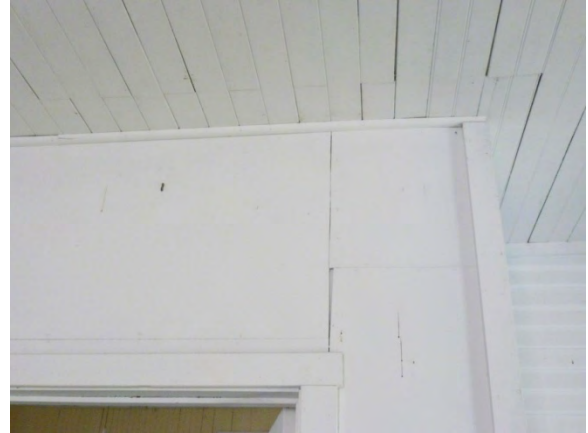
Image 9 - Random interior wood paneling at Cottage

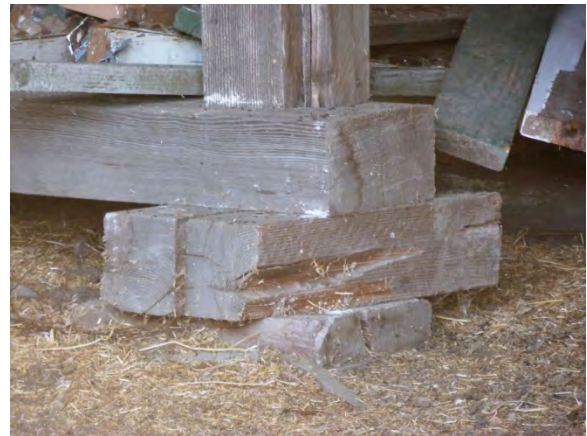
Image 60 - Wood framing resting directly on grade

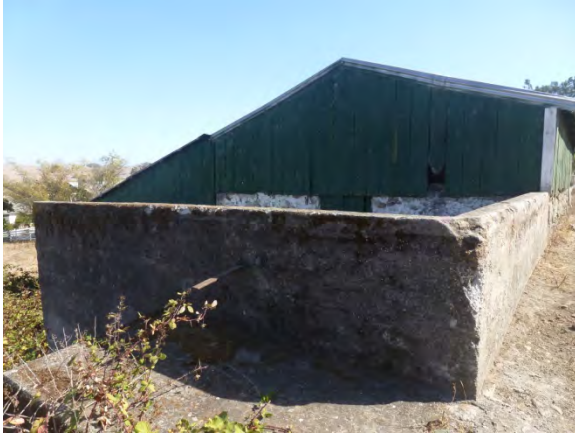
Image 67 - Concrete walls on north side of creamery

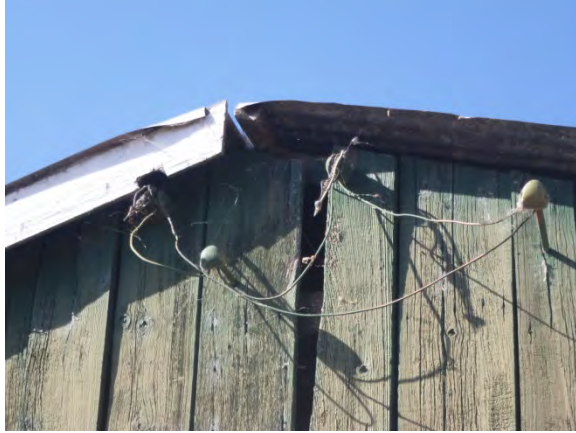
Image 72 - Condition at ridge

The corrugated metal roofing is in poor condition. Some panels are bent, have missing fasteners and small holes, and rust staining on the exterior. The panels do not meet at the ridge, but there is no ridge cap covering the space between them.

- Cut back overgrown vegetation and re-grade around building to provide positive drainage away from perimeter.
- Replace corrugated metal roofing.
- Reattach loose wood siding and trim; replace severely deteriorated boards.
- Repair wood doors, replacing damaged boards; secure in place.
- Paint all wood elements.
- Provide interpretive signage nearby building.

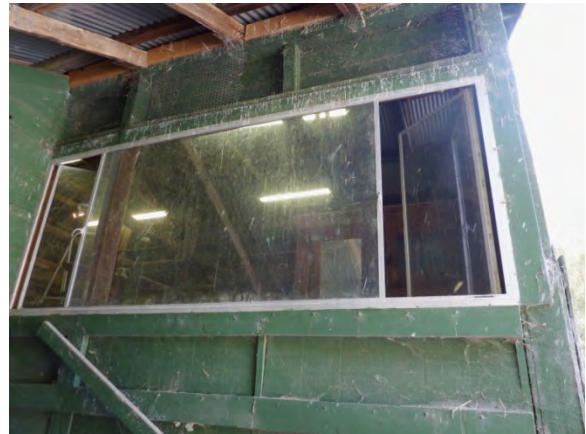
Aluminum windows are in poor condition. Two gable end windows that have been in-filled with corrugated fiberglass panels (one with a nailed on screen) are also in poor condition.

Image 91 - Poorly installed window adjacent to entrance.

- Add concrete curb at bottom of north entrance stair.
- Repair chicken coop partitions and roof as required.
- Replace deteriorated aluminum windows; replace window in north gable and fiberglass paneled openings in south gable and dormer.

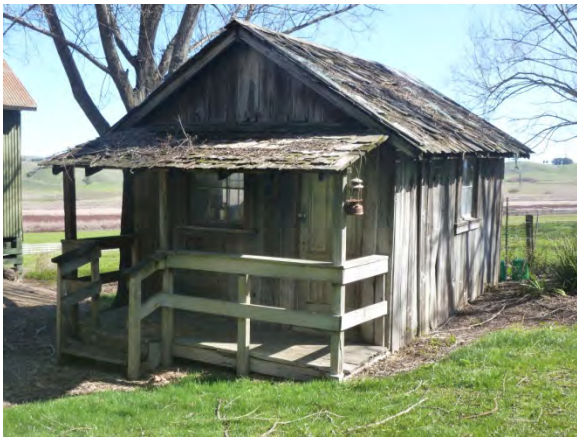
Image 96 – Front of Line Shack, facing north, leaning toward west

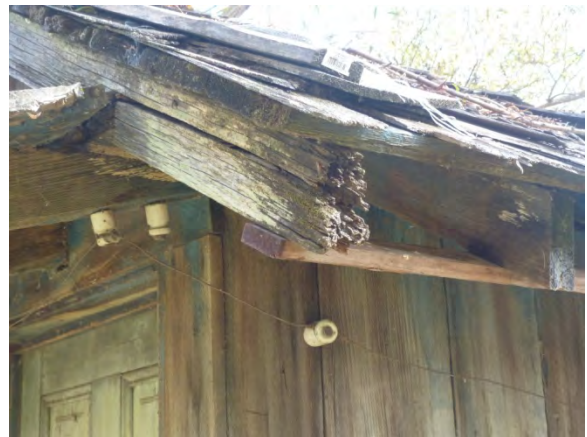
Image 98 - Roofing and structure at west side

The wood shingle roofing is in very poor condition. The east side has been covered by a tarp, which is now also deteriorated.

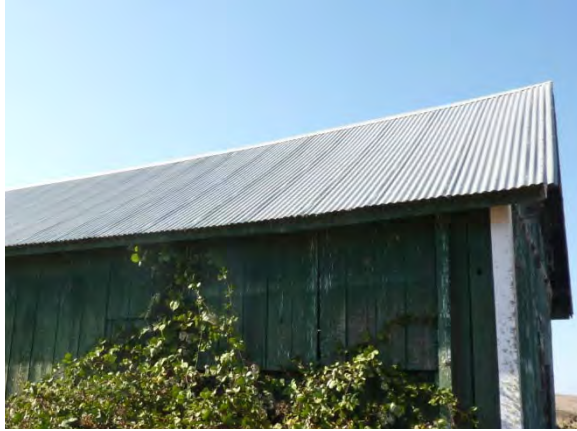
Image 136 - General condition of roofing.
